Pavement Condition Report

Grand Rapids - Itasca County Airport (GPZ)

December 2016

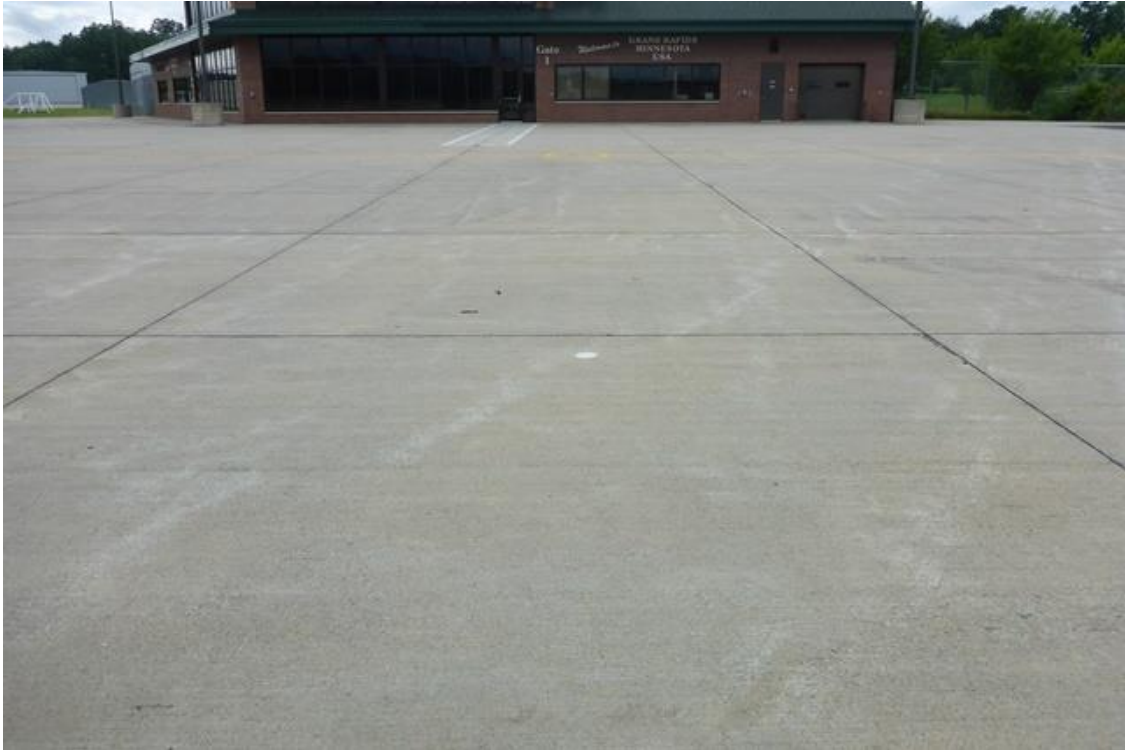
GPZ APA 001 (PCI = 98)

Network:	GPZ	Name:	GRAND RAPIDS						
Branch:	APA	Name:	APRON A	Use:	APRON	Area:	358,981 SqFt		
Section:	001	of 4	From:	100	To:	303	Last Const.:	9/30/1994	
Surface:	PCC	Family:	MN2013 PCC	Zone:	E	Category:	3	Rank:	S
Area:	48,981 SqFt	Length:	327 Ft	Width:	150 Ft				
Slabs:	280	Slab Length:	14 Ft	Slab Width:	13 Ft	Joint Length:	6,941 Ft		
Shoulder:		Street Type:		Grade:	0	Lanes:	0		
Section Comments:									
Last Insp. Date:	7/13/2016	TotalSamples:	12	Surveyed:	3				
Conditions:	PCI: 98								
Inspection Comments:									
Sample Number:	100	Type:	R	Area:	28.00 Slabs	PCI:	96		
Sample Comments:									
75	CORNER SPALL	L	3.00	Slabs					
Sample Number:	202	Type:	R	Area:	22.00 Slabs	PCI:	100		
Sample Comments:									
<No Distress>									
Sample Number:	303	Type:	R	Area:	28.00 Slabs	PCI:	100		
Sample Comments:									
<No Distress>

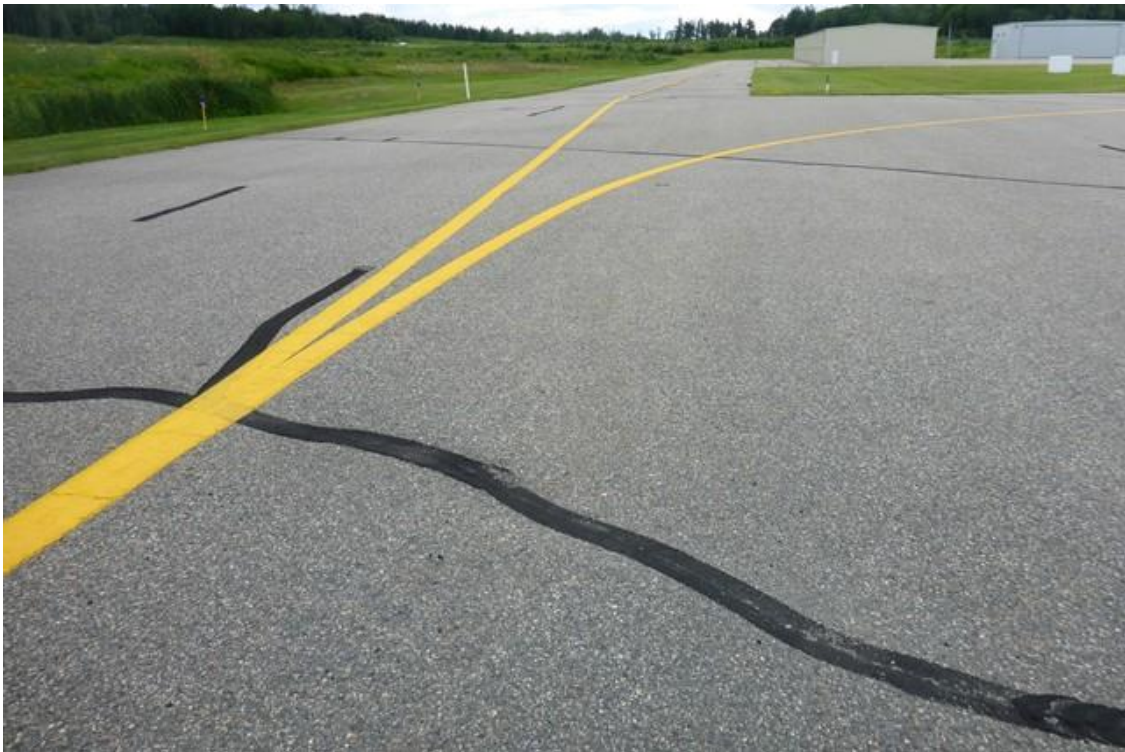
GPZ APA 003 (PCI = 76)

Network:	GPZ	Name:	GRAND RAPIDS						
Branch:	APA	Name:	APRON A	Use:	APRON	Area:	358,981 SqFt		
Section:	003	of 4	From:	100	To:	303	Last Const.: 8/5/2005		
Surface:	AC	Family:	MN2013 Asphalt Aprons	Zone:	E	Category:	3	Rank:	S
Area:	45,500 SqFt	Length:	375 Ft	Width:	100 Ft				
Slabs:	Slab Length:	Ft	Slab Width:	Ft	Joint Length:	Ft			
Shoulder:	Street Type:		Grade:	0	Lanes:	0			
Section Comments:									
Last Insp. Date:	7/13/2016	TotalSamples:	10	Surveyed:	2				
Conditions:	PCI: 76								
Inspection Comments:									
Sample Number:	101	Type:	R	Area:	5000.00 SqFt	PCI:	82		
Sample Comments:									
48	L & T CR	L	328.00	Ft					
Sample Number:	202	Type:	R	Area:	4800.00 SqFt	PCI:	69		
Sample Comments:									
41	ALLIGATOR CR	M	20.00	SqFt					
48	L & T CR	L	220.00	Ft					
48	L & T CR	M	14.00	Ft

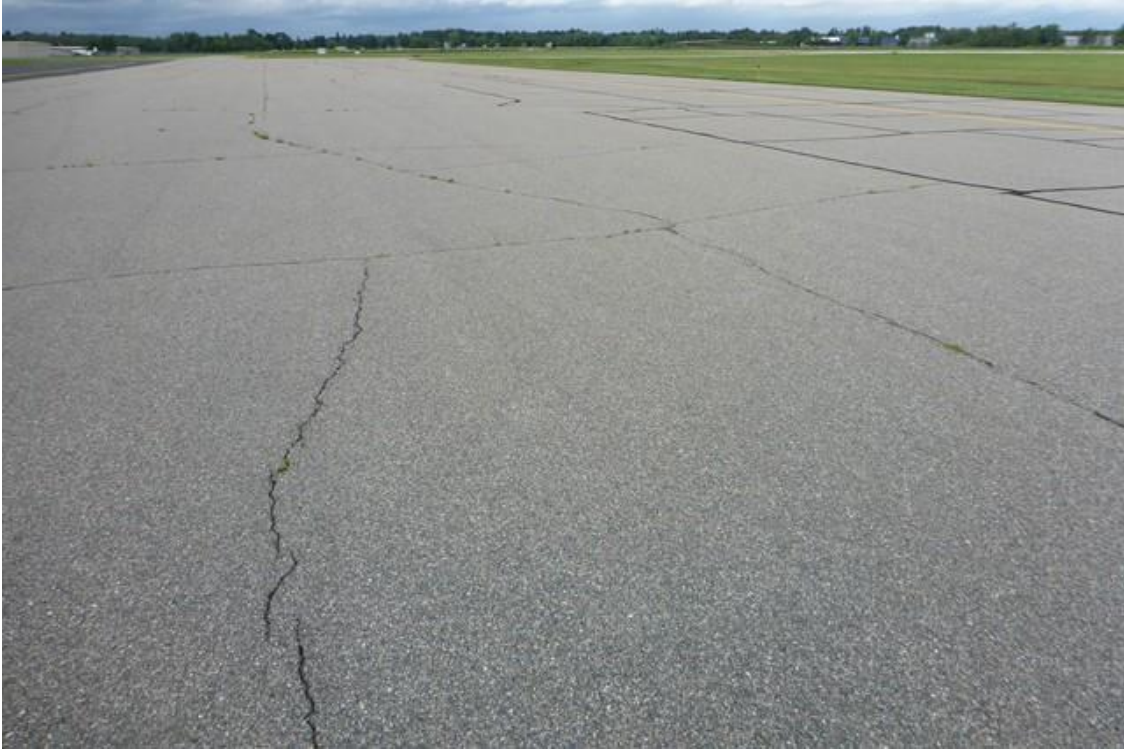
GPZ APA 02A (PCI = 70)

Network:	GPZ	Name:	GRAND RAPIDS						
Branch:	APA	Name:	APRON A	Use:	APRON	Area:	358,981 SqFt		
Section:	02A	of 4	From:	100	To:	307	Last Const.:	8/5/2005	
Surface:	AAC	Family:	MN2013 Asphalt Aprons	Zone:	E	Category:	3	Rank:	S
Area:	93,000 SqFt	Length:	750 Ft	Width:	124 Ft				
Slabs:		Slab Length:	Ft	Slab Width:	Ft	Joint Length:	Ft		
Shoulder:		Street Type:		Grade:	0	Lanes:	0		
Section Comments:									
Last Insp. Date:	7/13/2016	TotalSamples:	24	Surveyed:	4				
Conditions:	PCI: 70								
Inspection Comments:									
Sample Number:	101	Type:	R	Area:	5000.00 SqFt	PCI:	69		
Sample Comments:									
48	L & T CR	L	845.00	Ft					
Sample Number:	105	Type:	R	Area:	5000.00 SqFt	PCI:	69		
Sample Comments:									
48	L & T CR	M	40.00	Ft					
48	L & T CR	L	615.00	Ft					
Sample Number:	203	Type:	R	Area:	5000.00 SqFt	PCI:	71		
Sample Comments:									
48	L & T CR	M	190.00	Ft					
48	L & T CR	L	493.00	Ft					
Sample Number:	206	Type:	R	Area:	5000.00 SqFt	PCI:	71

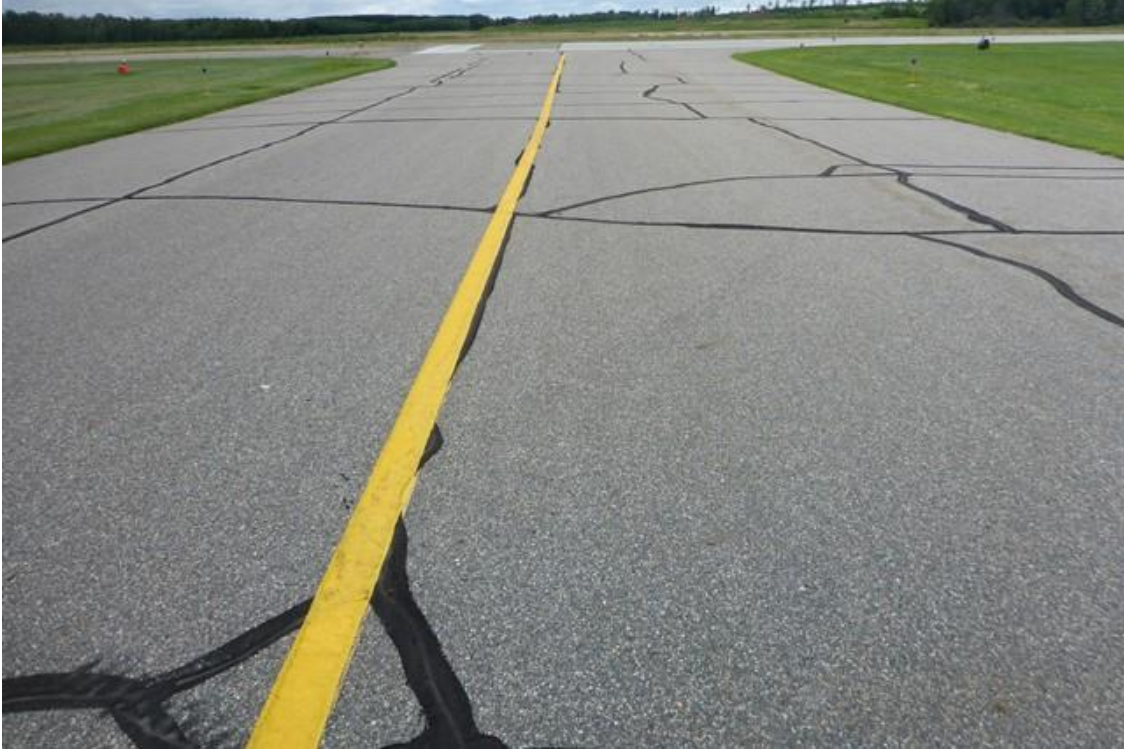
GPZ CTA 001 (PCI = 69)

Network:	GPZ	Name:	GRAND RAPIDS						
Branch:	CTA	Name:	CONNECTING TAXIWAY A	Use:	TAXIWAY	Area:	18,000 SqFt		
Section:	001	of 1	From:	400	To:	402	Last Const.: 8/30/2005		
Surface:	AC	Family:	MN2013 Asphalt Taxiways	Zone:	E	Category:	3	Rank:	P
Area:	18,000 SqFt	Length:	340 Ft	Width:	50 Ft				
Slabs:		Slab Length:	Ft	Slab Width:	Ft	Joint Length:	Ft		
Shoulder:		Street Type:		Grade:	0	Lanes:	0		
Section Comments:									
Last Insp. Date:	7/13/2016	TotalSamples:	3	Surveyed:	1				
Conditions:	PCI: 69								
Inspection Comments: Crack Seal OK									
Sample Number:	401	Type:	R	Area:	5000.00 SqFt	PCI:	69		
Sample Comments:									
48	L & T CR	M	3.00 Ft						
48	L & T CR	L	673.00 Ft

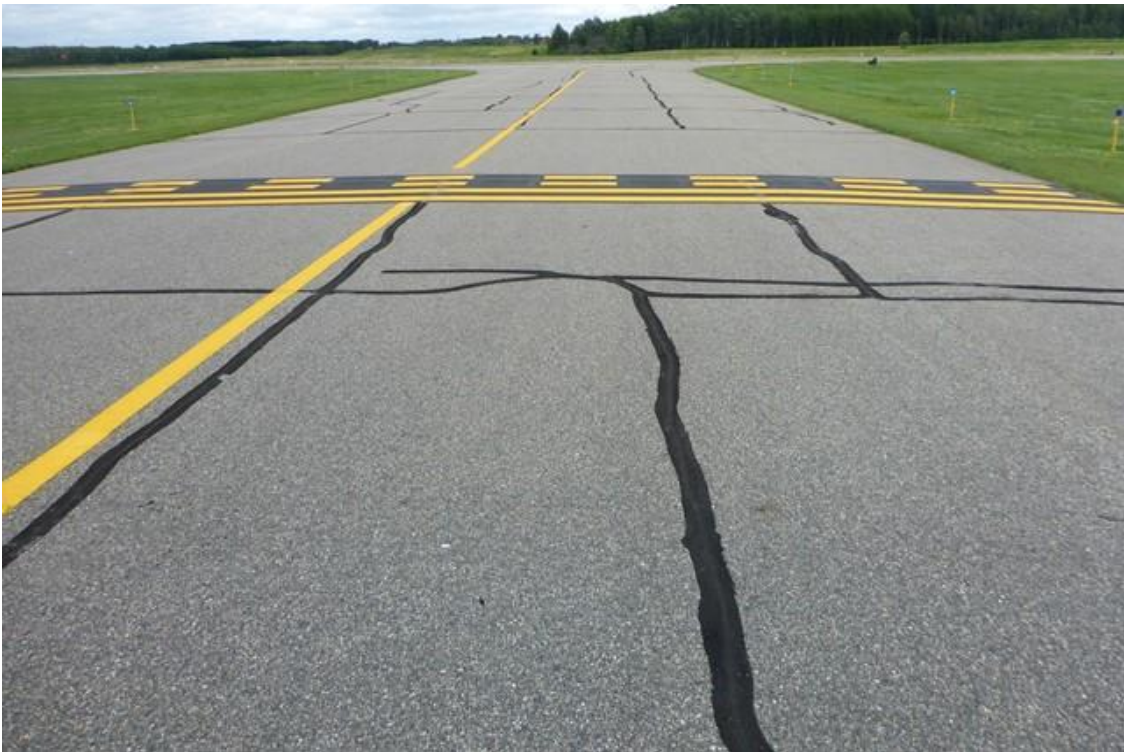
GPZ CTA1 001 (PCI = 70)

Network:	GPZ	Name:	GRAND RAPIDS						
Branch:	CTA1	Name:	CONNECTING TAXIWAY A1	Use:	TAXIWAY	Area:	18,400 SqFt		
Section:	001	of 1	From:	300	To:	302	Last Const.: 8/30/2005		
Surface:	AC	Family:	MN2013 Asphalt Taxiways	Zone:	E	Category:	3	Rank:	P
Area:	18,400 SqFt	Length:	340 Ft	Width:	50 Ft				
Slabs:		Slab Length:	Ft	Slab Width:	Ft	Joint Length:	Ft		
Shoulder:		Street Type:		Grade:	0	Lanes:	0		
Section Comments:									
Last Insp. Date:	7/13/2016	TotalSamples:	3	Surveyed:	1				
Conditions:	PCI: 70								
Inspection Comments:									
Sample Number:	301	Type:	R	Area:	5000.00 SqFt	PCI:	70		
Sample Comments:									
48	L & T CR	M	20.00	Ft					
48	L & T CR	L	566.00	Ft

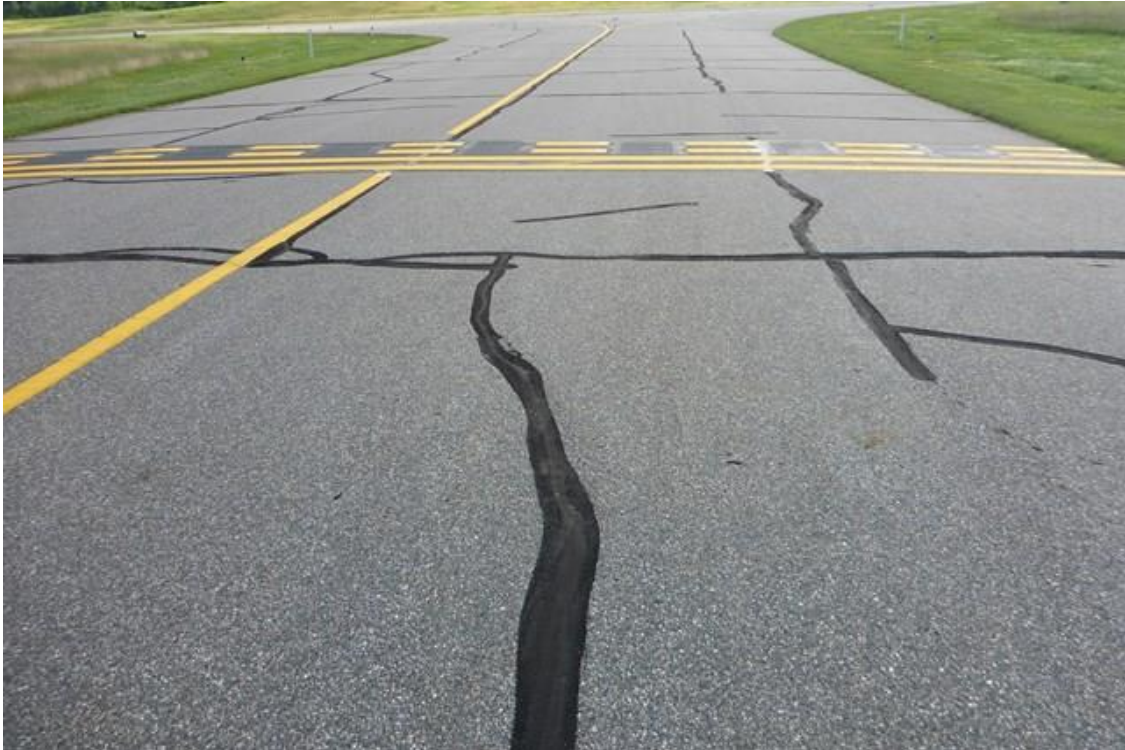
GPZ CTA2 001 (PCI = 72)

Network:	GPZ	Name:	GRAND RAPIDS						
Branch:	CTA2	Name:	CONNECTING TAXIWAY A2	Use:	TAXIWAY	Area:	21,875 SqFt		
Section:	001	of 2	From:	201	To:	202	Last Const.: 8/30/2005		
Surface:	AC	Family:	MN2013 Asphalt Taxiways	Zone:	E	Category:	3	Rank:	S
Area:	12,675 SqFt	Length:	240 Ft	Width:	50 Ft				
Slabs:		Slab Length:	Ft	Slab Width:	Ft	Joint Length:	Ft		
Shoulder:		Street Type:		Grade:	0	Lanes:	0		
Section Comments:									
Last Insp. Date:	7/13/2016	TotalSamples:	2	Surveyed:	1				
Conditions:	PCI: 72								
Inspection Comments: Crack Seal OK									
Sample Number:	201	Type:	R	Area:	5000.00 SqFt	PCI:	72		
Sample Comments:									
48	L & T CR	M	2.00 Ft						
48	L & T CR	L	530.00 Ft

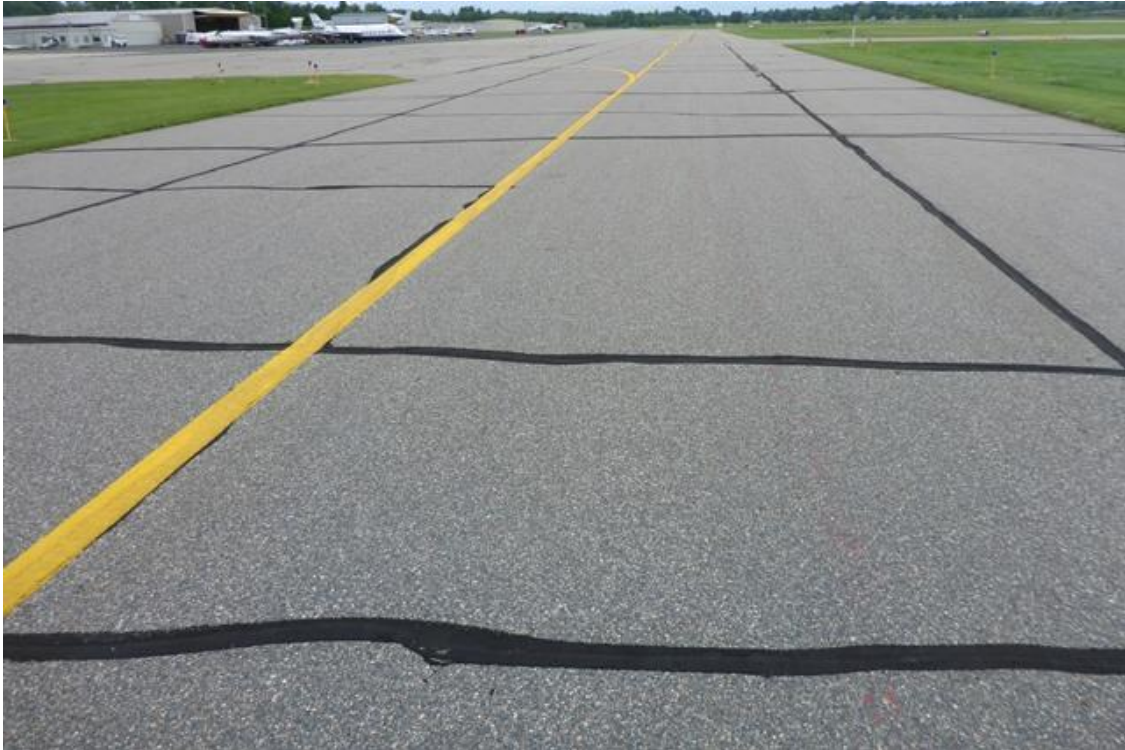
GPZ PTA 001 (PCI = 73)

Network:	GPZ	Name:	GRAND RAPIDS						
Branch:	PTA	Name:	PARALLEL TAXIWAY A	Use:	TAXIWAY	Area:	275,000 SqFt		
Section:	001	of 4	From:	100	To:	103	Last Const.:	8/30/2005	
Surface:	AC	Family:	MN2013 Asphalt Taxiways	Zone:	E	Category:	3	Rank:	P
Area:	23,250 SqFt	Length:	465 Ft	Width:	50 Ft				
Slabs:		Slab Length:	Ft	Slab Width:	Ft	Joint Length:	Ft		
Shoulder:		Street Type:		Grade:	0	Lanes:	0		
Section Comments:									
Last Insp. Date:	7/13/2016	TotalSamples:	4	Surveyed:	1				
Conditions:	PCI: 73								
Inspection Comments: Crack Seal OK									
Sample Number:	102	Type:	R	Area:	5000.00 SqFt	PCI:	73		
Sample Comments:									
48	L & T CR	L	673.00 Ft

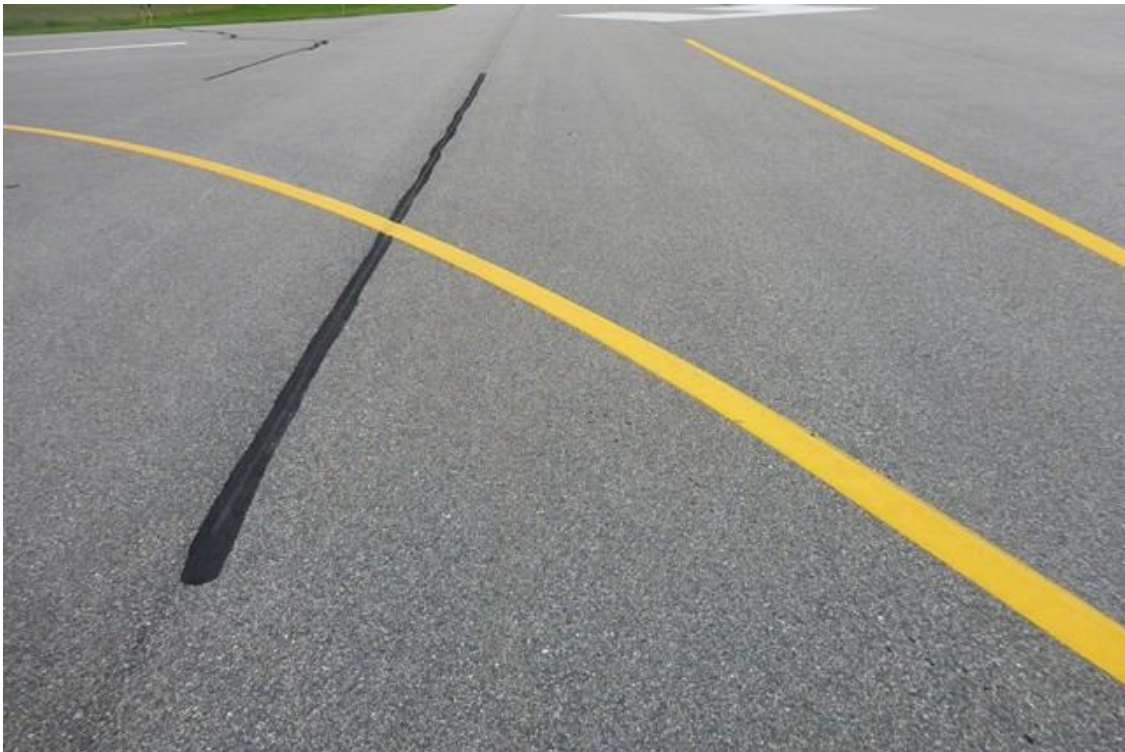
GPZ PTA 002 (PCI = 95)

Network:	GPZ	Name:	GRAND RAPIDS						
Branch:	PTA	Name:	PARALLEL TAXIWAY A	Use:	TAXIWAY	Area:	275,000 SqFt		
Section:	002	of 4	From:	104	To:	106	Last Const.:	10/1/2008	
Surface:	AC	Family:	MN2013 Asphalt Taxiways	Zone:	E	Category:	3	Rank:	P
Area:	10,350 SqFt	Length:	207 Ft	Width:	50 Ft				
Slabs:		Slab Length:	Ft	Slab Width:	Ft	Joint Length:	Ft		
Shoulder:		Street Type:		Grade:	0	Lanes:	0		
Section Comments:									
Last Insp. Date:	7/13/2016	TotalSamples:	2	Surveyed:	1				
Conditions:	PCI: 95								
Inspection Comments:									
Sample Number:	106	Type:	R	Area:	5000.00 SqFt	PCI:	95		
Sample Comments:									
48	L & T CR	L	49.00 Ft
