# Pavement Condition Report

## St James Municipal Airport (JYG)

**December 2016**

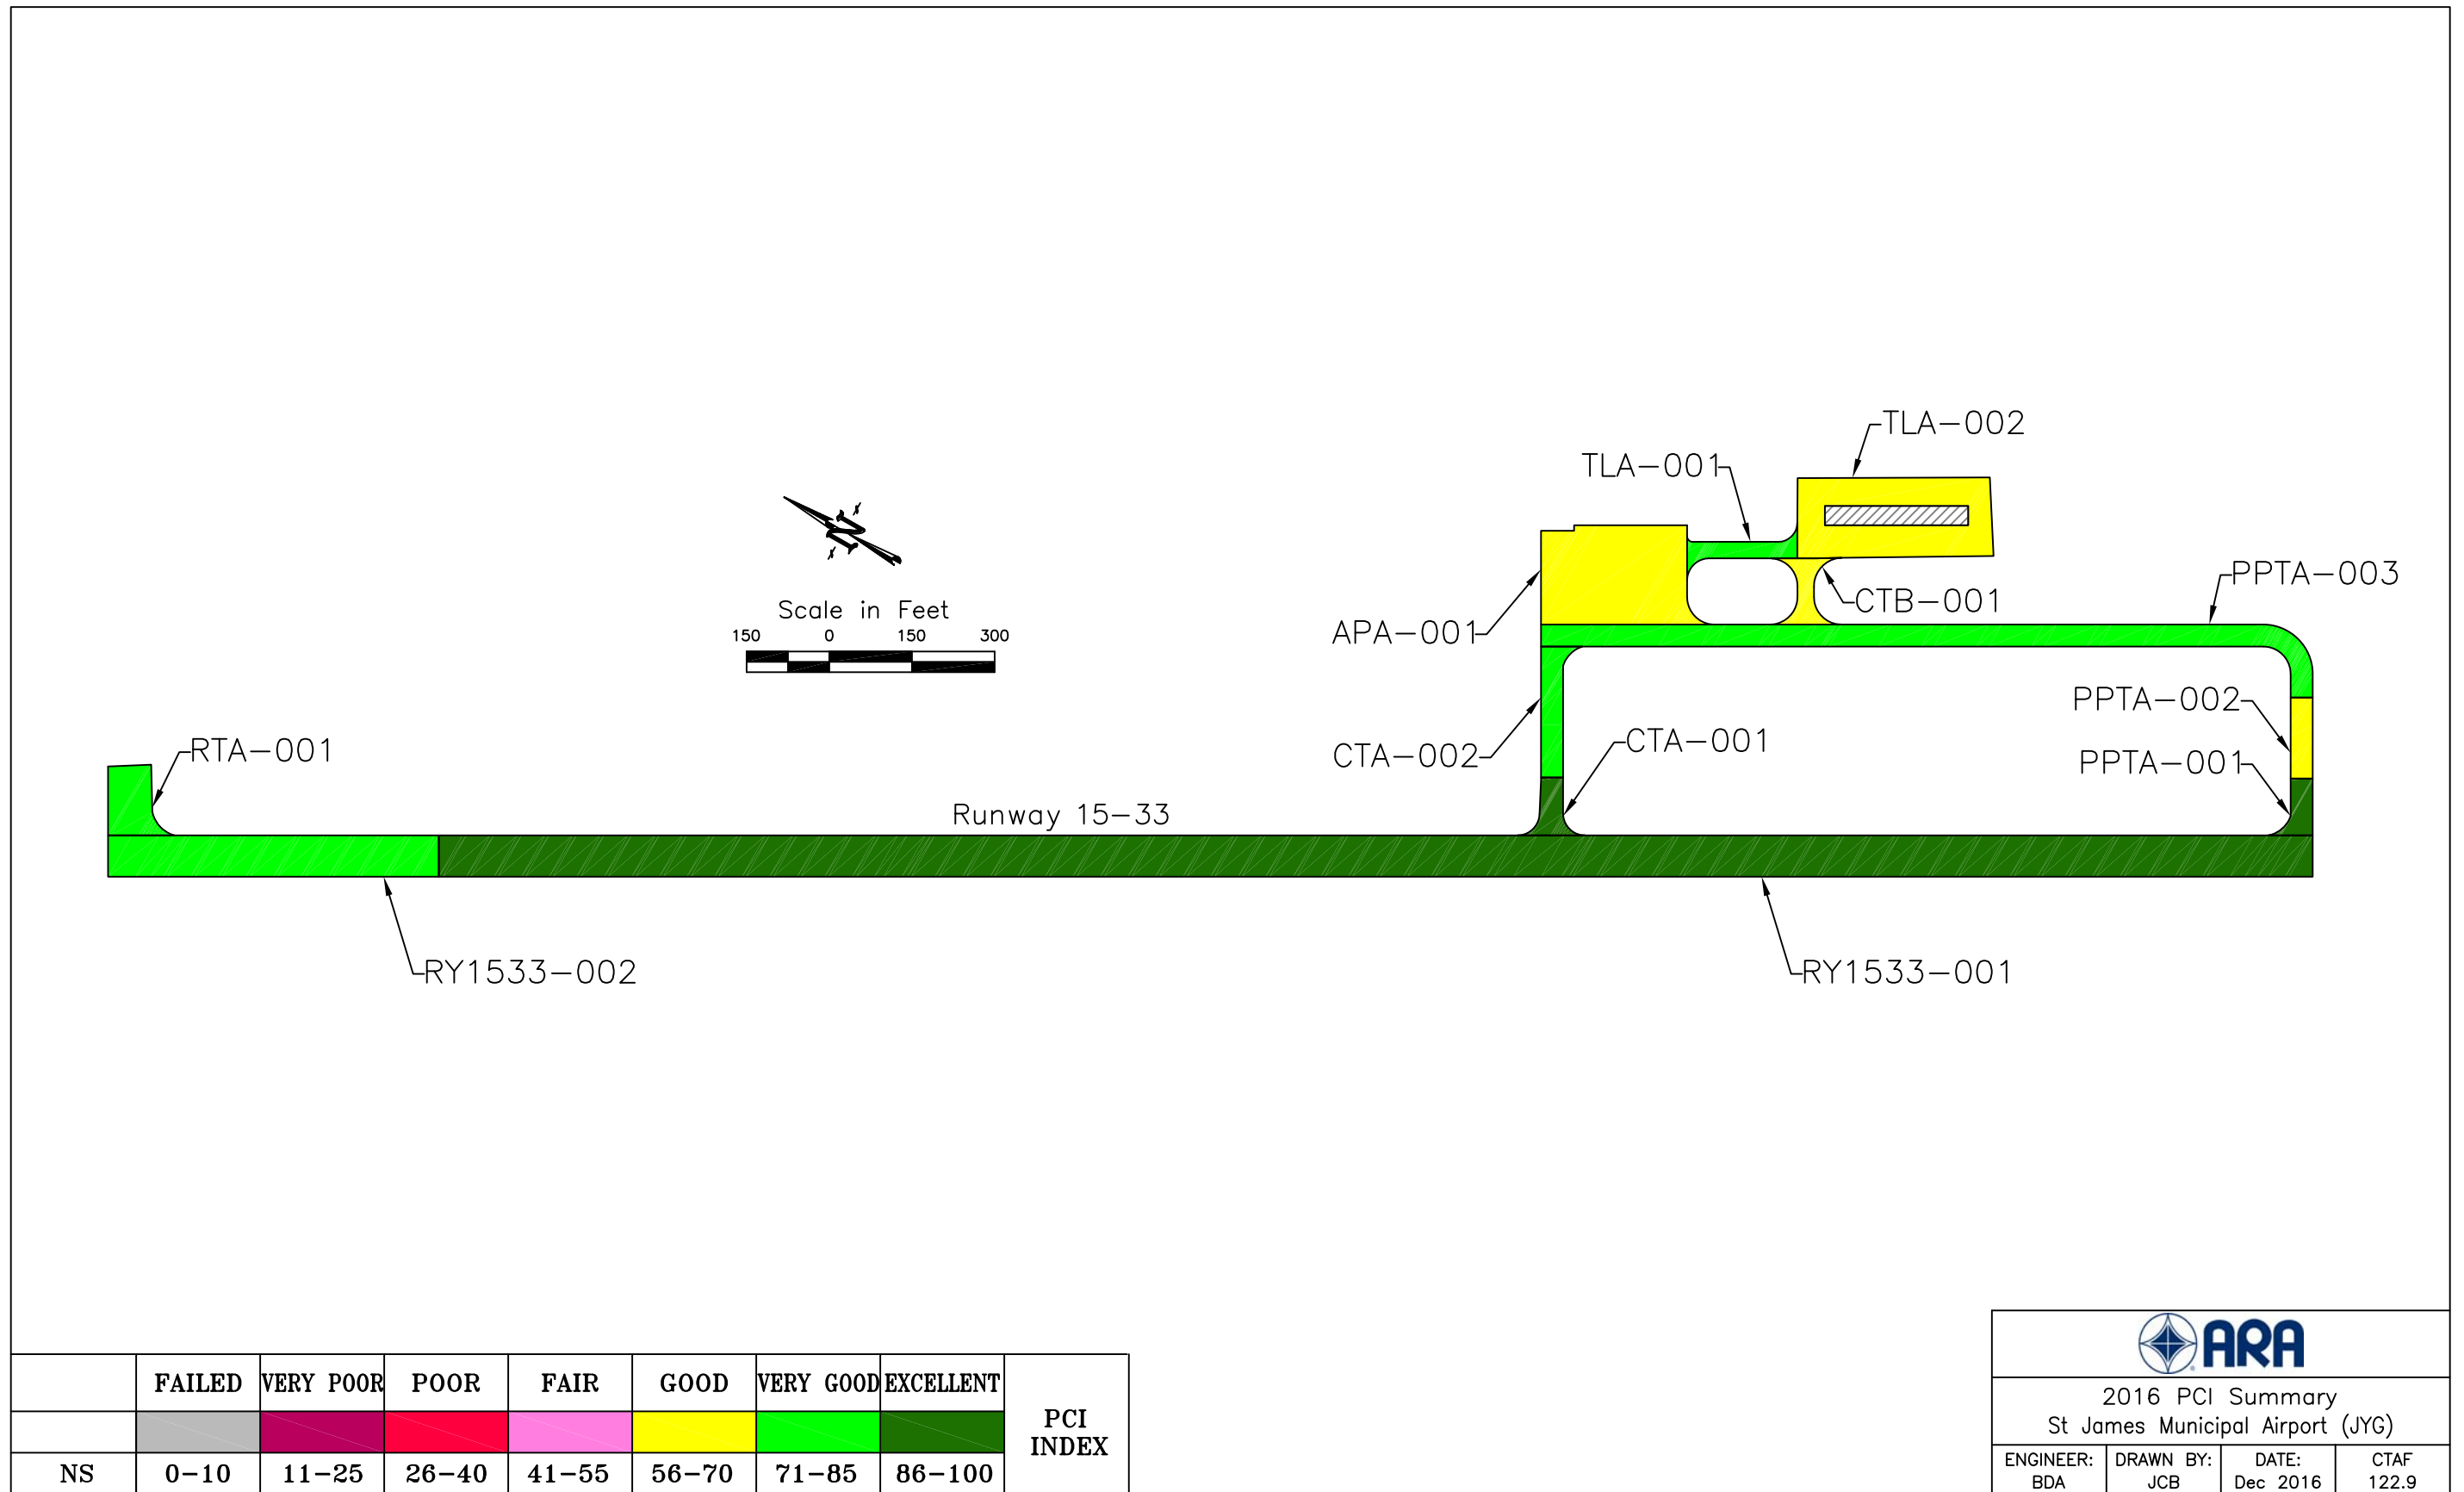
Figure 4. 2016 Pavement Condition Index Rating at St James Municipal Airport (JYG).

Active maintenance and crack sealing at St James Municipal Airport has improved the condition of some of the worst pavement cracks, and improved overall pavement condition.

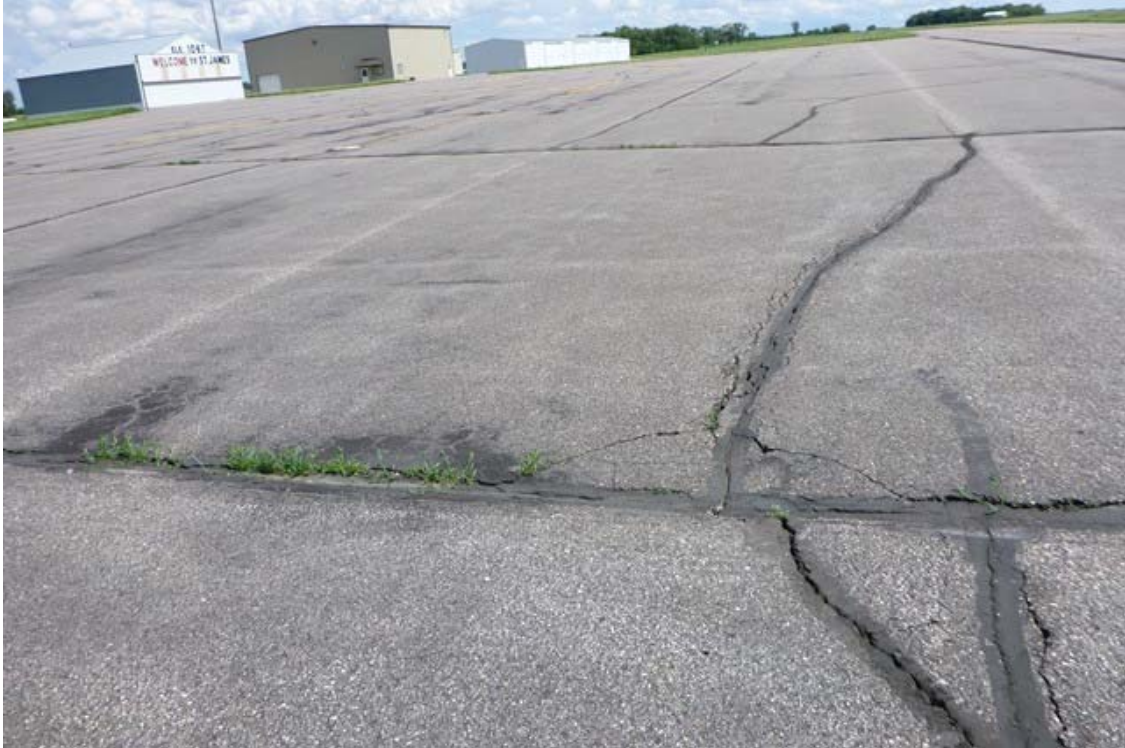
JYG APA 001 (PCI = 59)

**Conditions:** PCI: 59

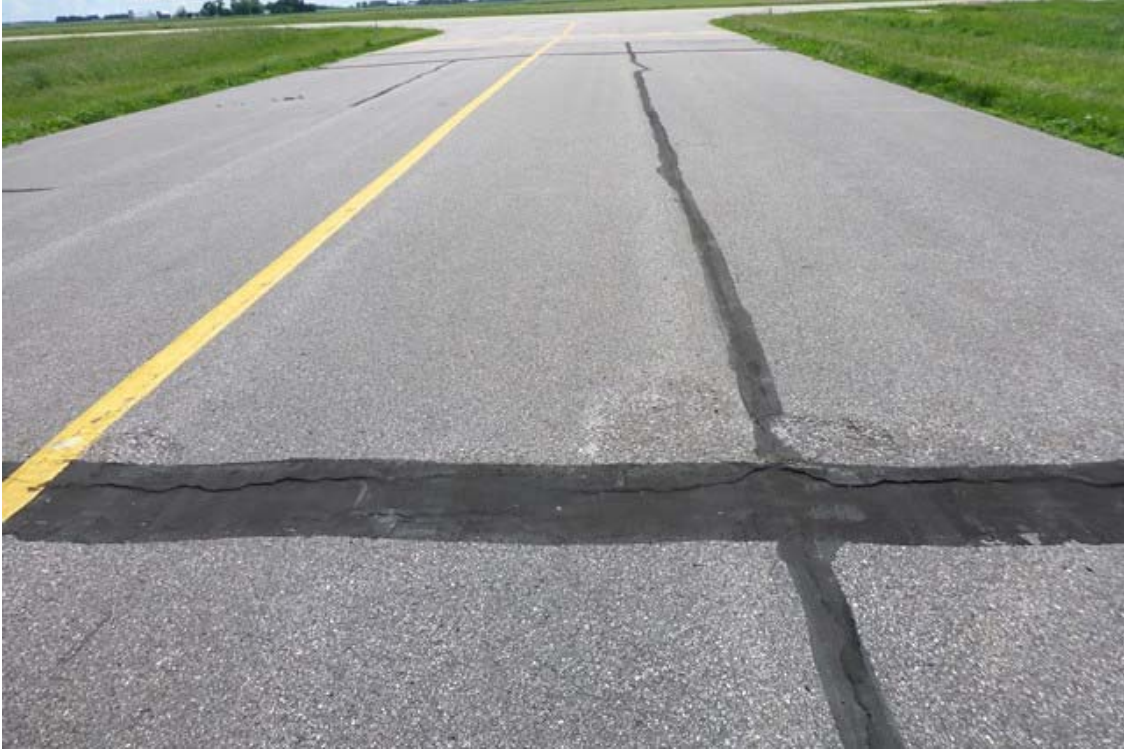
JYG CTA 002 (PCI = 71)

**Conditions:** PCI: 71

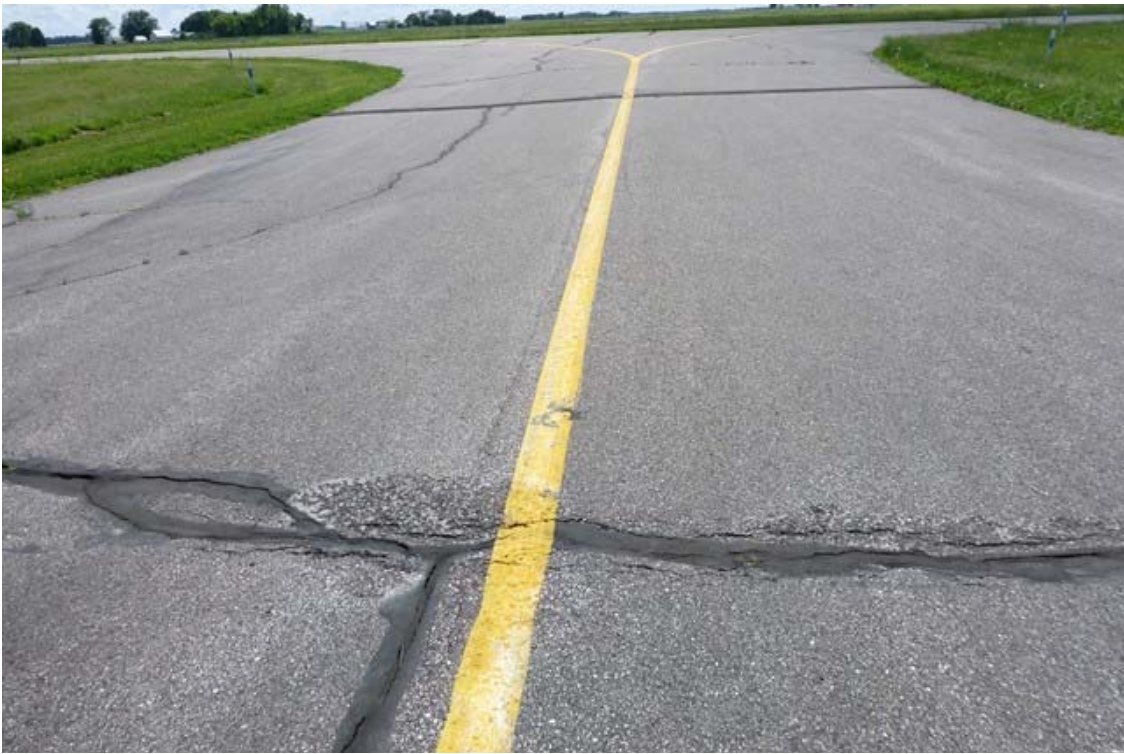
JYG CTB 001 (PCI = 65)

**Conditions:** PCI: 65

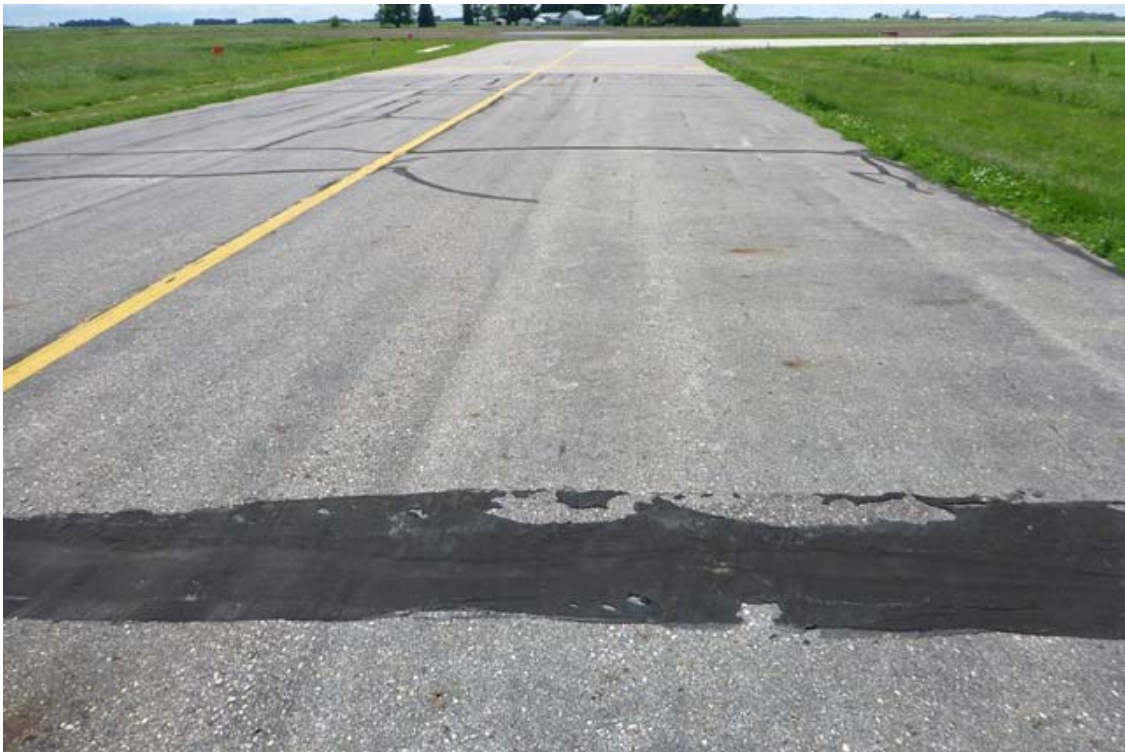
JYG PPTA 002 (PCI = 64)

**Conditions:** PCI: 64

**Re-Inspection Report** cs filling high cracks, unable to verify as amny feet

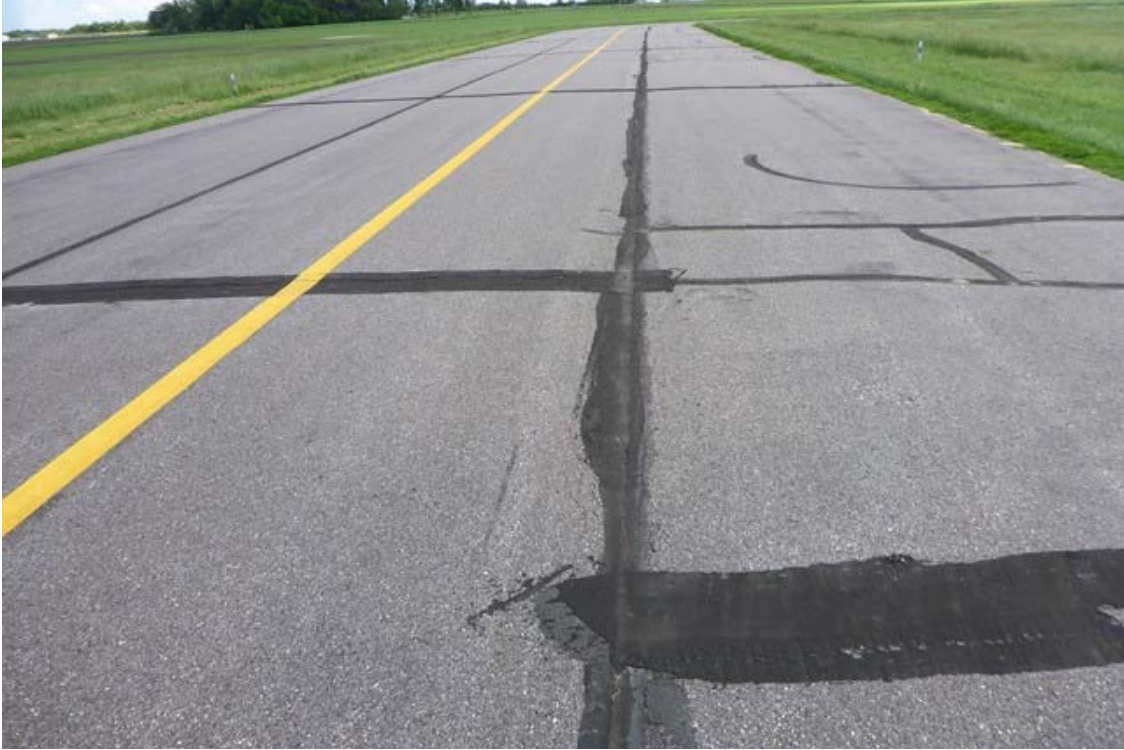
JYG PPTA 003 (PCI = 71)

**Conditions:** PCI: 71

**Inspection Comments:** Crack Seal OK

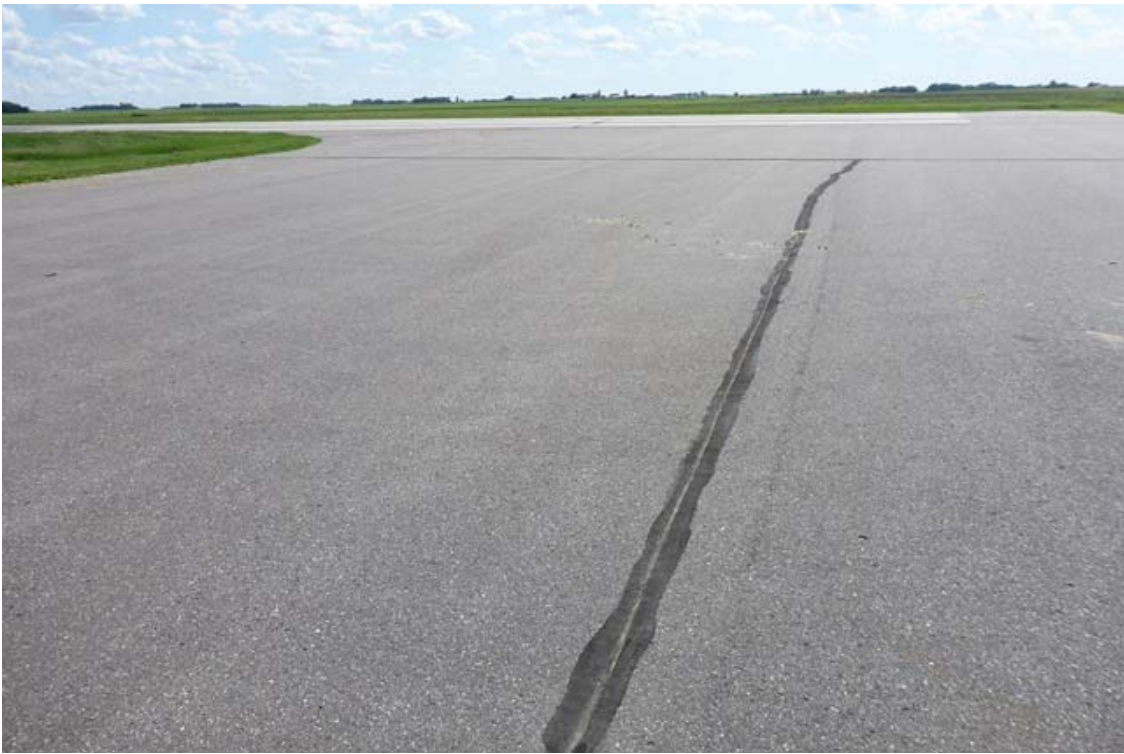
JYG RTA 001 (PCI = 84)

**Conditions:** PCI: 84

**Re-Inspection Report** Crack Seal OK

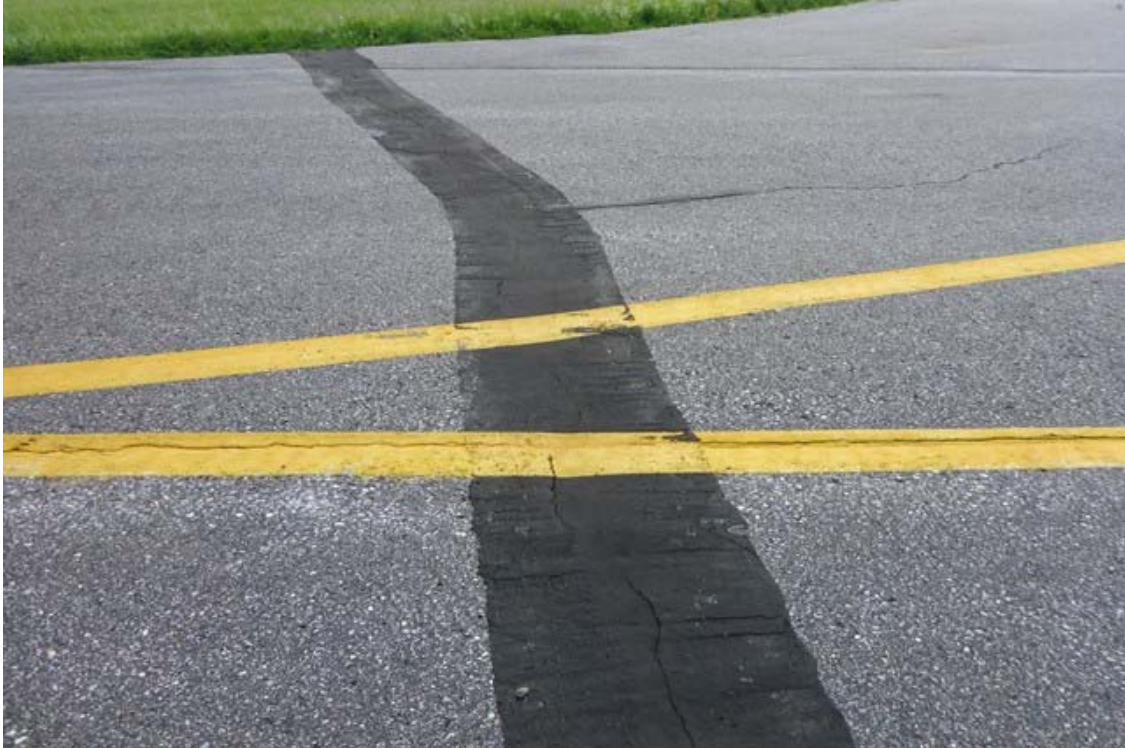
JYG TLA 001 (PCI = 71)

**Conditions:** PCI: 71

**Re-Inspection Report** Heavy Crack Seal Probably Hiding Distress

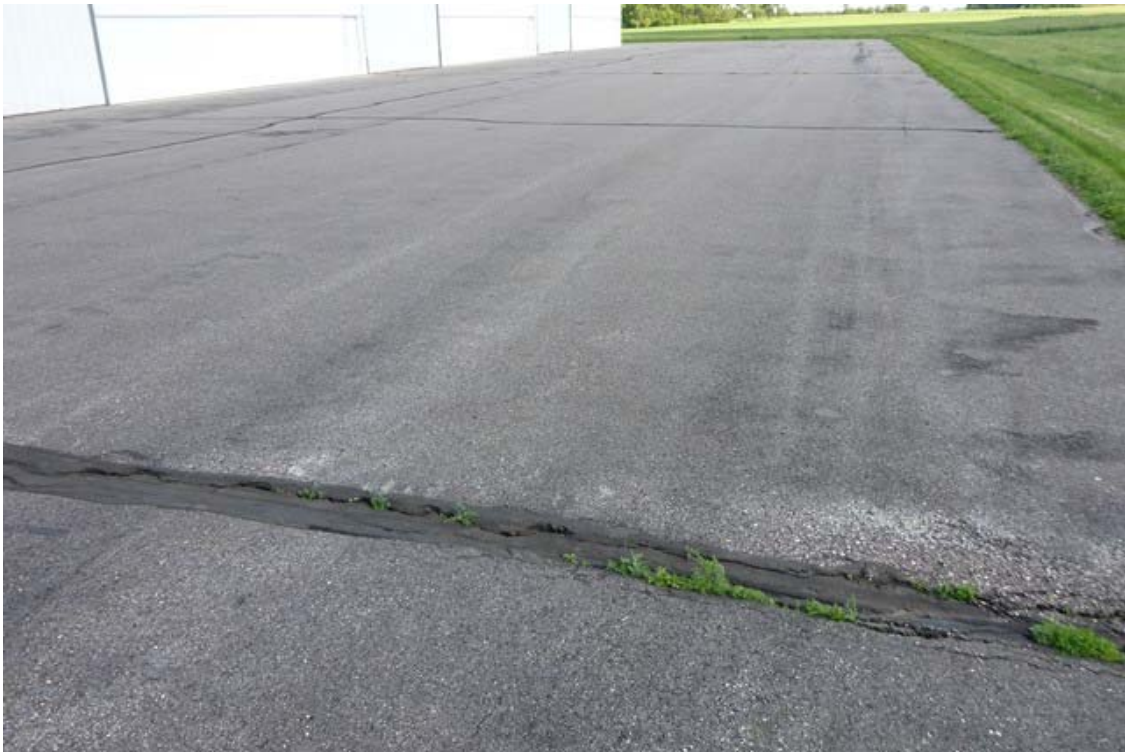
JYG TLA 002 (PCI = 65)

**Conditions:** PCI: 65
