Pavement Condition Report

Le Sueur Municipal Airport (12Y)

December 2017

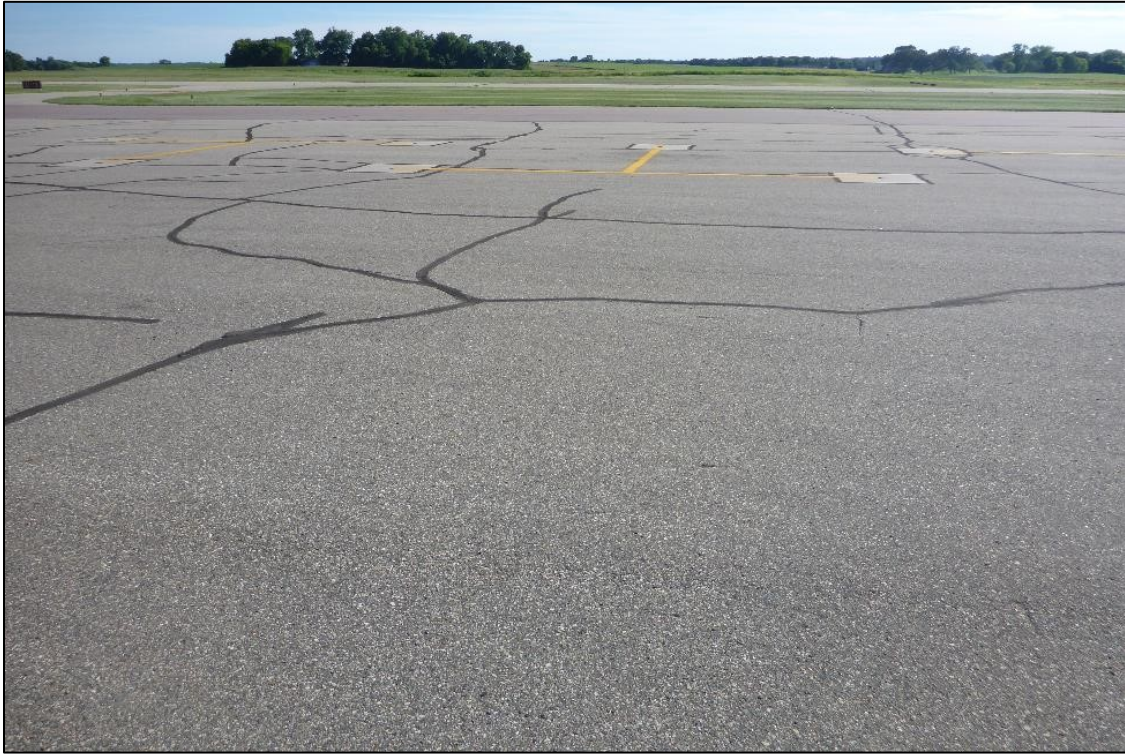
12Y APA 001 (PCI = 72) Photo taken pre-maintenance (crack seal and slurry seal)

Network:	12Y	Name:	LE SUEUR						
Branch:	APA	Name:	APRON A	Use:	APRON	Area:	117,600 SqFt		
Section:	001	of 2	From:	200	To:	402	Last Const.:	9/1/2008	
Surface:	AAC	Family:	MN2013 Asphalt Aprons	Zone:	S	Category:	1	Rank:	S
Area:	45,000 SqFt	Length:	300 Ft	Width:	150 Ft				
Slabs:		Slab Length:	Ft	Slab Width:	Ft	Joint Length:	Ft		
Shoulder:		Street Type:		Grade:	0	Lanes:	0		
Last Insp. Date:	6/20/2017	Total Samples:	9	Surveyed:	3				
Conditions:	PCI: 72								
Sample Number:	100	Type:	R	Area:	5000.00 SqFt	PCI:	78		
48	L & T CR		L	450.00	Ft				
Sample Number:	201	Type:	R	Area:	5000.00 SqFt	PCI:	67		
48	L & T CR		L	710.00	Ft				
48	L & T CR		M	10.00	Ft				
Sample Number:	302	Type:	R	Area:	4500.00 SqFt	PCI:	70		
48	L & T CR		L	538.00	Ft				
48	L & T CR		M	4.00	Ft

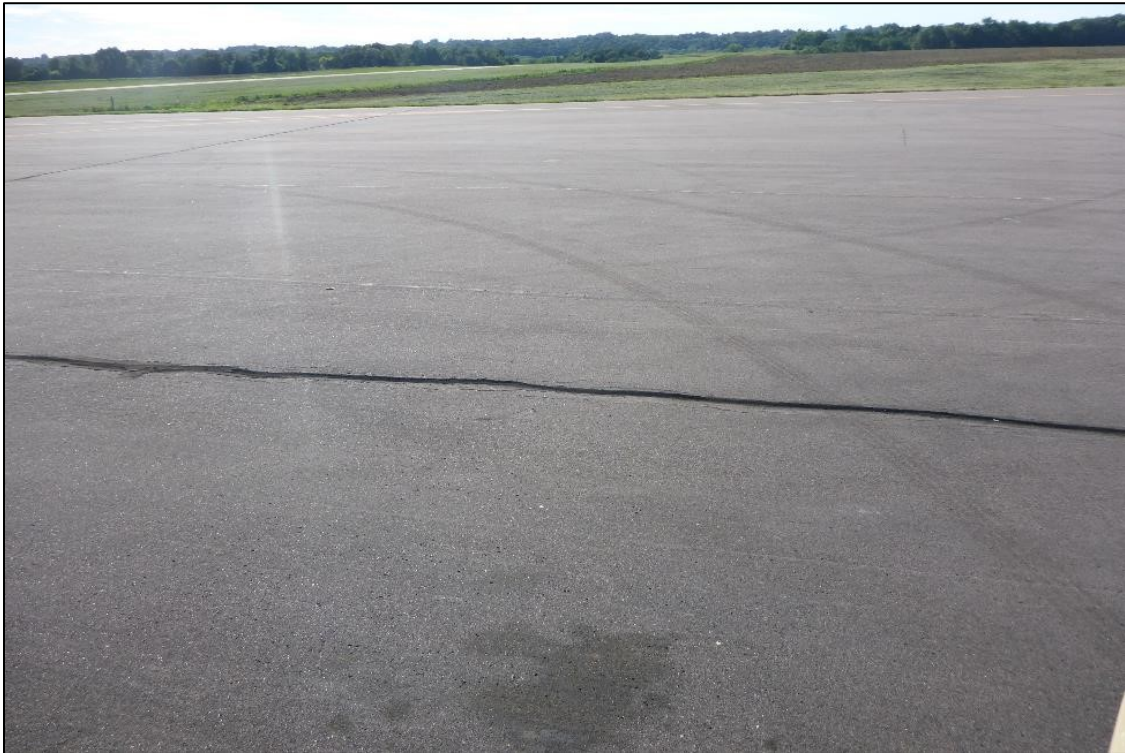
12Y APA 002 (PCI = 89)

Network:	12Y	Name:	LE SUEUR						
Branch:	APA	Name:	APRON A	Use:	APRON	Area:	117,600 SqFt		
Section:	002	of 2	From:	500	To:	510	Last Const.:	10/21/2004	
Surface:	AAC	Family:	MN2013 Asphalt Aprons	Zone:	S	Category:	1	Rank:	S
Area:	72,600 SqFt	Length:	214 Ft	Width:	162 Ft				
Slabs:	Slab Length:	Ft	Slab Width:	Ft	Joint Length:	Ft			
Shoulder:	Street Type:		Grade:	0	Lanes:	0			
Last Insp. Date:	6/20/2017	TotalSamples:	14	Surveyed:	4				
Conditions:	PCI: 89								
Sample Number:	200	Type:	R	Area:	5000.00 SqFt	PCI:	88		
48	L & T CR	L		86.00	Ft				
48	L & T CR	M		20.00	Ft				
Sample Number:	301	Type:	R	Area:	5000.00 SqFt	PCI:	86		
48	L & T CR	L		78.00	Ft				
48	L & T CR	M		34.00	Ft				
Sample Number:	600	Type:	R	Area:	5000.00 SqFt	PCI:	94		
48	L & T CR	L		63.00	Ft				
Sample Number:	703	Type:	R	Area:	5800.00 SqFt	PCI:	88		
48	L & T CR	L		220.00	Ft

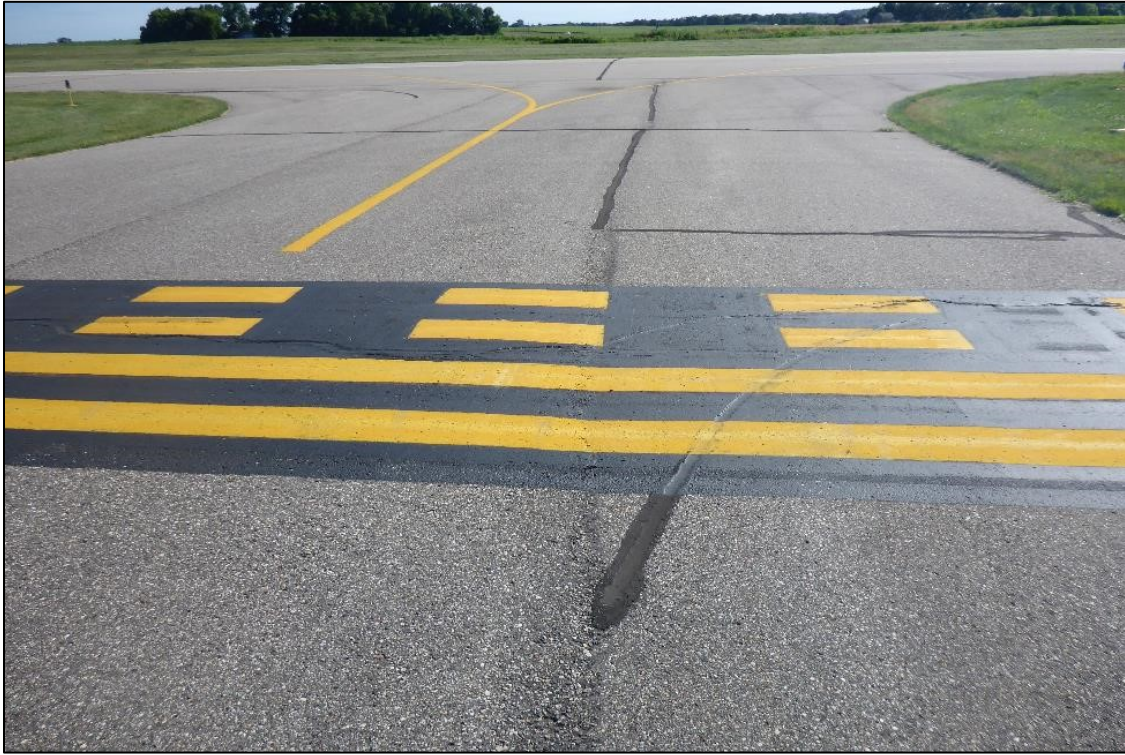
12Y CTA 001 (PCI = 84) Photo taken pre-maintenance (crack seal and slurry seal)

Network:	12Y	Name:	LE SUEUR				
Branch:	CTA	Name:	CONNECTING TAXIWAY A	Use:	TAXIWAY	Area:	10,000 SqFt
Section:	001	of 1	From:	100	To:	101	Last Const.: 9/1/2008
Surface:	AAC	Family:	MN2013 Asphalt Taxiways	Zone:	S	Category:	1
Area:	10,000 SqFt	Length:	238 Ft	Width:	40 Ft		
Slabs:		Slab Length:	Ft	Slab Width:	Ft	Joint Length:	Ft
Shoulder:		Street Type:		Grade:	0	Lanes:	0
Last Insp. Date:	6/20/2017	TotalSamples:	2	Surveyed:	1		
Conditions:	PCI: 84						
Sample Number:	100	Type:	R	Area:	4850.00 SqFt	PCI:	84
48	L & T CR		L	281.00	Ft

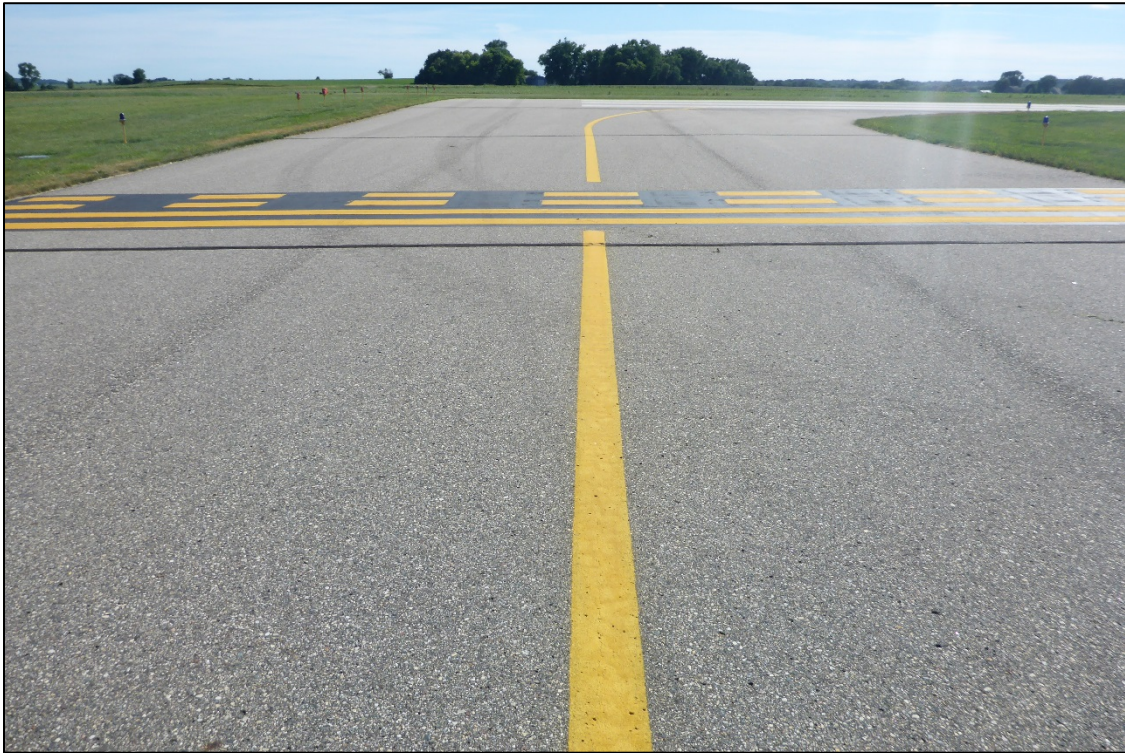
12Y CTB 001 (PCI = 88) Photo taken pre-maintenance (crack seal and slurry seal)

Network:	12Y	Name:	LE SUEUR				
Branch:	CTB	Name:	Connecting Taxiway B	Use:	TAXIWAY	Area:	7,500 SqFt
Section:	001	of 1	From:	100	To:	101	Last Const.: 9/1/2008
Surface:	AC	Family:	MN2013 Asphalt Taxiways	Zone:	S	Category:	1
Area:	7,500 SqFt	Length:	175 Ft	Width:	40 Ft		
Slabs:		Slab Length:	Ft	Slab Width:	Ft	Joint Length:	Ft
Shoulder:		Street Type:		Grade:	0	Lanes:	0
Last Insp. Date:	6/20/2017	TotalSamples:	2	Surveyed:	1		
Conditions:	PCI: 88						
Sample Number:	100	Type:	R	Area:	4250.00 SqFt	PCI:	88
48	L & T CR		L	63.00 Ft			
48	L & T CR		M	17.00 Ft

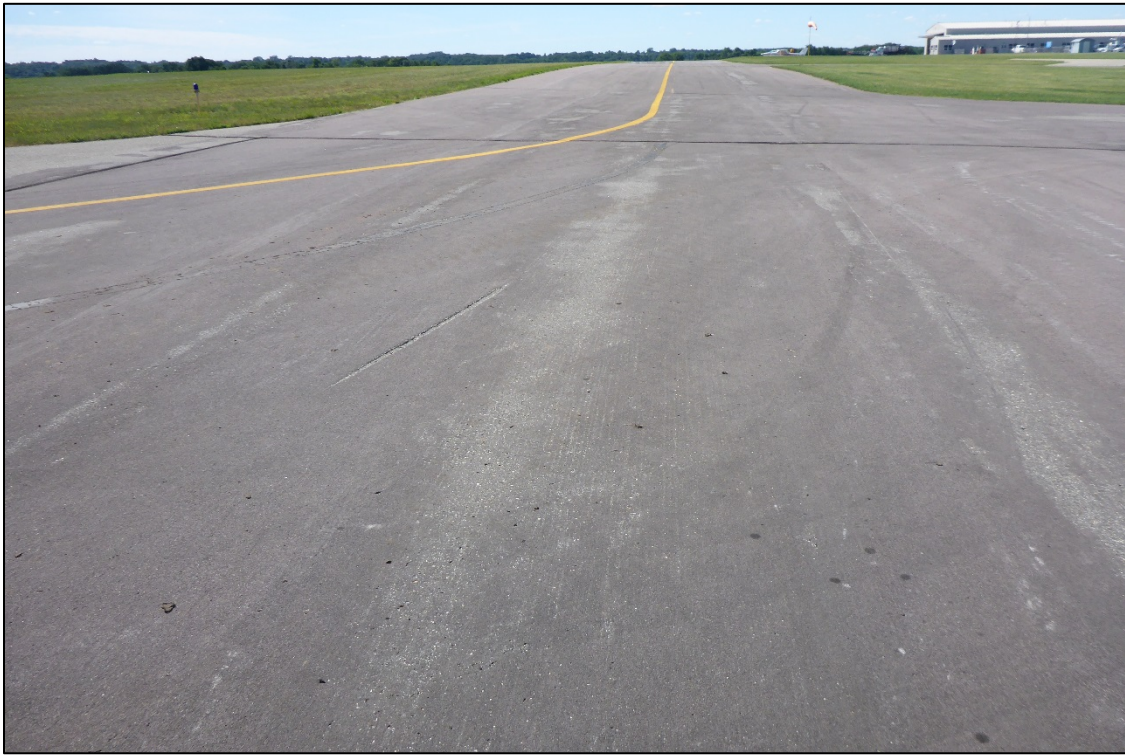
12Y PPTA 001 (PCI = 86)

Network:	12Y	Name:	LE SUEUR						
Branch:	PPTA	Name:	PARTIAL PARALLEL TAXIWAYA	Use:	TAXIWAY	Area:	25,600 SqFt		
Section:	001	of	1	From:	100	To:	106	Last Const.:	10/21/2004
Surface:	AC	Family:	MN2013 Asphalt Taxiways	Zone:	S	Category:	1	Rank:	P
Area:	25,600 SqFt	Length:	640 Ft	Width:	40 Ft				
Slabs:		Slab Length:	Ft	Slab Width:	Ft	Joint Length:	Ft		
Shoulder:		Street Type:		Grade:	0	Lanes:	0		
Last Insp. Date:	6/20/2017	TotalSamples:	7	Surveyed:	2				
Conditions:	PCI: 86								
Sample Number:	101	Type:	R	Area:	4000.00 SqFt	PCI:	88		
48	L & T CR		L	17.00	Ft				
48	L & T CR		M	33.00	Ft				
Sample Number:	104	Type:	R	Area:	4000.00 SqFt	PCI:	84		
48	L & T CR		L	59.00	Ft				
48	L & T CR		M	38.00	Ft

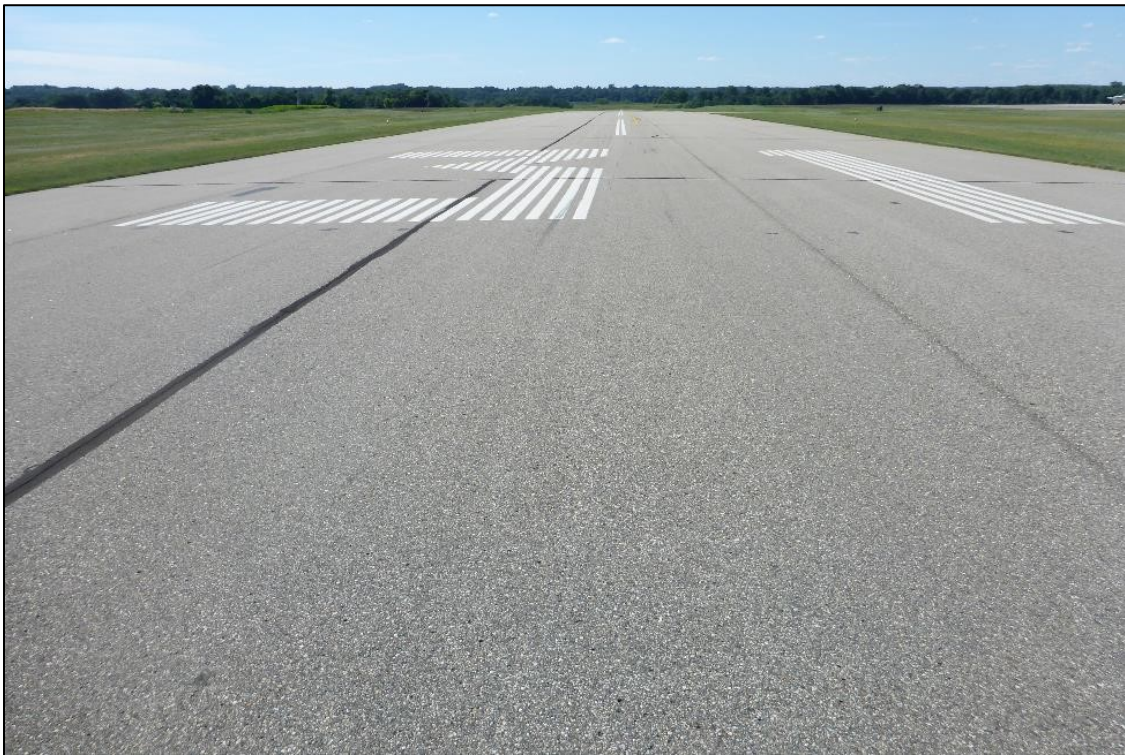
12Y RY1331 001 (PCI = 84) Photo taken pre-maintenance (crack seal and slurry seal)

Network:	12Y	Name:	LE SUEUR						
Branch:	RY1331	Name:	RUNWAY 13-31	Use:	RUNWAY	Area:	234,600 SqFt		
Section:	001	of 2	From:	100	To:	139	Last Const.:	9/1/2008	
Surface:	AAC	Family:	MN2013 Asphalt Runways	Zone:	S	Category:	1	Rank:	P
Area:	150,000 SqFt	Length:	2,000 Ft	Width:	75 Ft				
Slabs:	Slab Length:	Ft	Slab Width:	Ft	Joint Length:	Ft			
Shoulder:	Street Type:	Grade:	0	Lanes:	0				
Last Insp. Date:	6/20/2017	TotalSamples:	40	Surveyed:	5				
Conditions:	PCI: 84								
Sample Number:	105	Type:	R	Area:	3750.00 SqFt	PCI:	86		
48	L & T CR	L	176.00 Ft						
Sample Number:	117	Type:	R	Area:	3750.00 SqFt	PCI:	81		
48	L & T CR	L	166.00 Ft						
48	L & T CR	M	27.00 Ft						
Sample Number:	125	Type:	R	Area:	3750.00 SqFt	PCI:	85		
48	L & T CR	L	200.00 Ft						
Sample Number:	133	Type:	R	Area:	3750.00 SqFt	PCI:	89		
48	L & T CR	L	122.00 Ft						
Sample Number:	139	Type:	R	Area:	3750.00 SqFt	PCI:	77		
45	DEPRESSION	L	50.00 SqFt

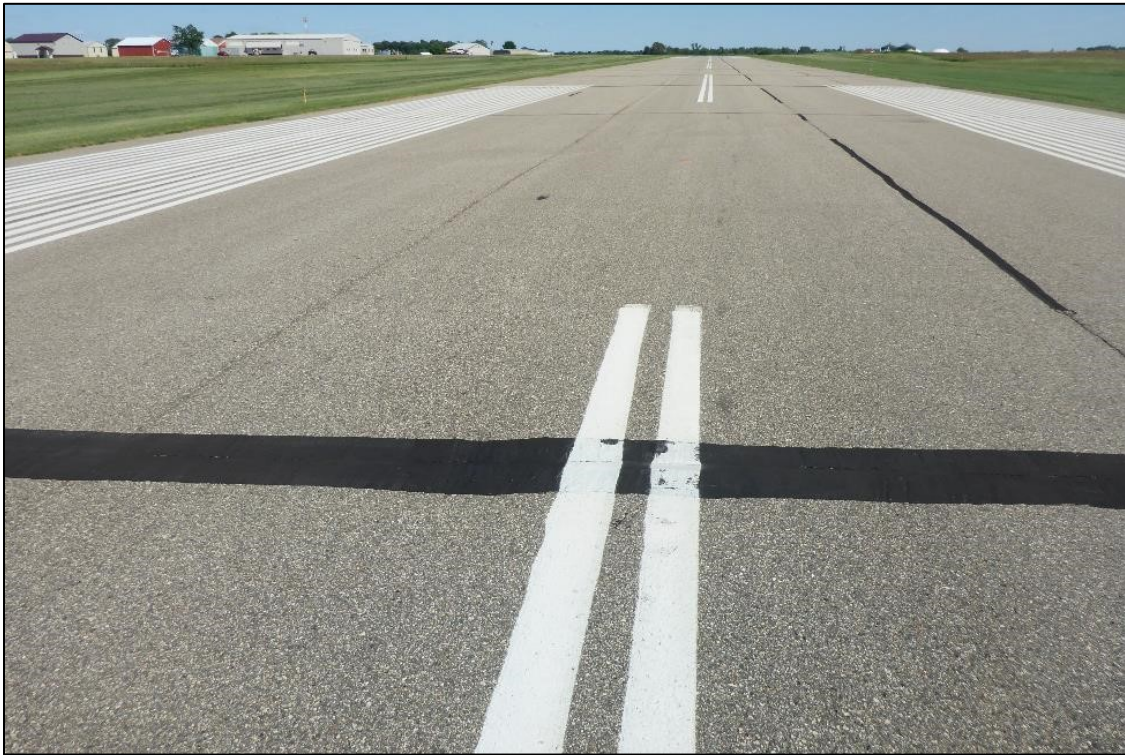
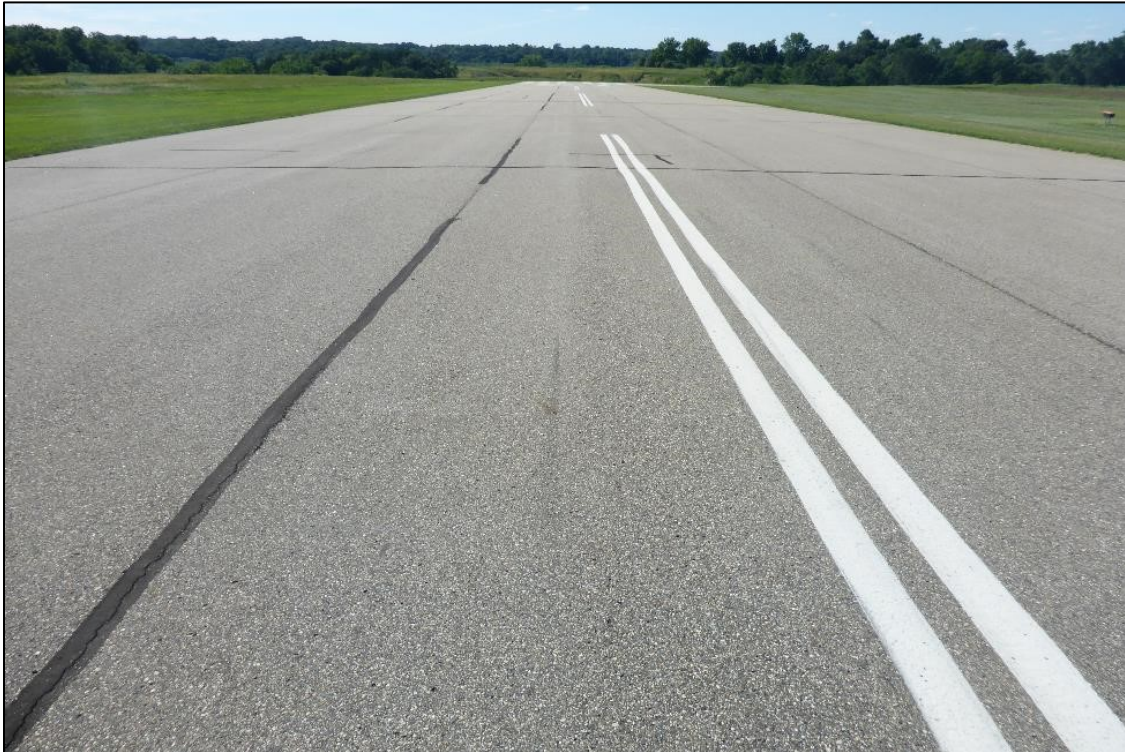
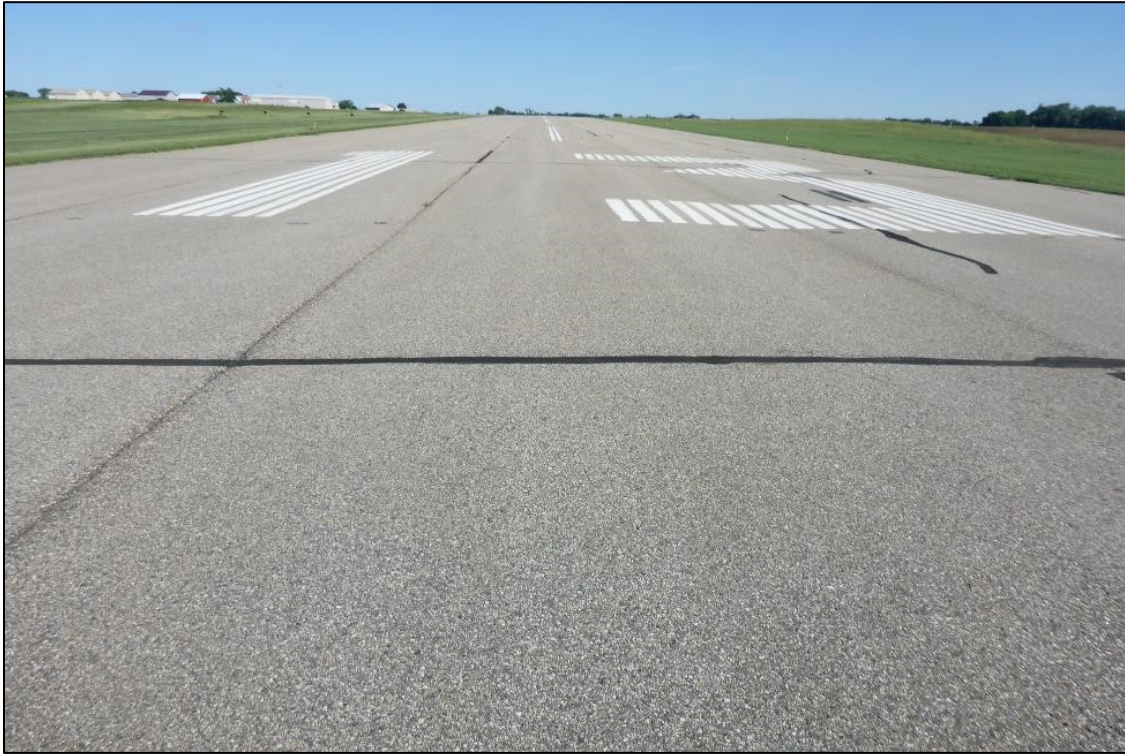
12Y RY1331 002 (PCI = 82)

Network:	12Y	Name:	LE SUEUR						
Branch:	RY1331	Name:	RUNWAY 13-31	Use:	RUNWAY	Area:	234,600 SqFt		
Section:	002	of 2	From:	140	To:	159	Last Const.: 9/1/2008		
Surface:	AAC	Family:	MN2013 Asphalt Runways	Zone:	S	Category:	1	Rank:	P
Area:	84,600 SqFt	Length:	1,000 Ft	Width:	75 Ft				
Slabs:	Slab Length:	Ft	Slab Width:	Ft	Joint Length:	Ft			
Shoulder:	Street Type:		Grade:	0	Lanes:	0			
Last Insp. Date:	6/20/2017	TotalSamples:	22	Surveyed:	4				
Conditions:	PCI: 82								
Sample Number:	143	Type:	R	Area:	3750.00 SqFt	PCI:	80		
48	L & T CR	L		185.00	Ft				
48	L & T CR	M		18.00	Ft				
Sample Number:	149	Type:	R	Area:	3750.00 SqFt	PCI:	74		
48	L & T CR	L		322.00	Ft				
48	L & T CR	M		27.00	Ft				
Sample Number:	152	Type:	R	Area:	3750.00 SqFt	PCI:	83		
48	L & T CR	L		135.00	Ft				
48	L & T CR	M		12.00	Ft				
Sample Number:	158	Type:	R	Area:	3750.00 SqFt	PCI:	89		
48	L & T CR	L		121.00	Ft

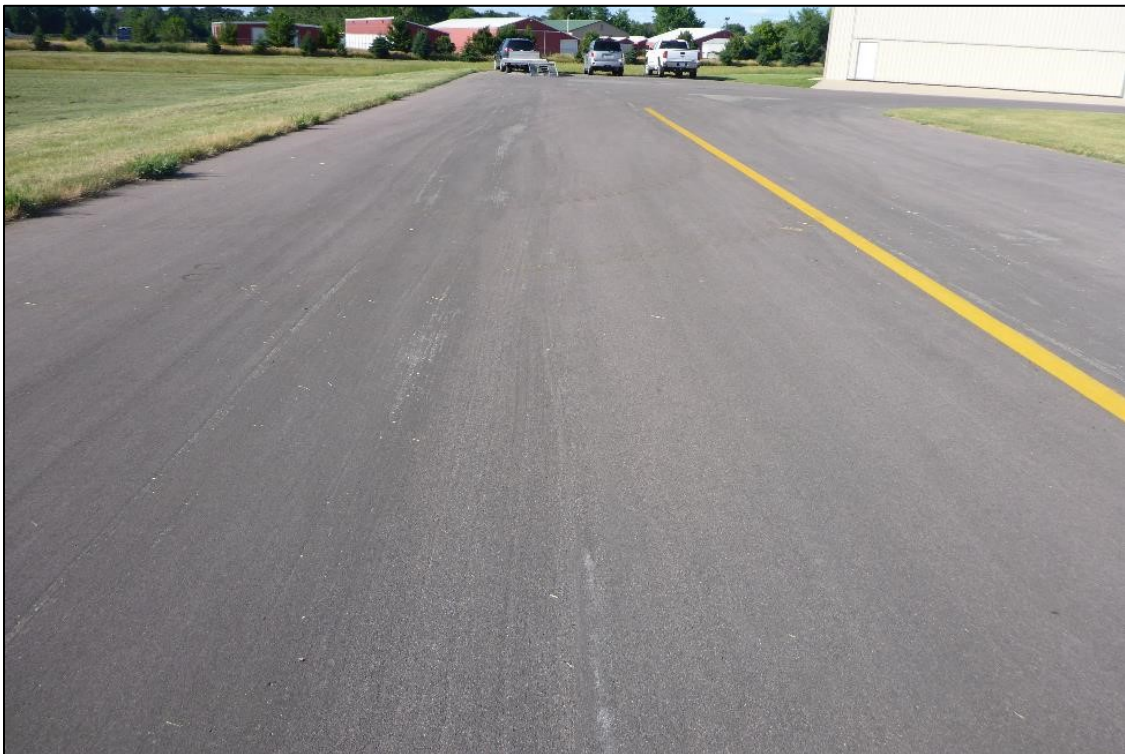
12Y TLA 001 (PCI = 95)

Network:	12Y	Name:	LE SUEUR				
Branch:	TLA	Name:	TAXILANE A	Use:	TAXILANE	Area:	9,900 SqFt
Section:	001	of 1	From:	100	To:	101	Last Const.: 10/31/2004
Surface:	AC	Family:	MN2013 Asphalt Taxilanes	Zone:	S	Category:	1
Area:	9,900 SqFt	Length:	234 Ft	Width:	40 Ft		
Slabs:		Slab Length:	Ft	Slab Width:	Ft	Joint Length:	Ft
Shoulder:		Street Type:		Grade:	0	Lanes:	0
Last Insp. Date:	6/20/2017	TotalSamples:	2	Surveyed:	1		
Conditions:	PCI: 95						
Sample Number:	100	Type:	R	Area:	4000.00 SqFt	PCI:	95
48	L & T CR		L	40.00	Ft

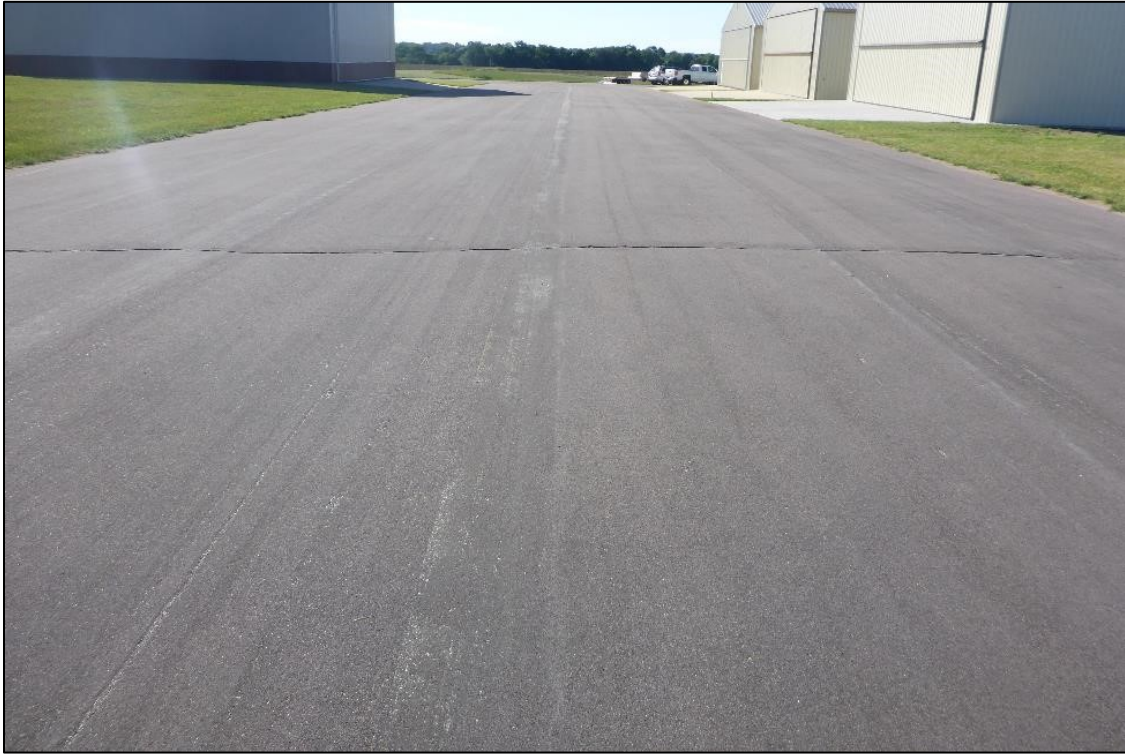
12Y TLB 001 (PCI = 88)

Network:	12Y	Name:	LE SUEUR				
Branch:	TLB	Name:	Taxilane B	Use:	TAXILANE	Area:	21,100 SqFt
Section:	001	of 1	From:	200	To:	204	Last Const.: 10/31/2004
Surface:	AC	Family:	MN2013 Asphalt Taxilanes	Zone:	S	Category:	1
Area:	21,100 SqFt	Length:	507 Ft	Width:	40 Ft	Joint Length:	Ft
Slabs:		Slab Length:	Ft	Slab Width:	Ft	Joint Length:	Ft
Shoulder:		Street Type:		Grade:	0	Lanes:	0
Last Insp. Date:	6/20/2017	TotalSamples:	5	Surveyed:	1		
Conditions:	PCI: 88						
Sample Number:	202	Type:	R	Area:	4000.00 SqFt	PCI:	88
48	L & T CR		L	11.00	Ft		
48	L & T CR		M	37.00	Ft

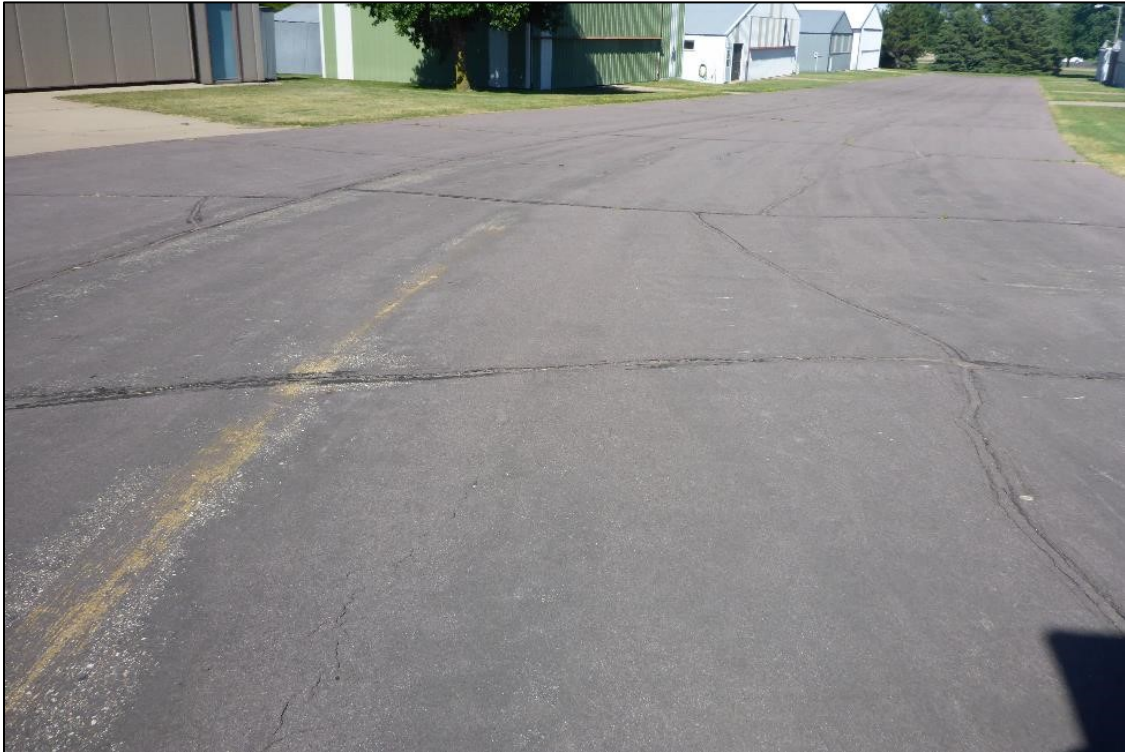
12Y TLC 001 (PCI = 66) Photo taken pre-maintenance (crack seal and slurry seal)

Network:	12Y	Name:	LE SUEUR				
Branch:	TLC	Name:	Taxilane C	Use:	TAXILANE	Area:	18,650 SqFt
Section:	001	of 1	From:	100	To:	105	Last Const.: 9/1/1971
Surface:	AC	Family:	MN2013 Asphalt Taxilanes	Zone:	S	Category:	1
Area:	18,650 SqFt	Length:	466 Ft	Width:	40 Ft		
Slabs:		Slab Length:	Ft	Slab Width:	Ft	Joint Length:	Ft
Shoulder:		Street Type:		Grade:	0	Lanes:	0
Last Insp. Date:	6/20/2017	TotalSamples:	5	Surveyed:	2		
Conditions:	PCI: 66						
Sample Number:	101	Type:	R	Area:	4000.00 SqFt	PCI:	63
48	L & T CR		L	525.00	Ft		
43	BLOCK CR		L	2000.00	SqFt		
Sample Number:	102	Type:	R	Area:	4000.00 SqFt	PCI:	68
48	L & T CR		L	745.00	Ft
