Pavement Condition Report

Austin Municipal Airport (AUM)

December 2017

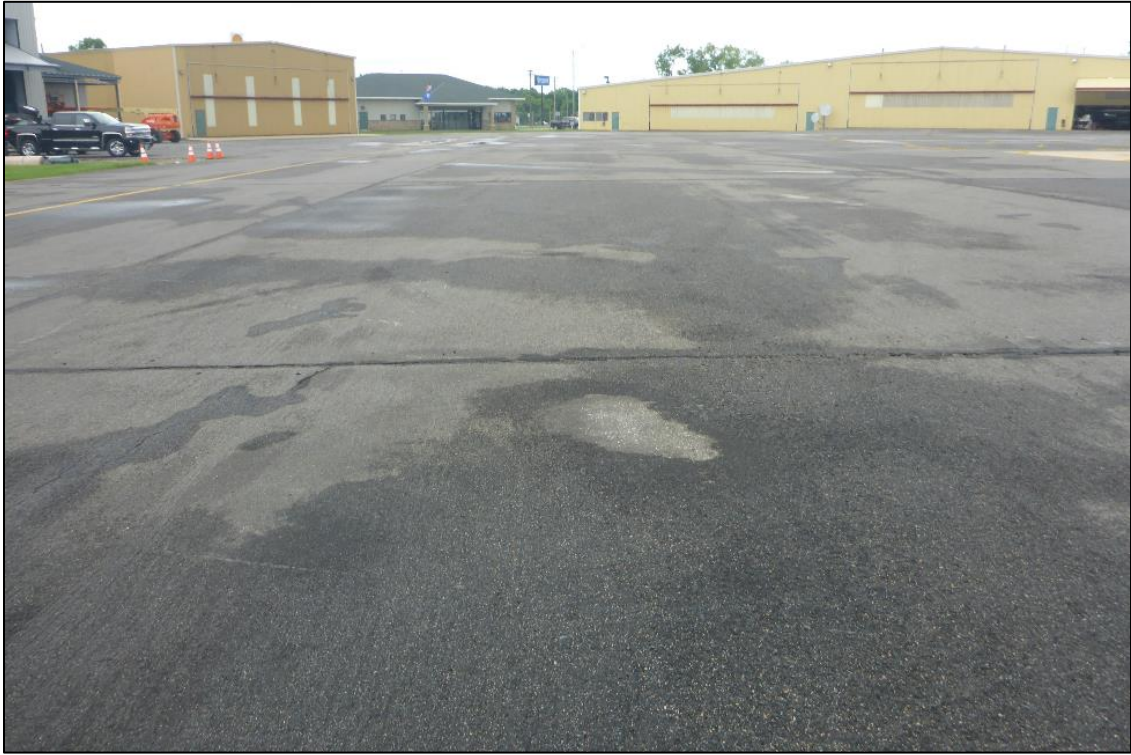
AUM APA 001 (PCI = 79)

Branch ID	Section ID	Surface type ¹	Section area (SF)	LCD ²	2014 PCI	2017 PCI	Drop in PCI/Yr ³	% Deduct due to		Distress types
								Load ⁴	Climate ⁵	
APA	001	AC	129,000	2007	71	79 ⁶	2.1	0	88	Depression, L&T cr, Patching, Swelling
APA	002	PCC	11,200	2007	95	93	0.7	0	100	Joint seal damage
APA	003	PCC	6,400	2007	100	95	0.5	61	39	Linear cr, Joint seal damage
CTA1	001	AC	7,500	2005	71	80 ⁷	1.7	0	100	L&T cr, Patching
CTA1	002	AC	19,250	2004	83	76	1.8	0	100	L&T cr, Patching
CTA2	001	AC	7,700	2005	71	74 ⁷	2.2	0	100	L&T cr, Patching
CTA2	002	AC	12,050	2004	76	74	2.0	0	100	L&T cr
CTA2X	001	AC	21,300	2004	79	70	2.3	0	100	L&T cr, Patching
CTA2X	002	PCC	11,900	2004	96	94	0.5	48	28	Corner brk, Joint seal damage, Small patch, Shrinkage cr
CTA3	001	AC	8,400	2005	73	85 ⁷	1.3	0	100	L&T cr
CTA3	002	AC	11,500	2004	78	80 ⁷	1.5	0	100	L&T cr
CTA4	001	AC	7,750	2005	76	81 ⁷	1.6	0	100	L&T cr, Patching
CTA4	002	AC	12,400	2004	72	80 ⁷	1.5	0	100	L&T cr

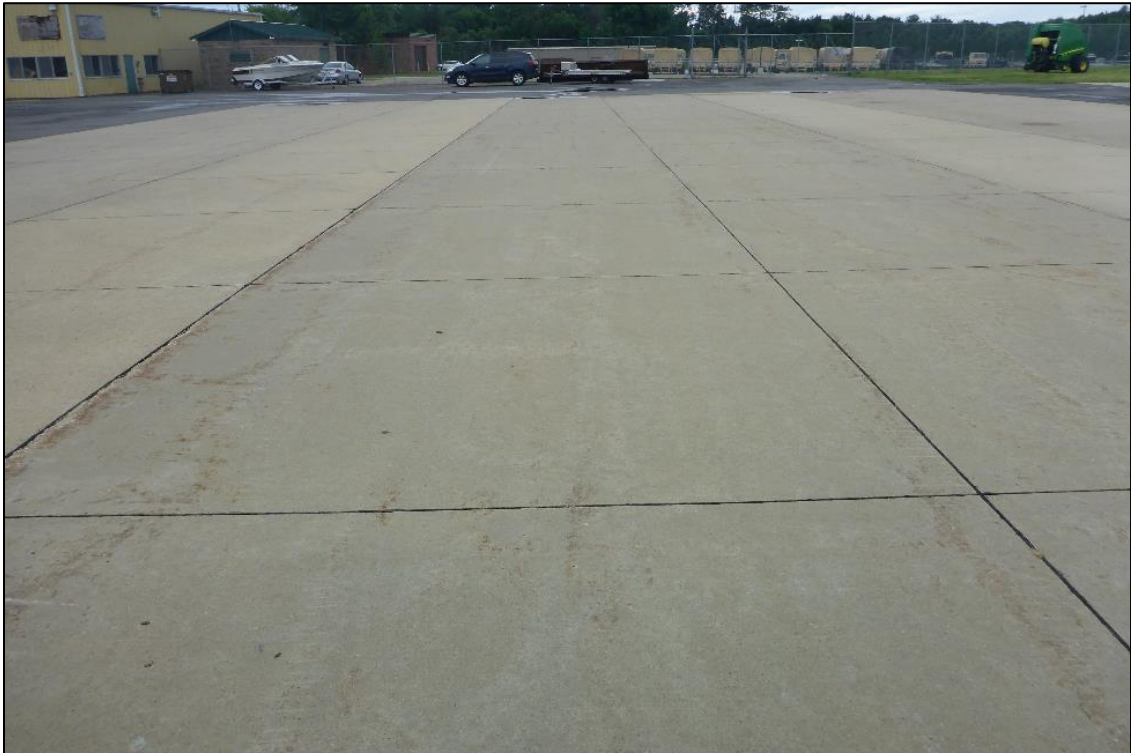
AUM APA 002 (PCI = 93)

Network:	AUM		Name:	AUSTIN					
Branch:	APA	Name:	Apron A	Use:	APRON	Area:	146,600 SqFt		
Section:	002	of 3	From:	100	To:	104	Last Const.: 9/1/2007		
Surface:	PCC	Family:	MN2013 PCC	Zone:	E	Category:	1	Rank:	S
Area:	11,200 SqFt	Length:	140 Ft	Width:	80 Ft				
Slabs:	112	Slab Length:	10 Ft	Slab Width:	10 Ft	Joint Length:	2,020 Ft		
Shoulder:		Street Type:		Grade:	0	Lanes:	0		
Last Insp. Date:	6/22/2017		TotalSamples:	5	Surveyed:	3			
Conditions:	PCI:	93							
Sample Number:	100	Type:	R	Area:	24.00 Slabs	PCI:	93		
65	JT SEAL DMG		M		24.00 Slabs				
Sample Number:	102	Type:	R	Area:	24.00 Slabs	PCI:	93		
65	JT SEAL DMG		M		24.00 Slabs				
Sample Number:	103	Type:	R	Area:	24.00 Slabs	PCI:	93		
65	JT SEAL DMG		M		24.00 Slabs

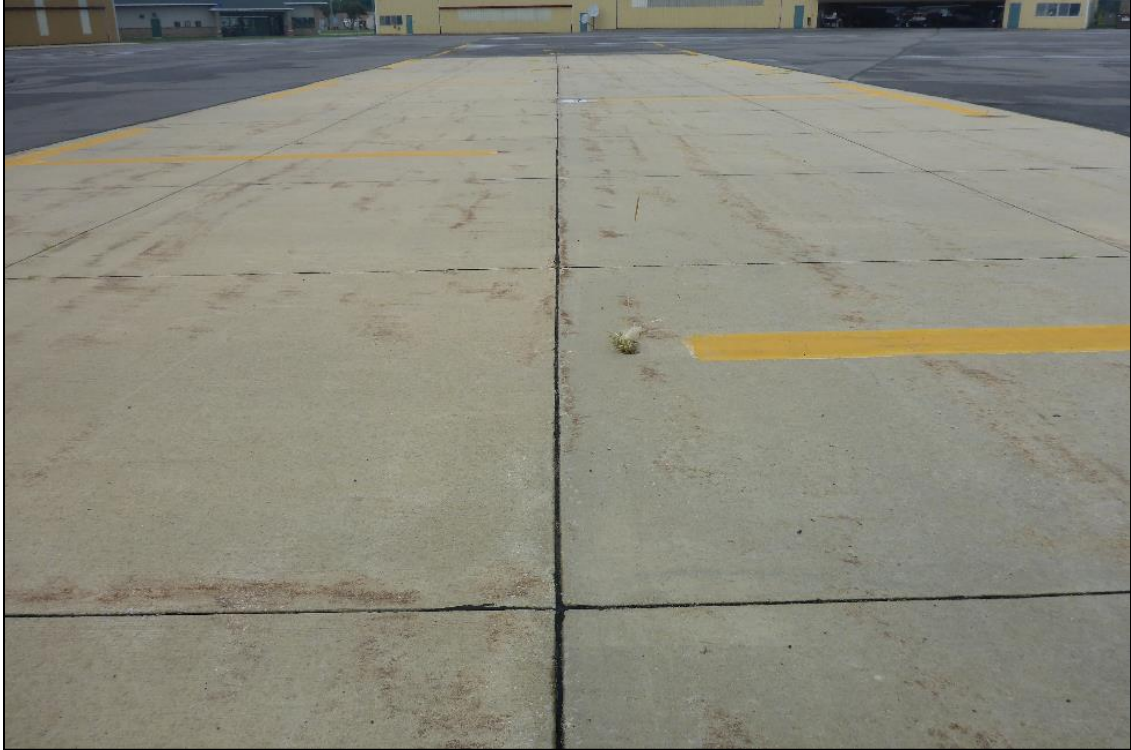
AUM APA 003 (PCI = 95)

Network:	AUM		Name:	AUSTIN			
Branch:	APA	Name:	Apron A	Use:	APRON	Area:	146,600 SqFt
Section:	003	of 3	From:	-	To:	-	Last Const.: 9/1/2007
Surface:	PCC	Family:	MN2013 PCC	Zone:	E	Category:	1
Area:	6,400 SqFt	Length:	160 Ft	Width:	40 Ft	Rank:	S
Slabs:	64	Slab Length:	10 Ft	Slab Width:	10 Ft	Joint Length:	1,080 Ft
Shoulder:		Street Type:		Grade:	0	Lanes:	0
Last Insp. Date:	6/22/2017		TotalSamples:	4		Surveyed:	2
Conditions:	PCI: 95						
Sample Number:	100	Type:	R	Area:	16.00 Slabs	PCI:	92
63	LINEAR CR		L		1.00 Slabs		
65	JT SEAL DMG		L		16.00 Slabs		
Sample Number:	102	Type:	R	Area:	16.00 Slabs	PCI:	98
65	JT SEAL DMG		L		16.00 Slabs

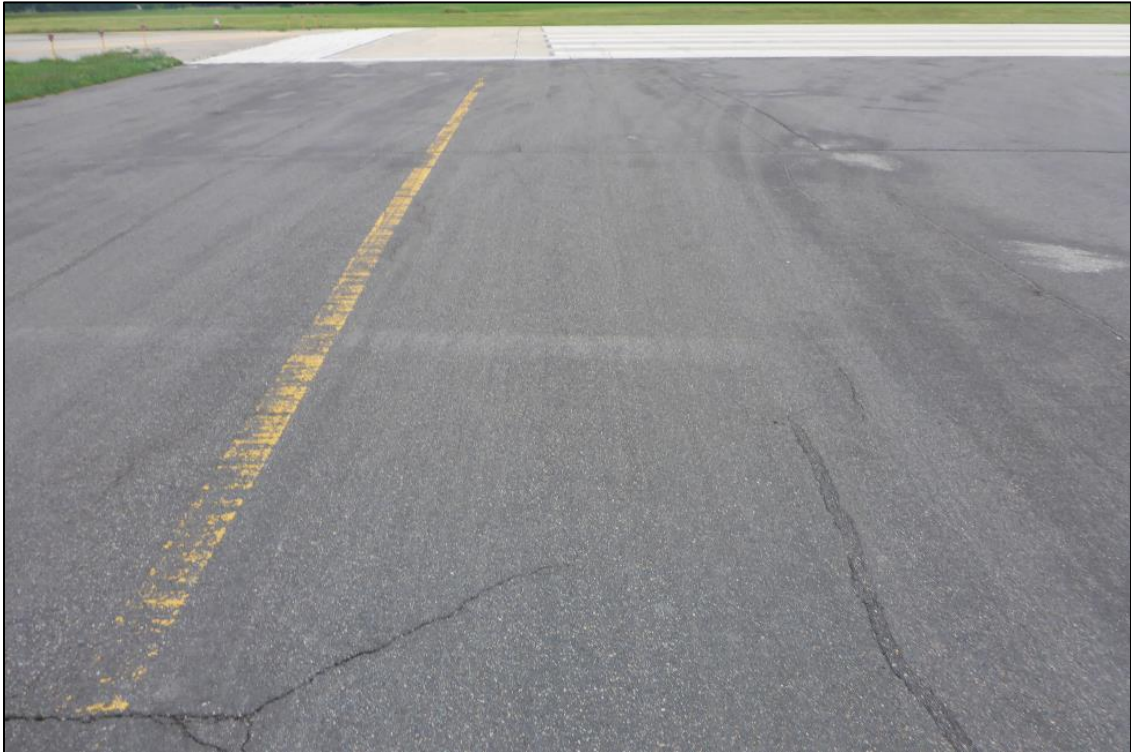
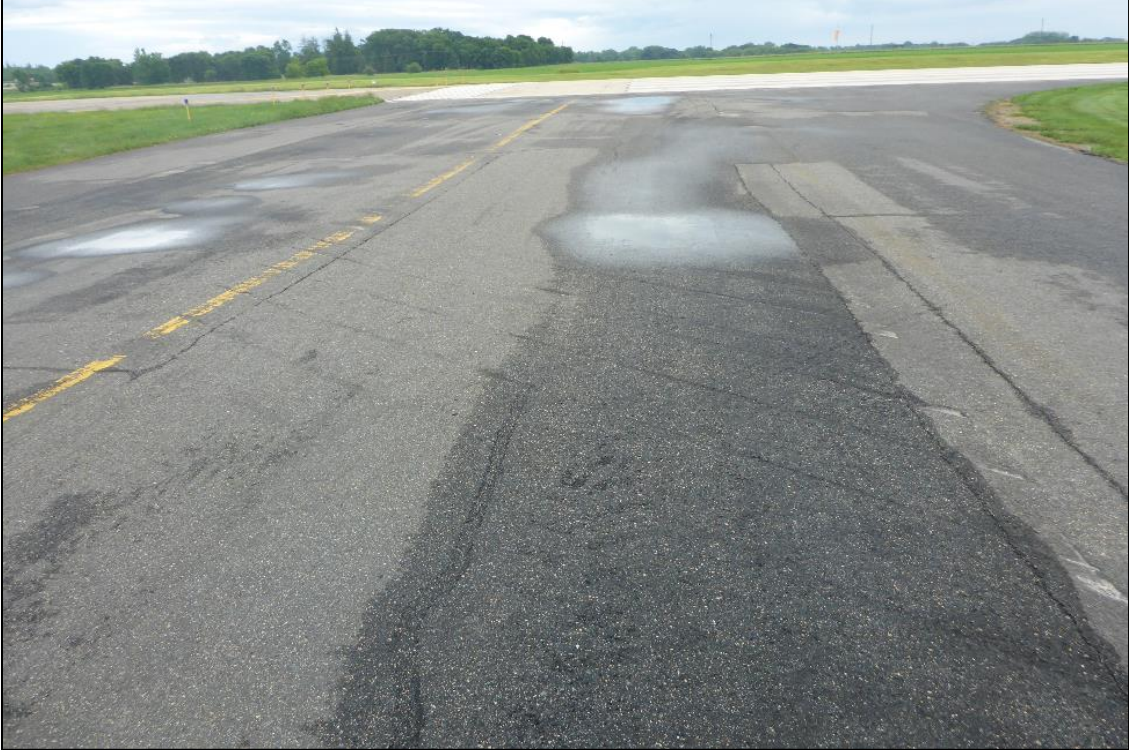
AUM CTA1 001 (PCI = 80)

Network:	AUM		Name:	AUSTIN					
Branch:	CTA1	Name:	CONNECTING TAXIWAY A1	Use:	TAXIWAY	Area:	26,750 SqFt		
Section:	001	of 2	From:	100	To:	100	Last Const.:	10/31/2005	
Surface:	AC	Family:	MN2013 Asphalt Taxiways	Zone:	E	Category:	1	Rank:	P
Area:	7,500 SqFt	Length:	130 Ft	Width:	50 Ft				
Slabs:		Slab Length:	Ft	Slab Width:	Ft	Joint Length:	Ft		
Shoulder:		Street Type:		Grade:	0	Lanes:	0		
Last Insp. Date:	6/22/2017	TotalSamples:	1	Surveyed:	1				
Conditions:	PCI: 80								
Sample Number:	100	Type:	R	Area:	7025.00 SqFt	PCI:	80		
48	L & T CR		L	362.00	Ft				
50	PATCHING		L	465.00	SqFt

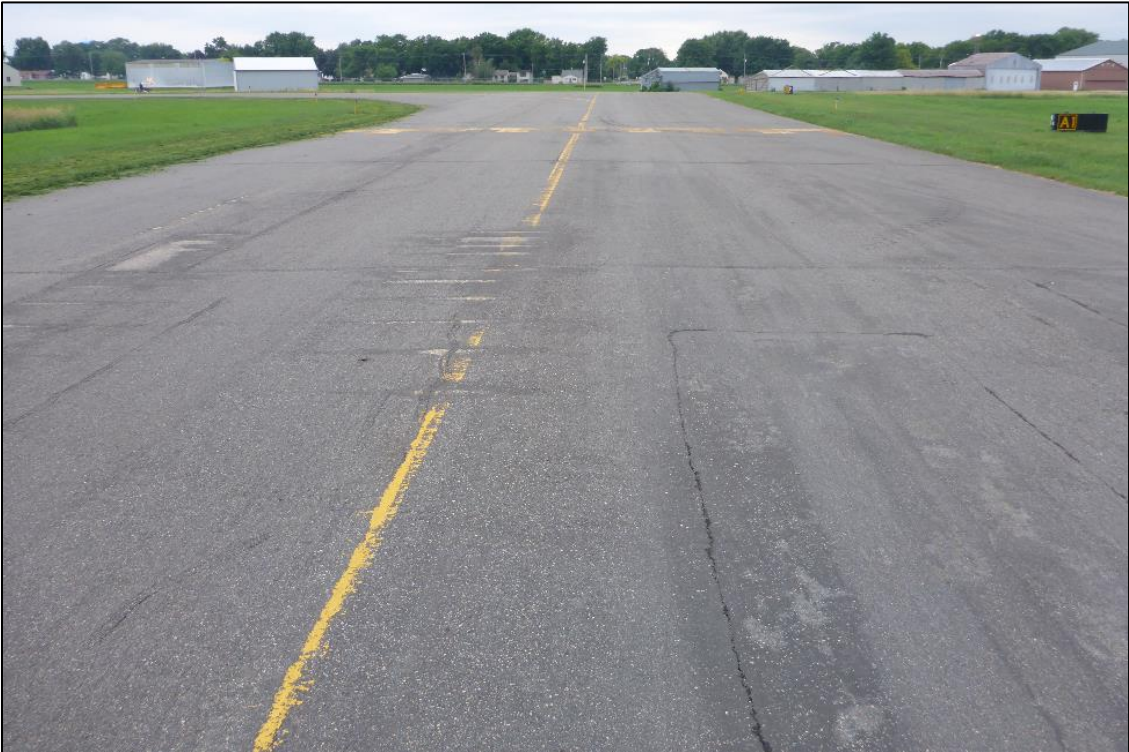
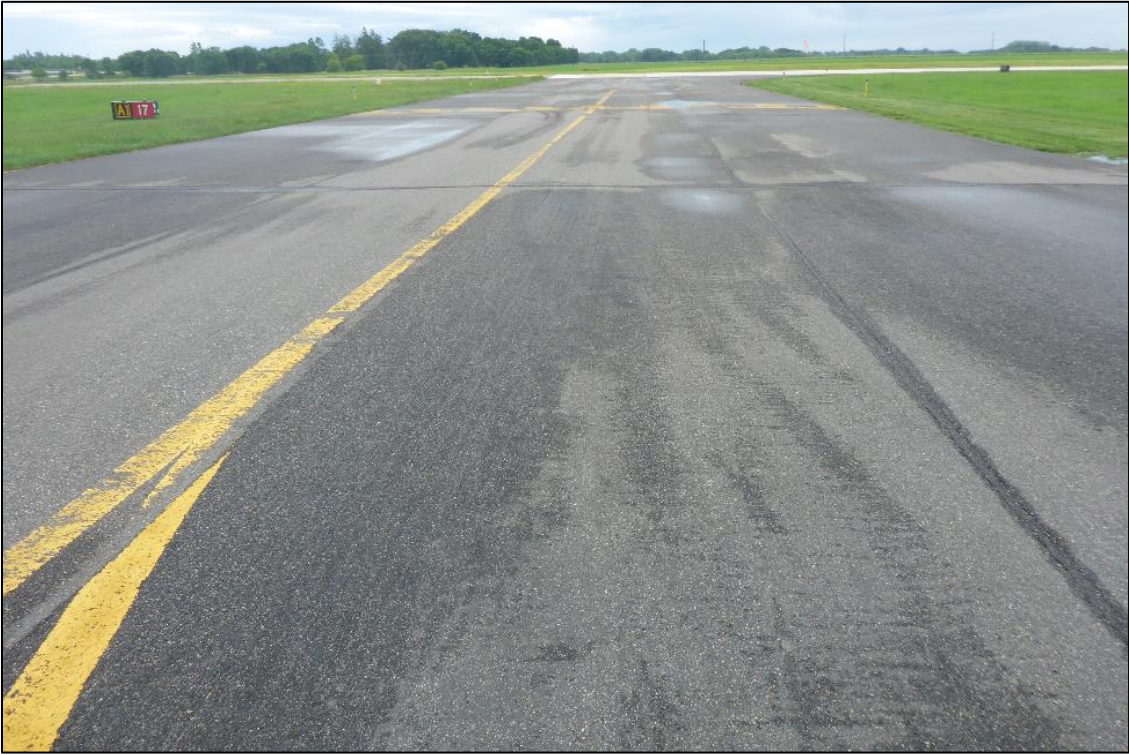
AUM CTA1 002 (PCI = 76)

Network:	AUM		Name:	AUSTIN					
Branch:	CTA1	Name:	CONNECTING TAXIWAY A1	Use:	TAXIWAY	Area:	26,750 SqFt		
Section:	002	of 2	From:	101	To:	105+46.5	Last Const.:	9/30/2004	
Surface:	AC	Family:	MN2013 Asphalt Taxiways	Zone:	E	Category:	1	Rank:	P
Area:	19,250 SqFt	Length:	385 Ft	Width:	50 Ft				
Slabs:		Slab Length:	Ft	Slab Width:	Ft	Joint Length:	Ft		
Shoulder:		Street Type:		Grade:	0	Lanes:	0		
Last Insp. Date:	6/22/2017	TotalSamples:	4	Surveyed:	2				
Conditions:	PCI:	76							
Sample Number:	102	Type:	R	Area:	5000.00 SqFt	PCI:	79		
48	L & T CR	L		349.00	Ft				
50	PATCHING	L		8.00	SqFt				
Sample Number:	103	Type:	R	Area:	5000.00 SqFt	PCI:	73		
48	L & T CR	L		398.00	Ft				
48	L & T CR	M		54.00	Ft				
50	PATCHING	L		2.00	SqFt

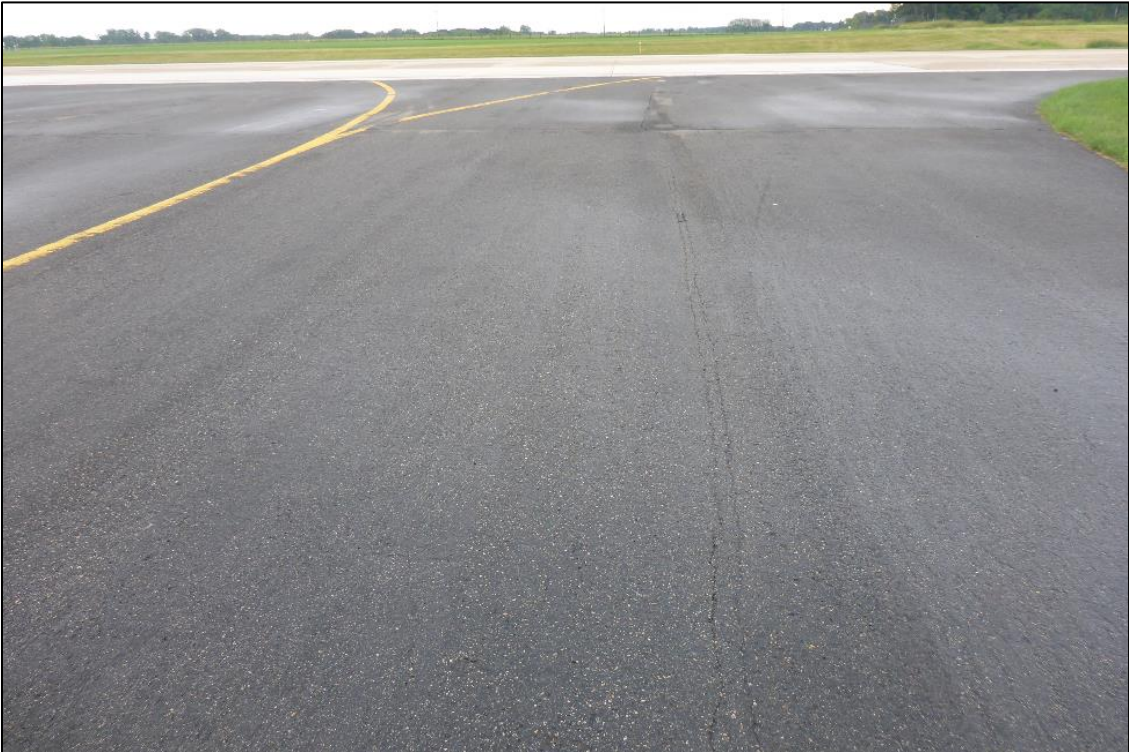
AUM CTA2 001 (PCI = 74)

Network:	AUM		Name:	AUSTIN					
Branch:	CTA2	Name:	CONNECTING TAXIWAY A2	Use:	TAXIWAY	Area:	19,750 SqFt		
Section:	001	of 2	From:	200	To:	200	Last Const.:	10/31/2005	
Surface:	AC	Family:	MN2013 Asphalt Taxiways	Zone:	E	Category:	1	Rank:	P
Area:	7,700 SqFt	Length:	114 Ft	Width:	50 Ft				
Slabs:	Slab Length:	Ft	Slab Width:	Ft	Joint Length:	Ft			
Shoulder:	Street Type:	Grade:	0	Lanes:	0				
Last Insp. Date:	6/22/2017	TotalSamples:	1	Surveyed:	1				
Conditions:	PCI:	74							
Sample Number:	200	Type:	R	Area:	7200.00 SqFt	PCI:	74		
48	L & T CR	L	612.00	Ft					
50	PATCHING	L	112.00	SqFt

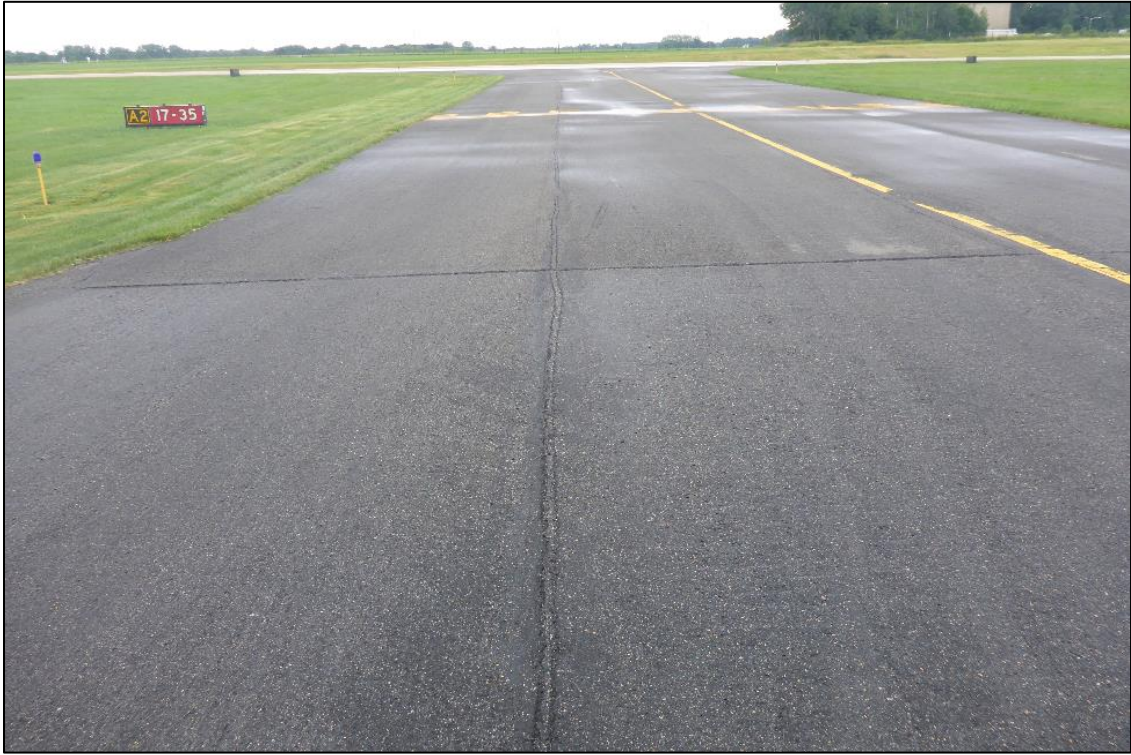
AUM CTA2 002 (PCI = 74)

Network:	AUM		Name:	AUSTIN					
Branch:	CTA2	Name:	CONNECTING TAXIWAY A2	Use:	TAXIWAY	Area:	19,750 SqFt		
Section:	002	of 2	From:	201	To:	202+25	Last Const.:	9/30/2004	
Surface:	AC	Family:	MN2013 Asphalt Taxiways	Zone:	E	Category:	1	Rank:	P
Area:	12,050 SqFt	Length:	211 Ft	Width:	50 Ft				
Slabs:	Slab Length:	Ft	Slab Width:	Ft	Joint Length:	Ft			
Shoulder:	Street Type:	Grade:	0	Lanes:	0				
Last Insp. Date:	6/22/2017	TotalSamples:	2	Surveyed:	1				
Conditions:	PCI:	74							
Sample Number:	202	Type:	R	Area:	5500.00 SqFt	PCI:	74		
48	L & T CR	M	13.00	Ft					
48	L & T CR	L	454.00	Ft
