Pavement Condition Report

Brooten Municipal Airport (6D1)

December 2018

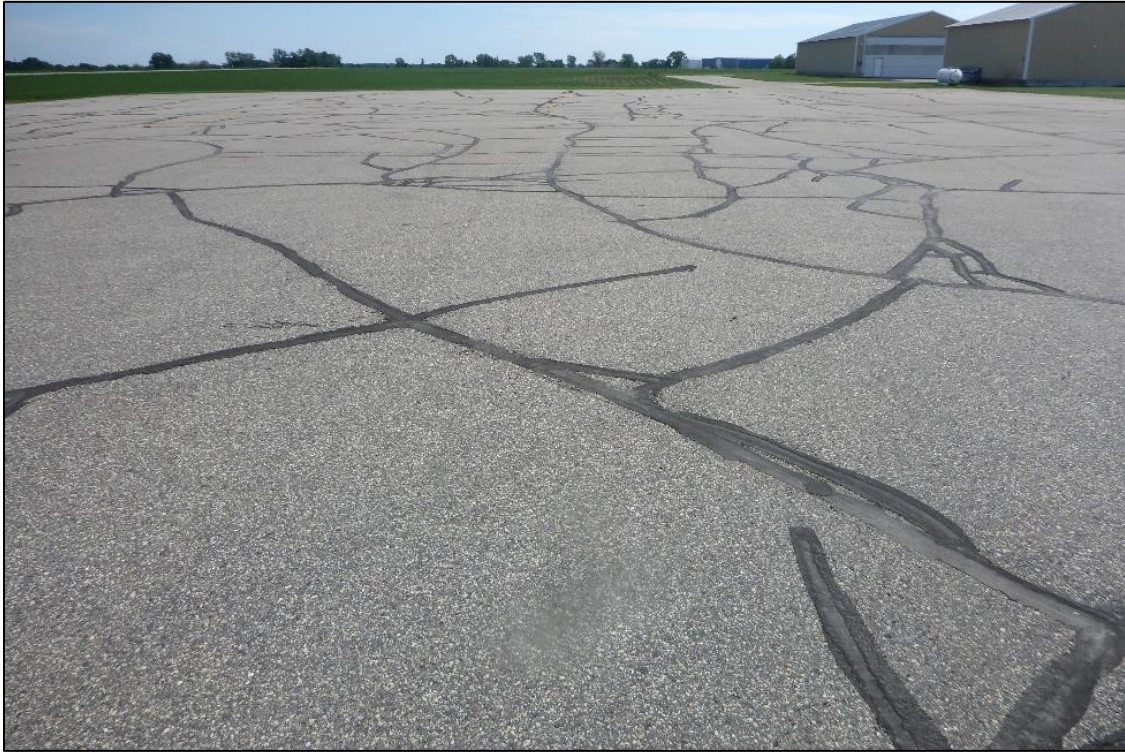
6D1 APA 001 (PCI = 56)

Network: 6D1				Name: BROOTEN		
Branch: APA	Name: APRON A	Use: APRON	Area: 52,500 SqFt			
Section: 001	of 1	From: 100	To: 302	Last Const.: 9/27/2003		
Surface: AAC	Family: MN2018 Asphalt Aprons	Zone: W	Category: 2	Rank: S		
Area: 52,500 SqFt	Length: 300 Ft	Width: 175 Ft				
Slabs:	Slab Length: Ft	Slab Width: Ft	Joint Length: Ft			
Shoulder:	Street Type:	Grade: 0	Lanes: 0			
Last Insp. Date: 5/31/2018	Total Samples: 12	Surveyed: 3				
Conditions: PCI: 56						
Sample Number: 102	Type: R	Area: 5000.00 SqFt	PCI: 57			
57 WEATHERING	L	4500.00 SqFt				
48 L & T CR	M	14.00 Ft				
48 L & T CR	L	711.00 Ft				
57 WEATHERING	M	500.00 SqFt				
Sample Number: 201	Type: R	Area: 5000.00 SqFt	PCI: 57			
57 WEATHERING	M	1500.00 SqFt				
48 L & T CR	L	981.00 Ft				
57 WEATHERING	L	3500.00 SqFt				
Sample Number: 300	Type: R	Area: 5000.00 SqFt	PCI: 53			
48 L & T CR	M	6.00 Ft				
57 WEATHERING	M	3500.00 SqFt				
57 WEATHERING	L	1500.00 SqFt

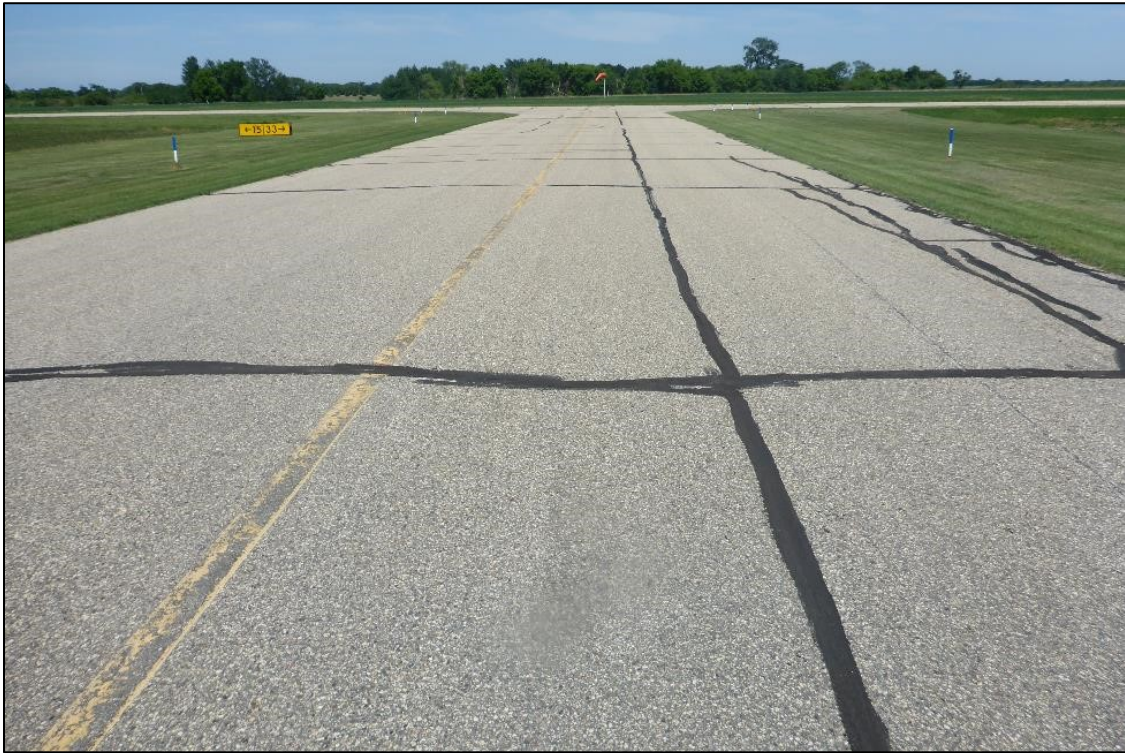
6D1 CTA 001 (PCI = 66)

Network:	6D1	Name:	BROOTEN				
Branch:	CTA	Name:	CONNECTING TAXIWAY A	Use:	TAXIWAY	Area:	16,000 SqFt
Section:	001	of 1	From:	100	To:	402	Last Const.: 9/28/2003
Surface:	AAC	Family:	MN2018 Asphalt Runway- Taxiways	Zone:	W	Category:	2
Area:	16,000 SqFt	Length:	370 Ft	Width:	40 Ft	Joint Length:	Ft
Slabs:		Slab Length:	Ft	Slab Width:	Ft	Joint Length:	Ft
Shoulder:		Street Type:		Grade:	0	Lanes:	0
Last Insp. Date:	5/31/2018	TotalSamples:	4	Surveyed:	1		
Conditions:	PCI: 66						
Sample Number:	101	Type:	R	Area:	4000.00 SqFt	PCI:	66
57	WEATHERING		M	2000.00	SqFt		
57	WEATHERING		L	2000.00	SqFt		
48	L & T CR		L	443.00	Ft

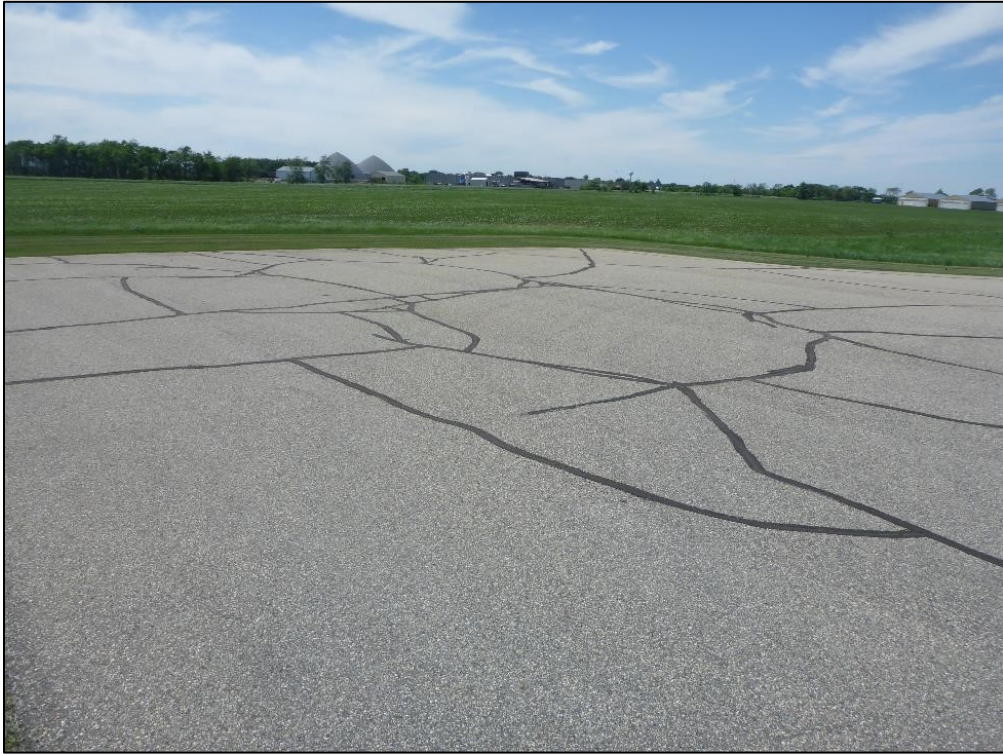
D61 RTA 001 (PCI = 59)

Network:	6D1	Name:	BROOTEN							
Section:	001	of	2	From:	200	To:	201	Last Const.:	9/28/2003	
Surface:	AAC	Family:	MN2018 Asphalt Runway- Taxiways		Zone:	W	Category:	2	Rank:	S
Area:	7,650 SqFt	Length:	80 Ft	Width:	80 Ft					
Slabs:		Slab Length:	Ft	Slab Width:	Ft	Joint Length:	Ft			
Shoulder:		Street Type:		Grade:	0	Lanes:	0			
Last Insp. Date:	6/1/2018	TotalSamples:	2	Surveyed:	1					
Conditions:	PCI: 59									
Sample Number:	200	Type:	R	Area:	4000.00 SqFt	PCI:	59			
48	L & T CR	L		531.00	Ft					
48	L & T CR	M		3.00	Ft					
57	WEATHERING	L		800.00	SqFt					
57	WEATHERING	M		2000.00	SqFt					
52	RAVELING	M		70.00	SqFt

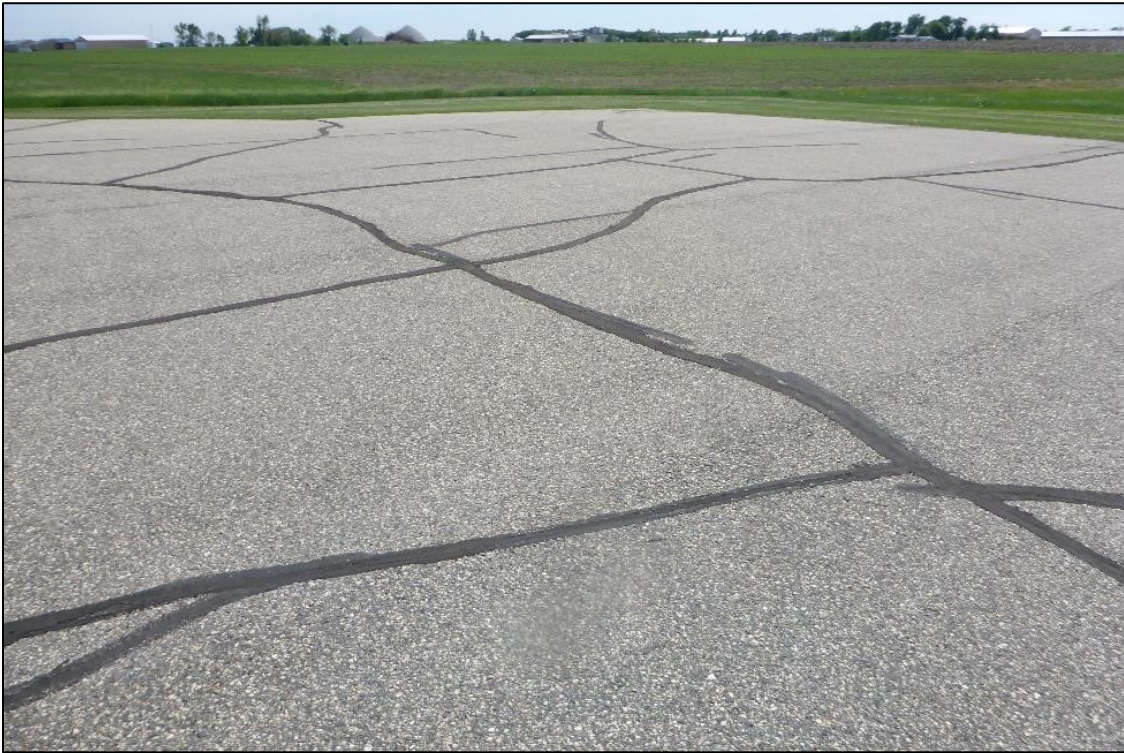
6D1 RTA 002 (PCI = 71)

Network:	6D1	Name:	BROOTEN				
Branch:	RTA	Name:	Runway Turn-Around	Use:	TAXIWAY	Area:	15,300 SqFt
Section:	002	of 2	From:	268	To:	269	Last Const.: 9/28/2003
Surface:	AAC	Family:	MN2018 Asphalt Runway-Taxiways	Zone:	W	Category:	2
Area:	7,650 SqFt	Length:	80 Ft	Width:	80 Ft	Joint Length:	Ft
Slabs:		Slab Length:	Ft	Slab Width:	Ft	Joint Length:	Ft
Shoulder:		Street Type:		Grade:	0	Lanes:	0
Last Insp. Date:	5/31/2018	TotalSamples:	2	Surveyed:	1		
Conditions:	PCI: 67						
Sample Number:	269	Type:	R	Area:	4000.00 SqFt	PCI:	67
57	WEATHERING		M	2000.00	SqFt		
48	L & T CR		L	410.00	Ft		
57	WEATHERING		L	2000.00	SqFt

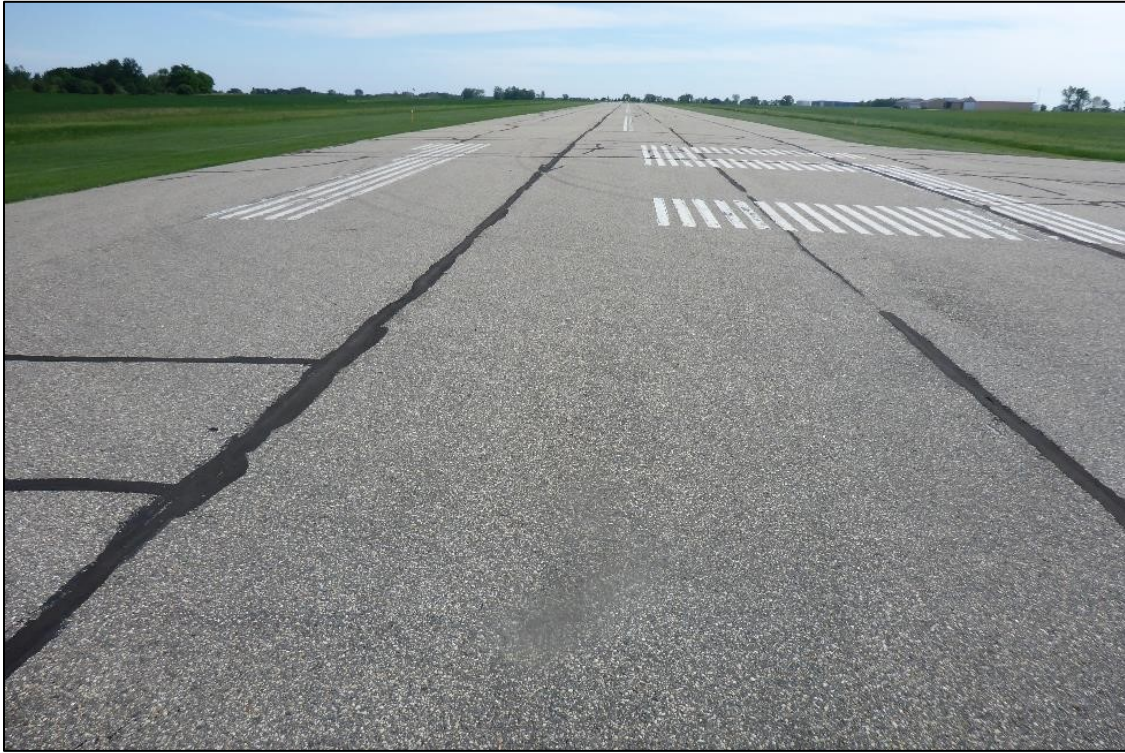
6D1 RY1533 001 (PCI = 58)

Network:	6D1		Name:	BROOTEN					
Branch:	RY1533	Name:	RUNWAY 15-33	Use:	RUNWAY	Area:	210,000 SqFt		
Section:	001	of 1	From:	100	To:	169	Last Const.:	9/28/2003	
Surface:	AAC	Family:	MN2018 Asphalt Runway-Taxiways	Zone:	W	Category:	2	Rank:	P
Area:	210,000 SqFt	Length:	3,500 Ft	Width:	60 Ft	Joint Length:	Ft		
Slabs:		Slab Length:	Ft	Slab Width:	Ft	Joint Length:	Ft		
Shoulder:		Street Type:		Grade:	0	Lanes:	0		
Last Insp. Date:	6/1/2018		Total Samples:	70		Surveyed:	7		
Conditions:	PCI: 58								
Sample Number:	108	Type:	R	Area:	3000.00 SqFt	PCI:	56		
48	L & T CR	L		465.00 Ft					
57	WEATHERING	L		1900.00 SqFt					
52	RAVELING	L		75.00 SqFt					
57	WEATHERING	M		1000.00 SqFt					
Sample Number:	116	Type:	R	Area:	3000.00 SqFt	PCI:	60		
57	WEATHERING	M		2000.00 SqFt					
48	L & T CR	L		526.00 Ft					
52	RAVELING	L		50.00 SqFt					
57	WEATHERING	L		1000.00 SqFt					
Sample Number:	124	Type:	R	Area:	3000.00 SqFt	PCI:	57

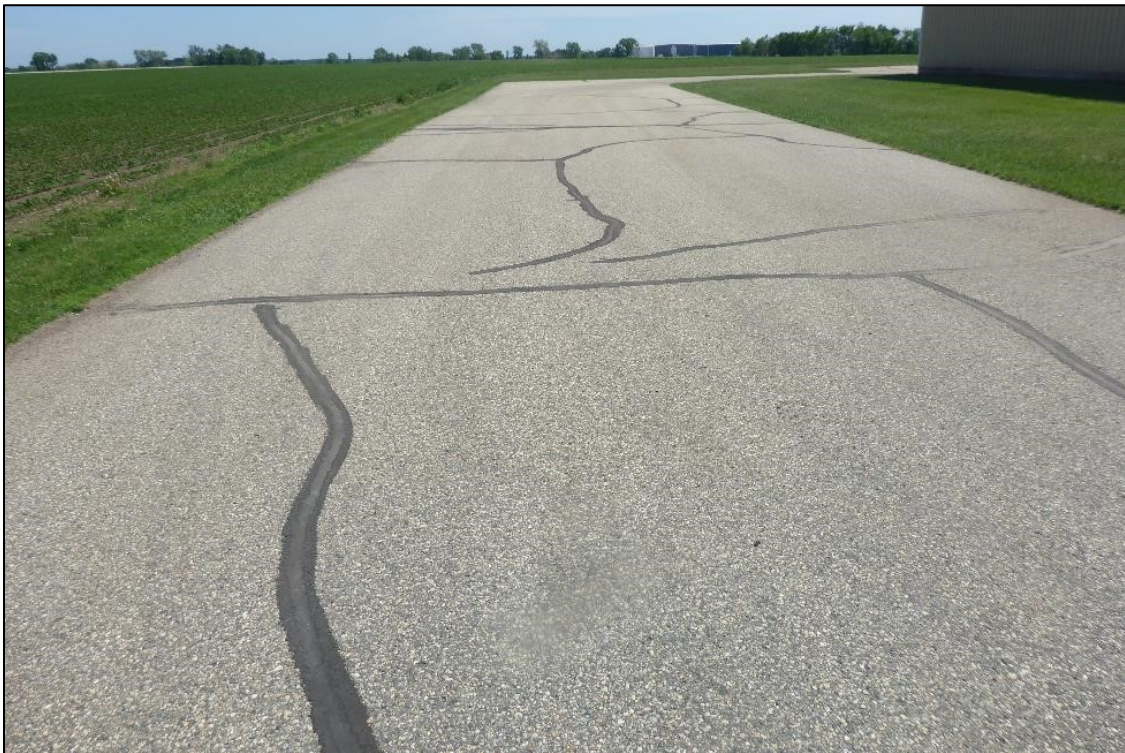
6D1 TLA 001 (PCI = 70)

Network:	6D1	Name:	BROOTEN				
Branch:	TLA	Name:	Taxilane A	Use:	TAXILANE	Area:	13,875 SqFt
Section:	001	of 1	From:	303	To:	404	Last Const.: 9/27/2003
Surface:	AAC	Family:	MN2018 Asphalt Taxilanes	Zone:	W	Category:	2
Rank:	T						
Area:	13,875 SqFt	Length:	555 Ft	Width:	25 Ft		
Slabs:	Slab Length:	Ft	Slab Width:	Ft	Joint Length:	Ft	
Shoulder:	Street Type:	Grade:	0	Lanes:	0		
Last Insp. Date:	5/31/2018	TotalSamples:	4	Surveyed:	1		
Conditions:	PCI: 70						
Sample Number:	303	Type:	R	Area:	3750.00 SqFt	PCI:	70
57	WEATHERING	L		1000.00	SqFt		
57	WEATHERING	M		2750.00	SqFt		
48	L & T CR	L		235.00	Ft		
48	L & T CR	M		10.00	Ft
