# Pavement Condition Report

## Appleton Municipal Airport (AQP)

**December 2018**

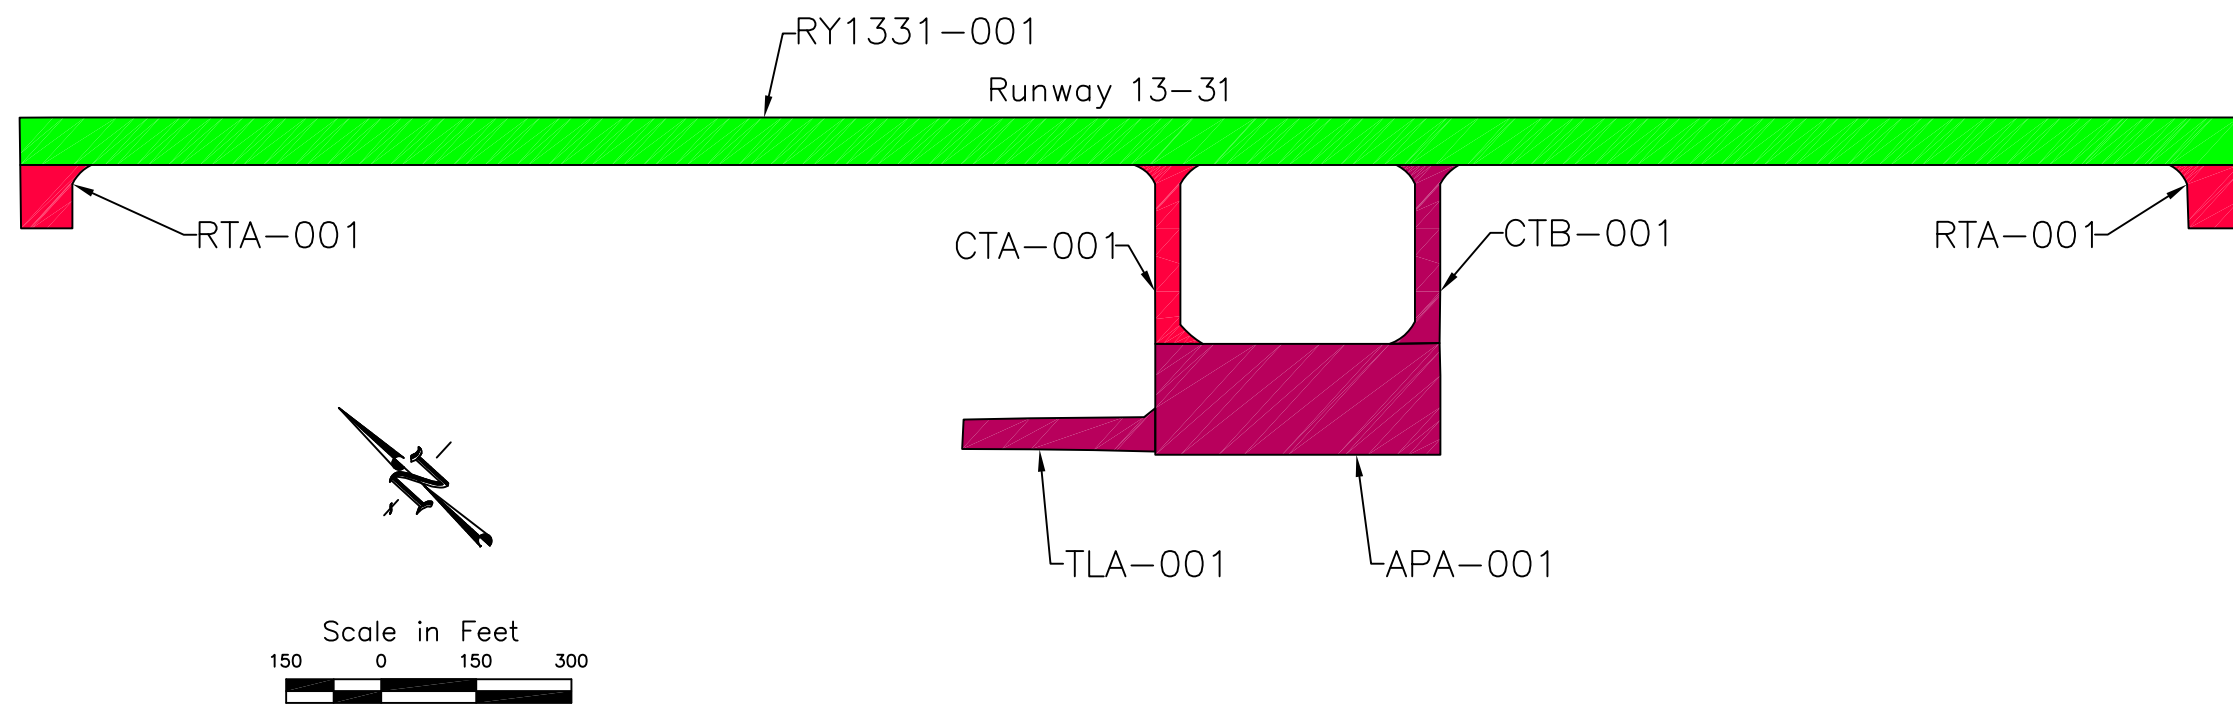
Figure 4. 2018 Pavement Condition Index Rating at Appleton Municipal Airport (AQP).

<sup>6</sup>Higher than expected deterioration rate of 5.8 PCI/year due to the development of low and medium L&T cracking in significant quantities.
