# Pavement Condition Report

## Grand Marais-Cook County Airport (CKC)

**December 2018**

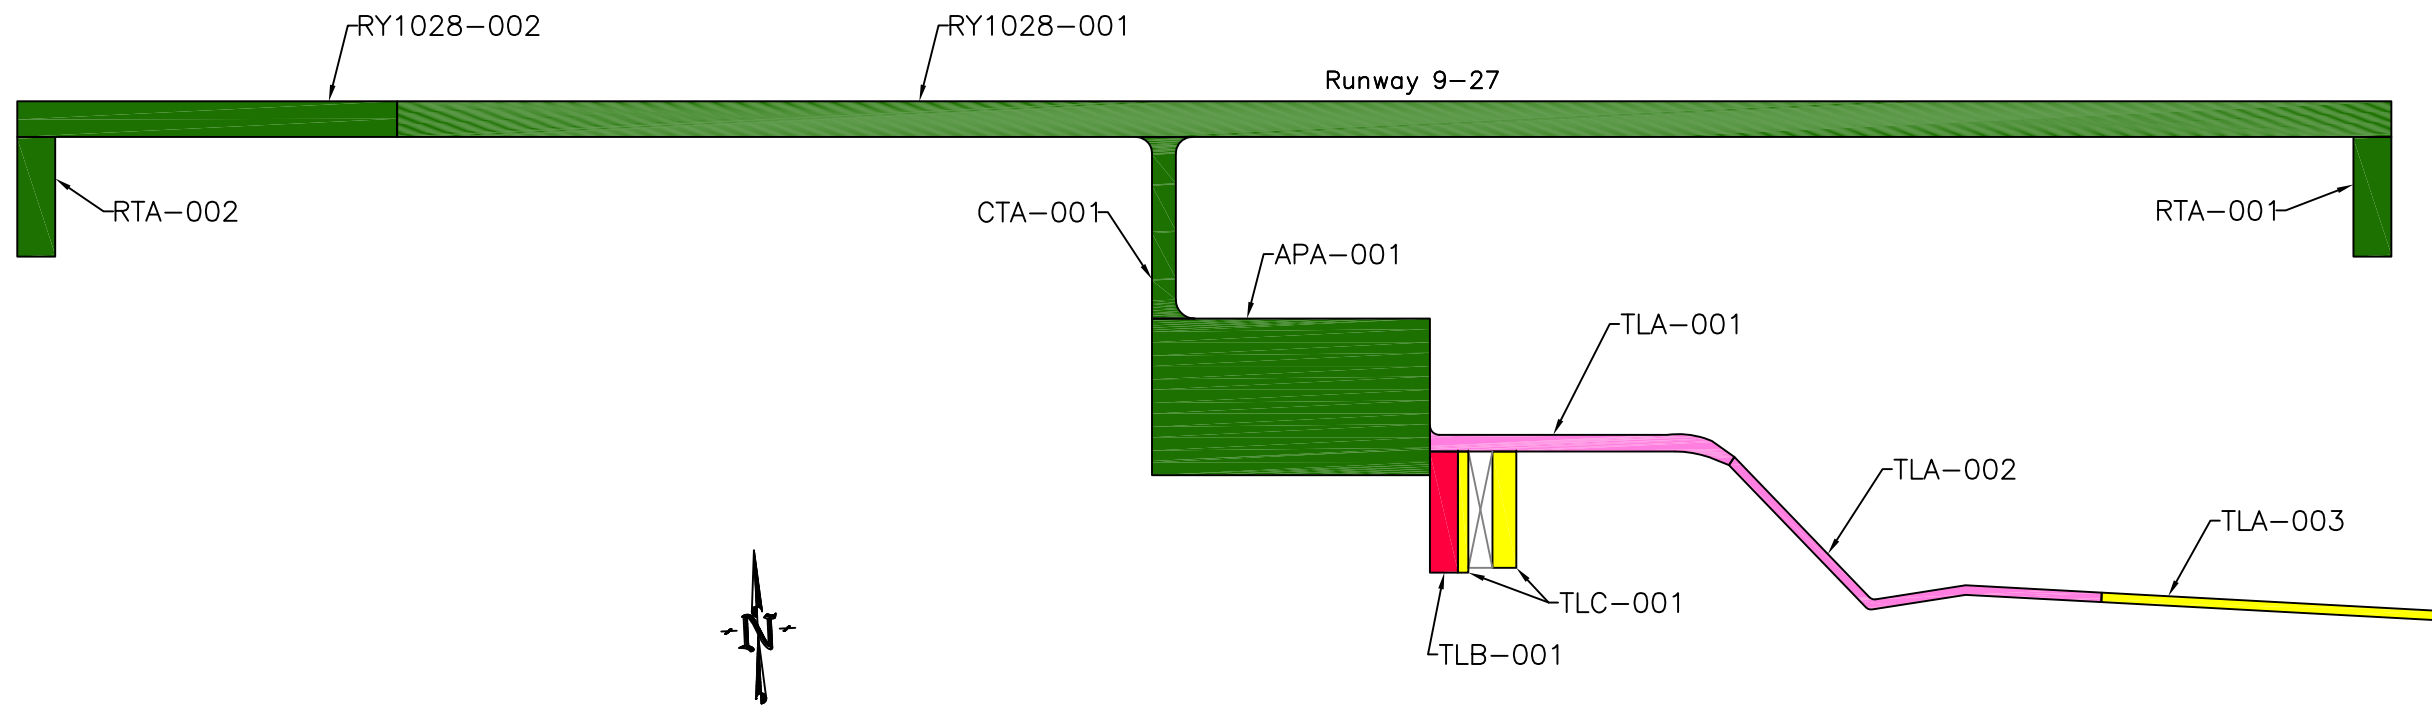
Figure 4. 2018 Pavement Condition Index Rating at Grand Marais-Cook County Airport (CKC).

Figures 5 and 6 present the overall PCI for CKC by area distribution and pavement use, respectively. Table 3 presents the PCI summary for each section at CKC, including the drop in PCI per year. Generally, pavement sections will deteriorate between 1 and 3 PCI points per year. Sections deteriorating at higher rates may need maintenance above the normal application rates and should be closely monitored in case major repairs become necessary earlier than expected.

<sup>6</sup>High deterioration rate is due to minor distresses (L&T cracking) on a year old pavement.
