Pavement Condition Report

Crookston Municipal Airport (CKN)

December 2018

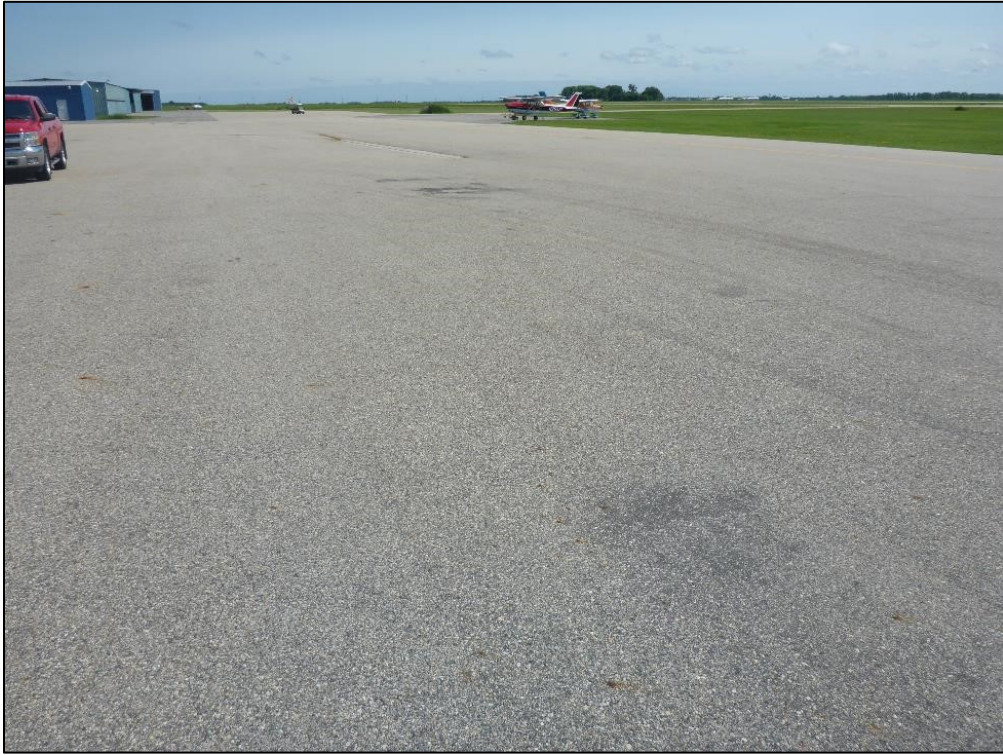
CKN APA 001 (PCI = 83)

Network:	CKN		Name:	CROOKSTON					
Branch:	APA	Name:	APRON A	Use:	APRON	Area:	106,956 SqFt		
Section:	001	of 4	From:	107	To:	213	Last Const.:	12/1/2013	
Surface:	AC	Family:	MN2018 Asphalt Aprons	Zone:	N	Category:	2	Rank:	S
Area:	67,134 SqFt	Length:	830 Ft	Width:	30 Ft				
Slabs:	Slab Length:	Ft	Slab Width:	Ft	Joint Length:	Ft			
Shoulder:	Street Type:		Grade:	0	Lanes:	0			
Last Insp. Date:	7/3/2018	Total Samples:	4	Surveyed:	3				
Conditions:	PCI:	83							
Sample Number:	101	Type:	R	Area:	2700.00 SqFt	PCI:	79		
48	L & T CR	L		43.00	Ft				
48	L & T CR	M		24.00	Ft				
57	WEATHERING	L		2600.00	SqFt				
Sample Number:	109	Type:	R	Area:	4250.00 SqFt	PCI:	94		
57	WEATHERING	L		4000.00	SqFt				
Sample Number:	112	Type:	R	Area:	5500.00 SqFt	PCI:	76		
48	L & T CR	M		87.00	Ft				
48	L & T CR	H		1.00	Ft				
57	WEATHERING	L		5300.00	SqFt				
48	L & T CR	L		20.00	Ft

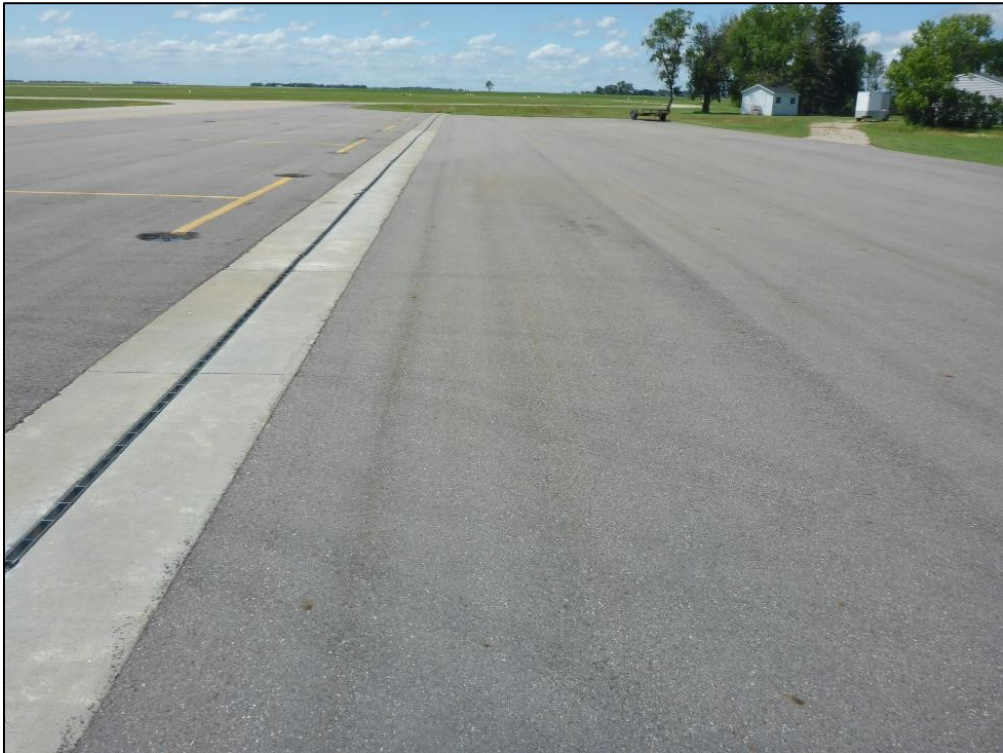
CKN APA 002 (PCI = 95)

Network:	CKN		Name:	CROOKSTON					
Branch:	APA	Name:	APRON A	Use:	APRON	Area:	106,956 SqFt		
Section:	002	of 4	From:	100	To:	107	Last Const.:	1/15/2016	
Surface:	AAC	Family:	MN2018 Asphalt Aprons	Zone:	N	Category:	2	Rank:	S
Area:	26,931 SqFt	Length:	400 Ft	Width:	75 Ft				
Slabs:	Slab Length:	Ft	Slab Width:	Ft	Joint Length:	Ft			
Shoulder:	Street Type:		Grade:	0	Lanes:	0			
Last Insp. Date:	7/3/2018	Total Samples:	7	Surveyed:	2				
Conditions:	PCI:	95							
Sample Number:	102	Type:	R	Area:	5150.00 SqFt	PCI:	94		
48	L & T CR	L	69.00	Ft					
Sample Number:	105	Type:	R	Area:	5150.00 SqFt	PCI:	96		
48	L & T CR	L	20.00	Ft

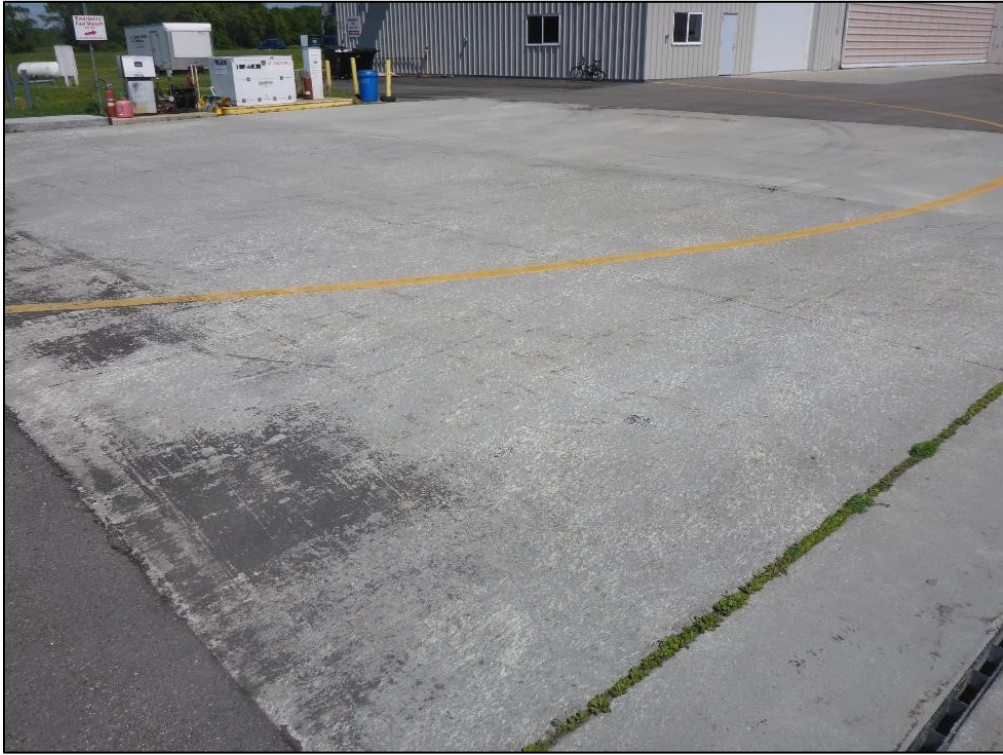
CKN APA 004 (PCI = 98)

Network:	CKN		Name:	CROOKSTON			
Branch:	APA	Name:	APRON A	Use:	APRON	Area:	106,956 SqFt
Section:	004	of 4	From:	100	To:	100	Last Const.: 12/1/2013
Surface:	PCC	Family:	MN2018 PCC	Zone:		Category:	Rank: P
Area:	2,970 SqFt	Length:	50 Ft	Width:	57 Ft		
Slabs:	30	Slab Length:	10 Ft	Slab Width:	10 Ft	Joint Length:	469 Ft
Shoulder:		Street Type:		Grade:	0	Lanes:	0
Last Insp. Date:	7/3/2018	TotalSamples:	1	Surveyed:	1		
Conditions:	PCI: 98						
Sample Number:	100	Type:	R	Area:	24.00 Slabs	PCI:	98
65	JT SEAL DMG		L		24.00 Slabs

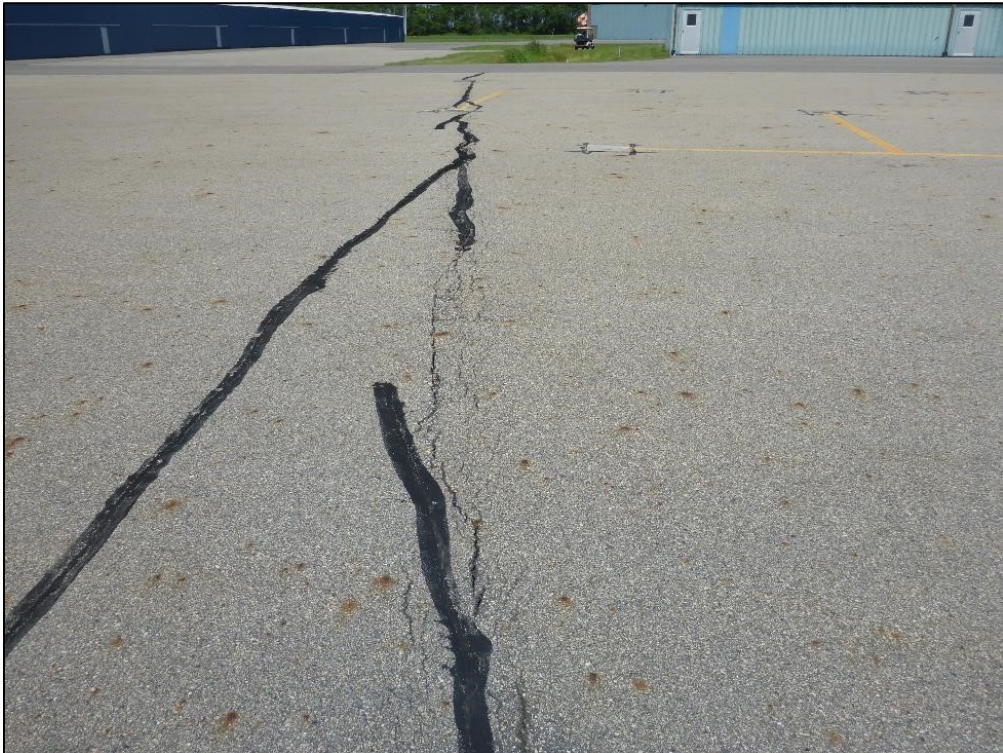
CKN APB 001 (PCI = 77)

Network:	CKN		Name:	CROOKSTON			
Branch:	APB	Name:	APRON B	Use:	APRON	Area:	28,007 SqFt
Section:	001	of 1	From:	101	To:	105	Last Const.: 12/1/2013
Surface:	AC	Family:	MN2018 Asphalt Aprons	Zone:	N	Category:	2
Area:	28,007 SqFt	Length:	290 Ft	Width:	100 Ft	Rank:	S
Slabs:	Slab Length:	Ft	Slab Width:	Ft	Joint Length:	Ft	
Shoulder:	Street Type:		Grade:	0	Lanes:	0	
Last Insp. Date:	7/3/2018	Total Samples:	6	Surveyed:	2		
Conditions:	PCI: 77						
Sample Number:	101	Type:	R	Area:	5250.00 SqFt	PCI:	64
41	ALLIGATOR CR	M	10.00	SqFt			
41	ALLIGATOR CR	L	40.00	SqFt			
48	L & T CR	L	69.00	Ft			
48	L & T CR	M	67.00	Ft			
56	SWELLING	L	60.00	SqFt			
Sample Number:	104	Type:	R	Area:	5250.00 SqFt	PCI:	90
48	L & T CR	L	28.00	Ft			
57	WEATHERING	L	4500.00	SqFt

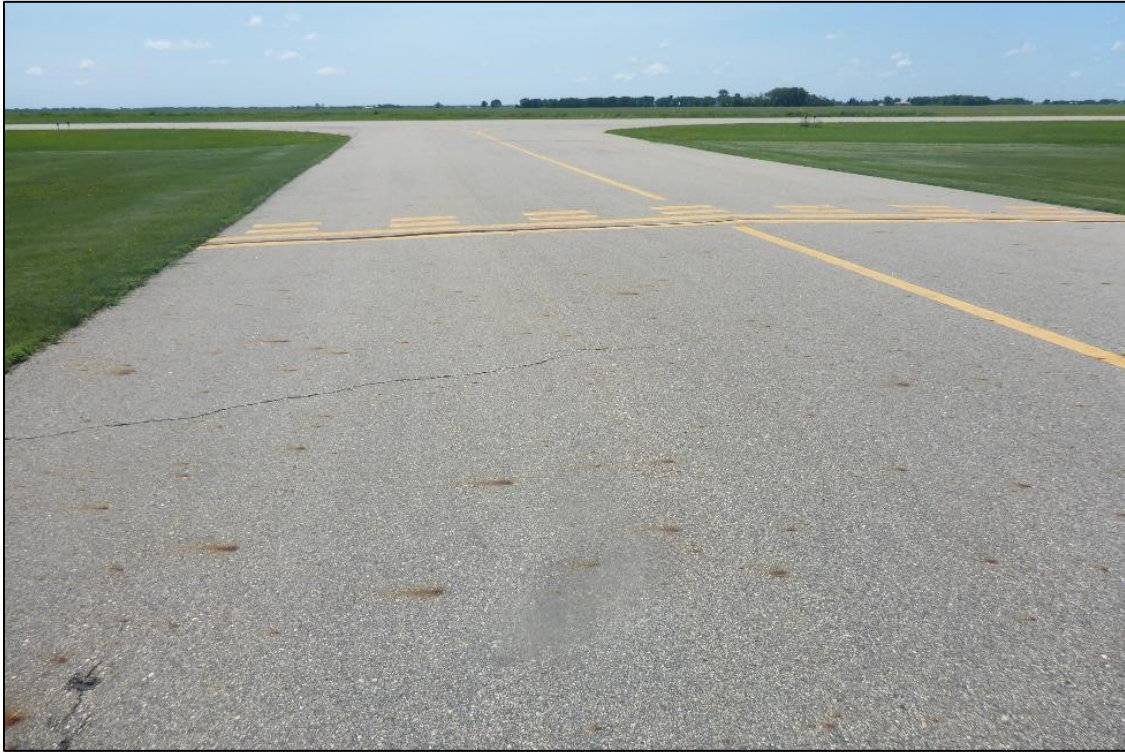
CKN CTA2 001 (PCI = 87)

Network:	CKN	Name:	CROOKSTON				
Branch:	CTA2	Name:	CONNECTING TAXIWAY A2	Use:	TAXIWAY	Area:	33,113 SqFt
Section:	001	of 2	From:	100	To:	102	Last Const.: 12/1/2013
Surface:	AAC	Family:	MN2018 Asphalt Runway- Taxiways	Zone:	N	Category:	2 Rank: P
Area:	12,005 SqFt	Length:	250 Ft	Width:	40 Ft		
Slabs:		Slab Length:	Ft	Slab Width:	Ft	Joint Length:	Ft
Shoulder:		Street Type:		Grade:	0	Lanes:	0
Last Insp. Date:	7/3/2018	TotalSamples:	3	Surveyed:	1		
Conditions:	PCI: 87						
Sample Number:	101	Type:	R	Area:	4000.00 SqFt	PCI:	87
57	WEATHERING		L	2000.00	SqFt		
48	L & T CR		L	86.00	Ft

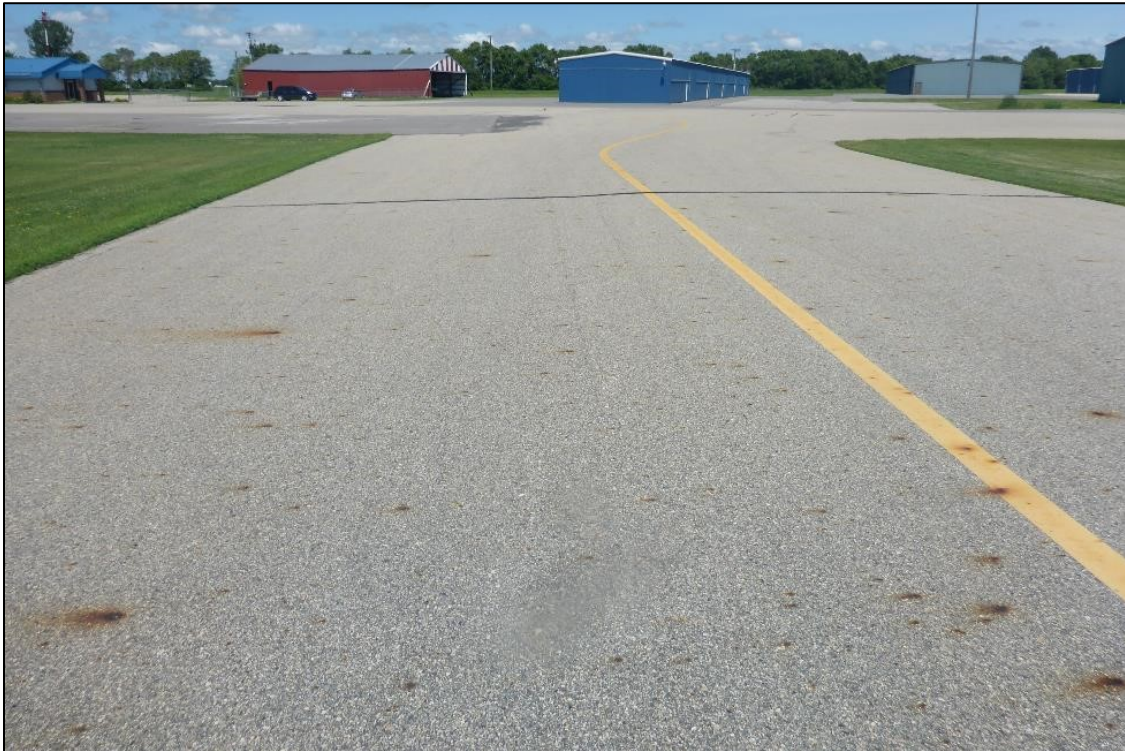
CKN CTA2 002 (PCI = 90)

Network:	CKN		Name:	CROOKSTON			
Branch:	CTA2	Name:	CONNECTING TAXIWAY A2	Use:	TAXIWAY	Area:	33,113 SqFt
Section:	002	of 2	From:	103	To:	107	Last Const.: 12/1/2013
Surface:	AAC	Family:	MN2018 Asphalt Runway- Taxiways	Zone:	N	Category:	2
Area:	21,108 SqFt	Length:	480 Ft	Width:	40 Ft		
Slabs:		Slab Length:	Ft	Slab Width:	Ft	Joint Length:	Ft
Shoulder:		Street Type:		Grade:	0	Lanes:	0
Last Insp. Date:	7/3/2018		TotalSamples:	5	Surveyed:	1	
Conditions:	PCI: 90						
Sample Number:	105	Type:	R	Area:	4000.00 SqFt	PCI:	90
57	WEATHERING		L	2500.00	SqFt		
48	L & T CR		L	40.00	Ft

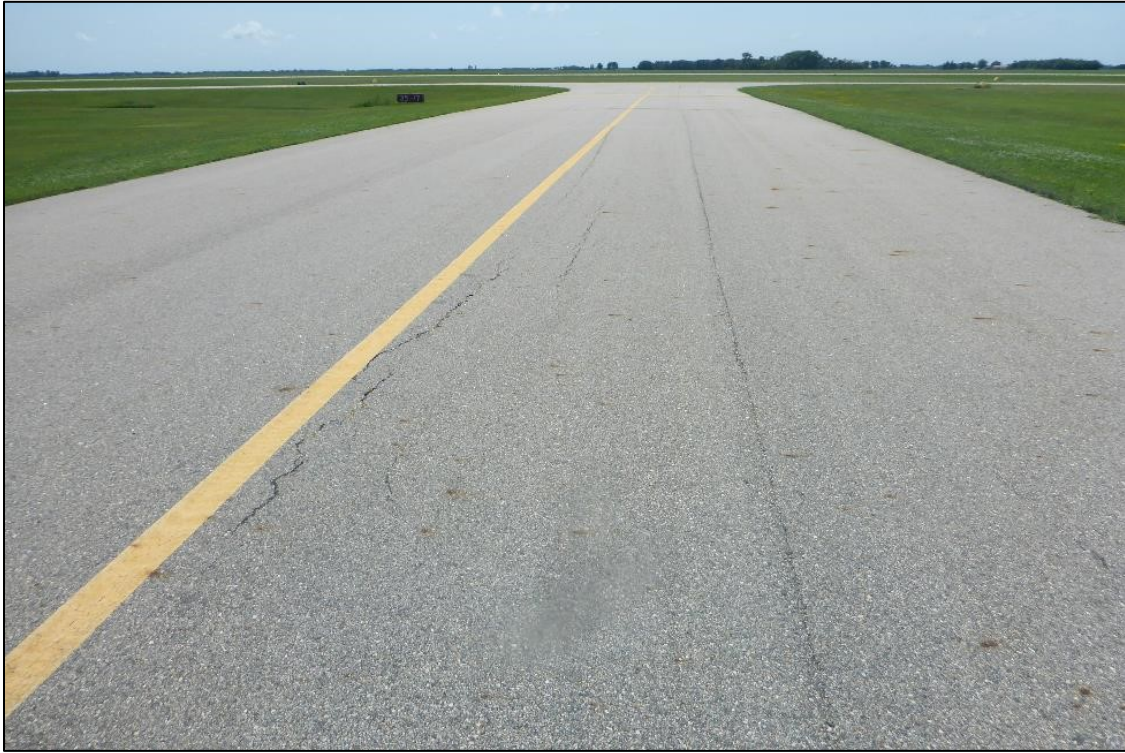
CKN CTA3 001 (PCI = 80)

Network:	CKN	Name:	CROOKSTON				
Branch:	CTA3	Name:	CONNECTING TAXIWAY A3	Use:	TAXIWAY	Area:	18,232 SqFt
Section:	001	of 1	From:	300	To:	303+20	Last Const.: 12/1/2013
Surface:	AC	Family:	MN2018 Asphalt Runway- Taxiways	Zone:	N	Category:	2 Rank: S
Area:	18,232 SqFt	Length:	420 Ft	Width:	40 Ft		
Slabs:		Slab Length:	Ft	Slab Width:	Ft	Joint Length:	Ft
Shoulder:		Street Type:		Grade:	0	Lanes:	0
Last Insp. Date:	7/3/2018	TotalSamples:	4	Surveyed:	1		
Conditions:	PCI: 80						
Sample Number:	302	Type:	R	Area:	4000.00 SqFt	PCI:	80
48	L & T CR		L	140.00 Ft			
57	WEATHERING		L	2000.00 SqFt			
48	L & T CR		M	2.00 Ft
