# Pavement Condition Report

## Fertile Municipal Airport (D14)

Applied Research Associates, Inc.  
6314 Odana Rd  
Madison, WI 53719  
(608) 274-6409

**December 2018**

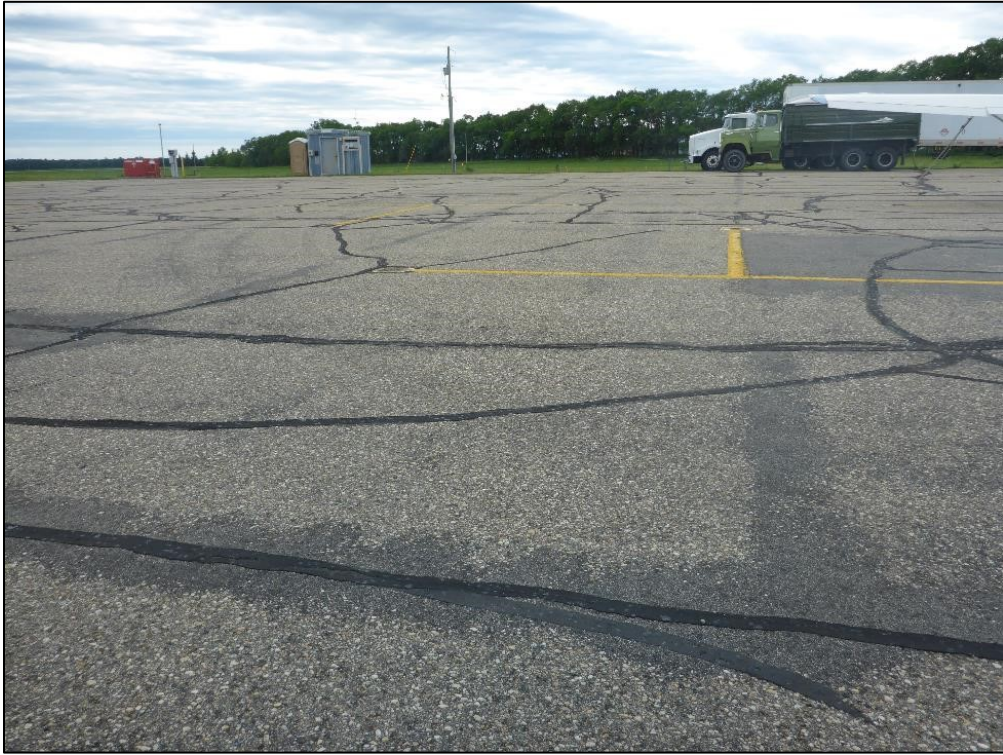
D14 APA 001 (PCI = 51)

| <b>Conditions:</b> PCI: 51 | | | | | | |

| Branch | Section | Distress Type | Severity | Treatment | Estimated Quantity | Unit | Cost |
|---|---|---|---|---|---|---|---|
| APA | 001 | ALLIGATOR CR | L | Crack Sealing - AC | 49 | Ft | \$61 |
| APA | 001 | L & T CR | M | Crack Sealing - AC | 11 | Ft | \$13 |
| APA | 001 | L & T CR | H | Crack Sealing - AC | 21 | Ft | \$27 |

| Branch | Section | Treatment | Quantity | Unit | Cost |
|---|---|---|---|---|---|
| APA | 001 | Crack Sealing - AC | 81 | Ft | \$102 |

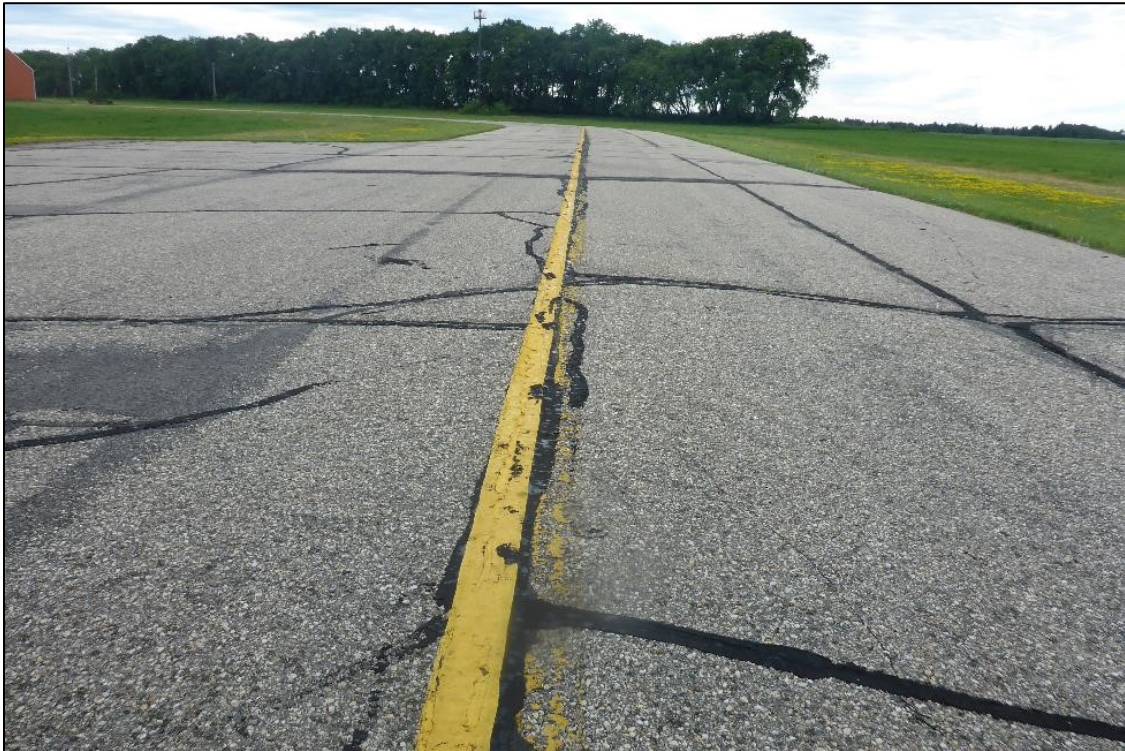
D14 CTA 001 (PCI = 60)

| <b>Conditions:</b> | PCI: 60 | | | | | | |

| Branch | Section | Distress Type | Severity | Treatment | Estimated Quantity | Unit | Cost |
|---|---|---|---|---|---|---|---|
| CTA | 001 | L & T CR | M | Crack Sealing - AC | 35 | Ft | \$44 |

| Branch | Section | Treatment | Quantity | Unit | Cost |
|---|---|---|---|---|---|
| CTA | 001 | Crack Sealing - AC | 35 | Ft | \$44 |

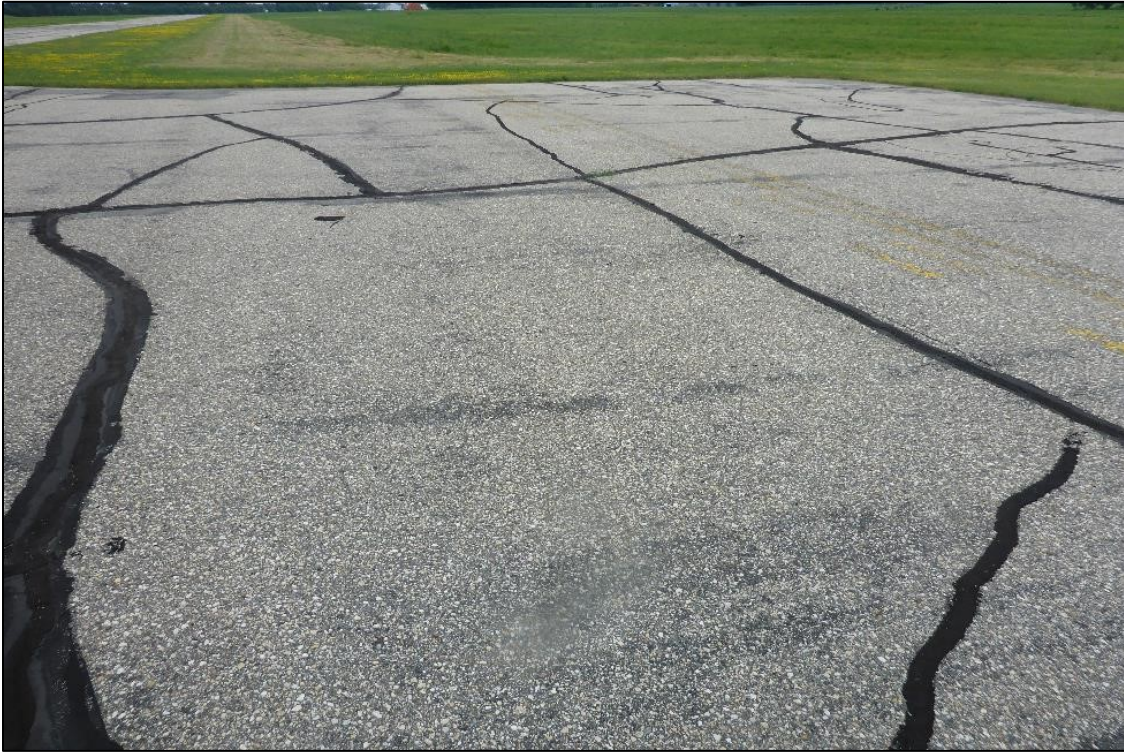
D14 RTA 001 (PCI = 65)

| <b>Conditions:</b> | PCI: 65 | | | | | | | | |

| Branch | Section | Distress Type | Severity | Treatment | Estimated Quantity | Unit | Cost |
|---|---|---|---|---|---|---|---|
| RTA | 001 | L & T CR | M | Crack Sealing - AC | 27 | Ft | \$34 |

| Branch | Section | Treatment | Quantity | Unit | Cost |
|---|---|---|---|---|---|
| RTA | 001 | Crack Sealing - AC | 27 | Ft | \$34 |

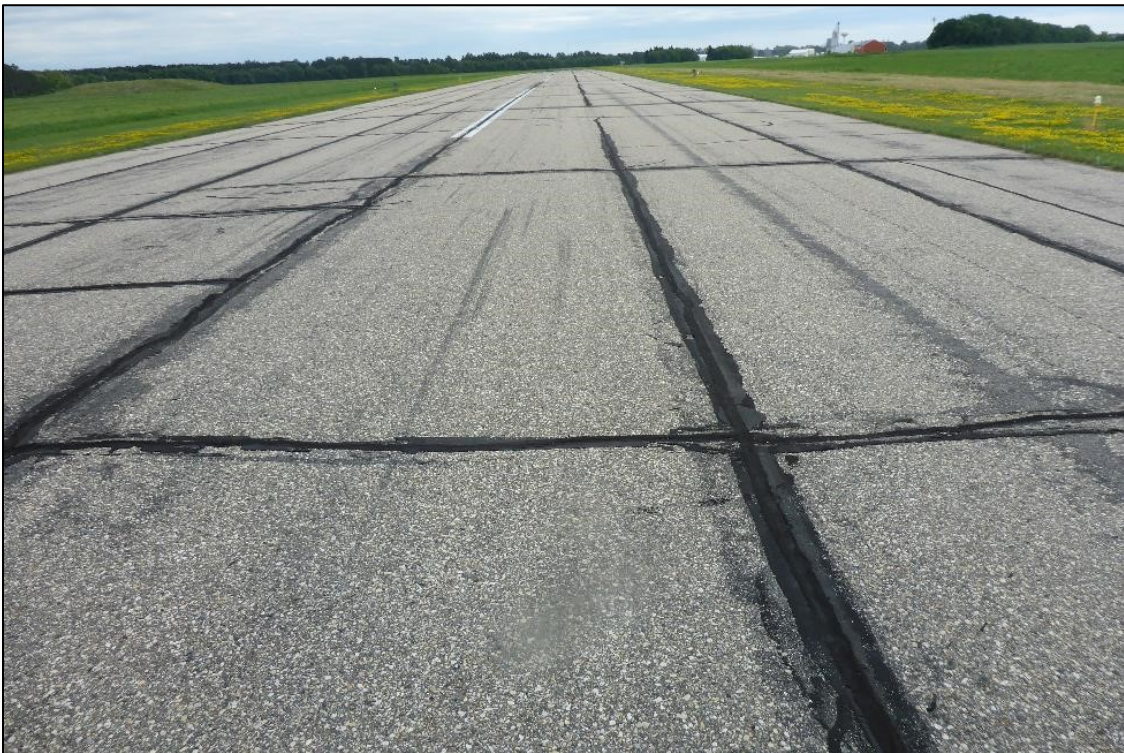
D14 RY1432 001 (PCI = 63)

| <b>Conditions:</b> | PCI: 63 | | | | | | | | |

| Branch | Section | Distress Type | Severity | Treatment | Estimated Quantity | Unit | Cost |
|---|---|---|---|---|---|---|---|
| RY1432 | 001 | L & T CR | M | Crack Sealing - AC | 1,601 | Ft | \$2,017 |

| Branch | Section | Treatment | Quantity | Unit | Cost |
|---|---|---|---|---|---|
| RY1432 | 001 | Crack Sealing - AC | 1,601 | Ft | \$2,017 |

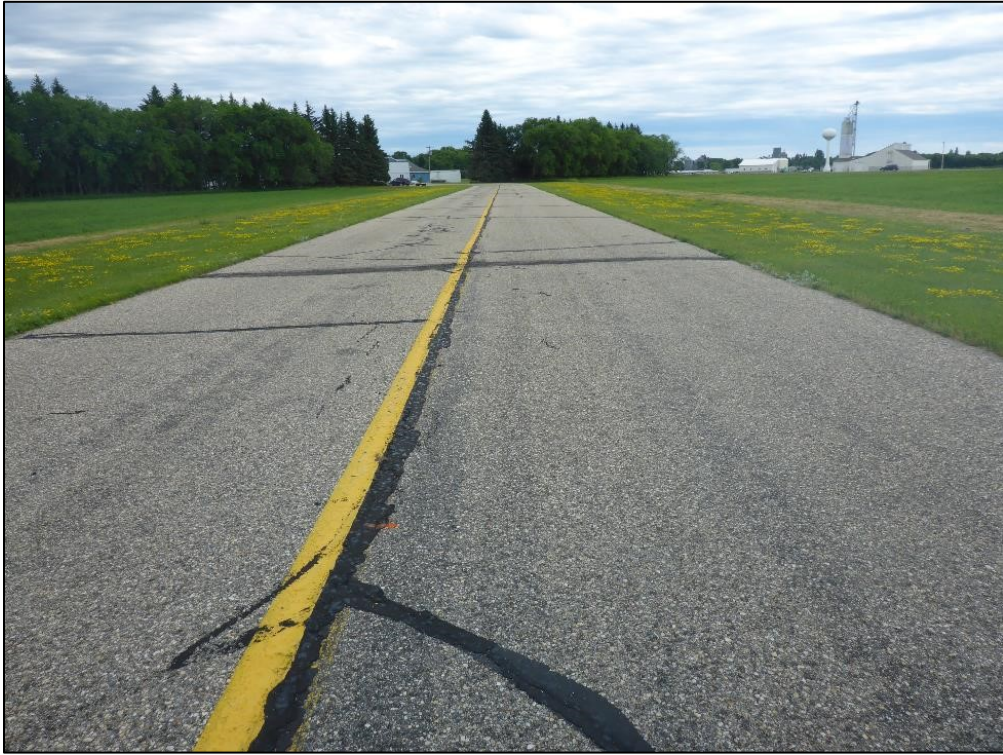
D14 TLA 001 (PCI = 62)

| <b>Conditions:</b> | PCI: 62 | | | | | | | | |

| Branch | Section | Distress Type | Severity | Treatment | Estimated Quantity | Unit | Cost |
|---|---|---|---|---|---|---|---|
| TLA | 001 | L & T CR | M | Crack Sealing - AC | 83 | Ft | \$105 |

| Branch | Section | Treatment | Quantity | Unit | Cost |
|---|---|---|---|---|---|
| TLA | 001 | Crack Sealing - AC | 83 | Ft | \$105 |
