Pavement Condition Report

Warren Municipal Airport (D37)

December 2018

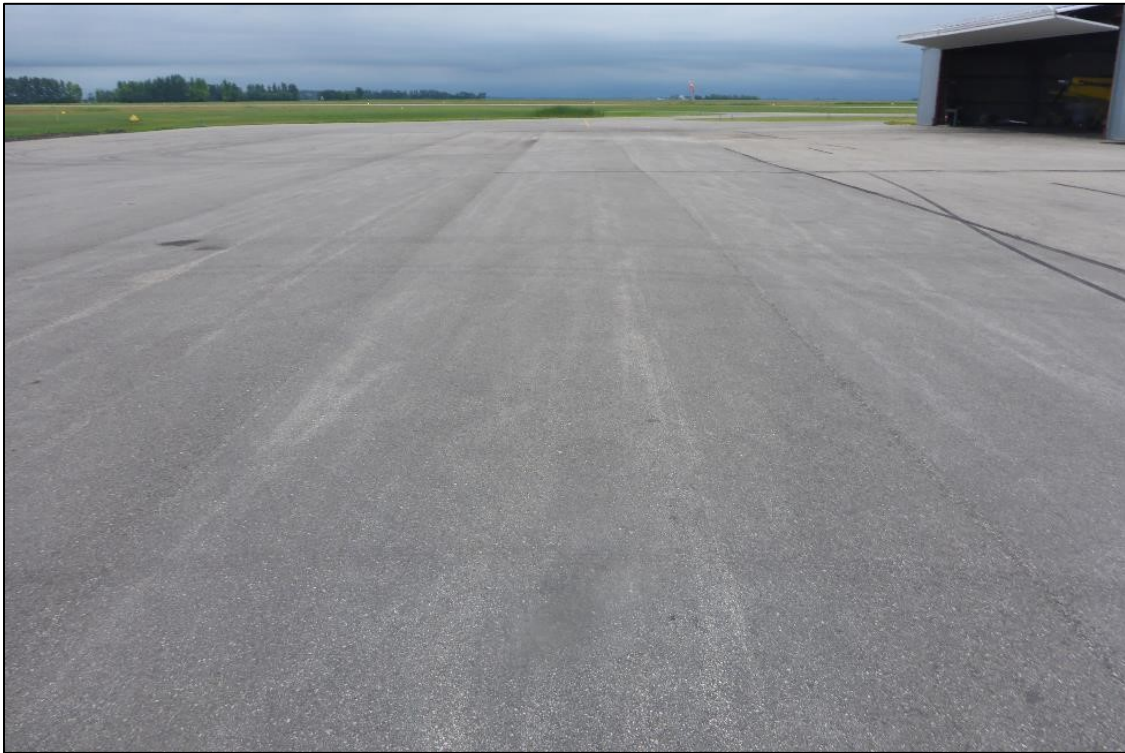
D37 APA 001 (PCI = 100)

Network: D37				Name: WARREN		
Branch: APA	Name: APRON A	Use: APRON	Area: 47,100 SqFt			
Section: 001	of 2	From: 100	To: 400	Last Const.: 5/1/2015		
Surface: AC	Family: MN2018 Asphalt Aprons	Zone:	Category:	Rank: P		
Area: 45,500 SqFt	Length: 300 Ft	Width: 150 Ft				
Slabs:	Slab Length: Ft	Slab Width: Ft	Joint Length: Ft			
Shoulder:	Street Type:	Grade: 0	Lanes: 0			
Last Insp. Date: 7/3/2018	TotalSamples: 10	Surveyed: 3				
Conditions: PCI: 100						
Sample Number: 100	Type: R	Area: 5000.00 SqFt	PCI: 100			
<No Distress>						
Sample Number: 201	Type: R	Area: 5000.00 SqFt	PCI: 100			
<No Distress>						
Sample Number: 202	Type: R	Area: 5000.00 SqFt	PCI: 100			
<No Distress>

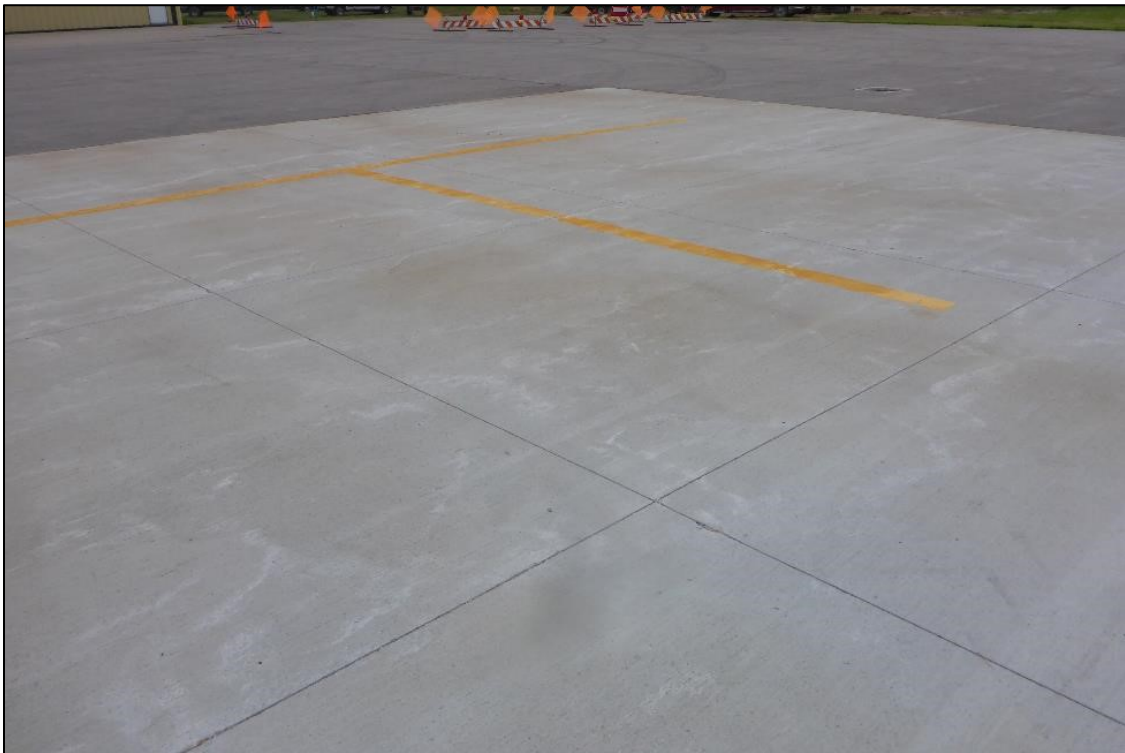
D37 APA 002 (PCI = 100)

Network:	D37	Name:	WARREN				
Branch:	APA	Name:	APRON A	Use:	APRON	Area:	47,100 SqFt
Section:	002	of 2	From:	102	To:	102	Last Const.: 5/1/2015
Surface:	PCC	Family:	MN2018 PCC	Zone:		Category:	Rank: P
Area:	1,600 SqFt	Length:	40 Ft	Width:	40 Ft		
Slabs:	16	Slab Length:	10 Ft	Slab Width:	10 Ft	Joint Length:	240 Ft
Shoulder:		Street Type:		Grade:	0	Lanes:	0
Last Insp. Date:	7/3/2018	TotalSamples:	1	Surveyed:	1		
Conditions:	PCI: 100						
Sample Number:	102	Type:	R	Area:	16.00 Slabs	PCI:	100
<No Distress>

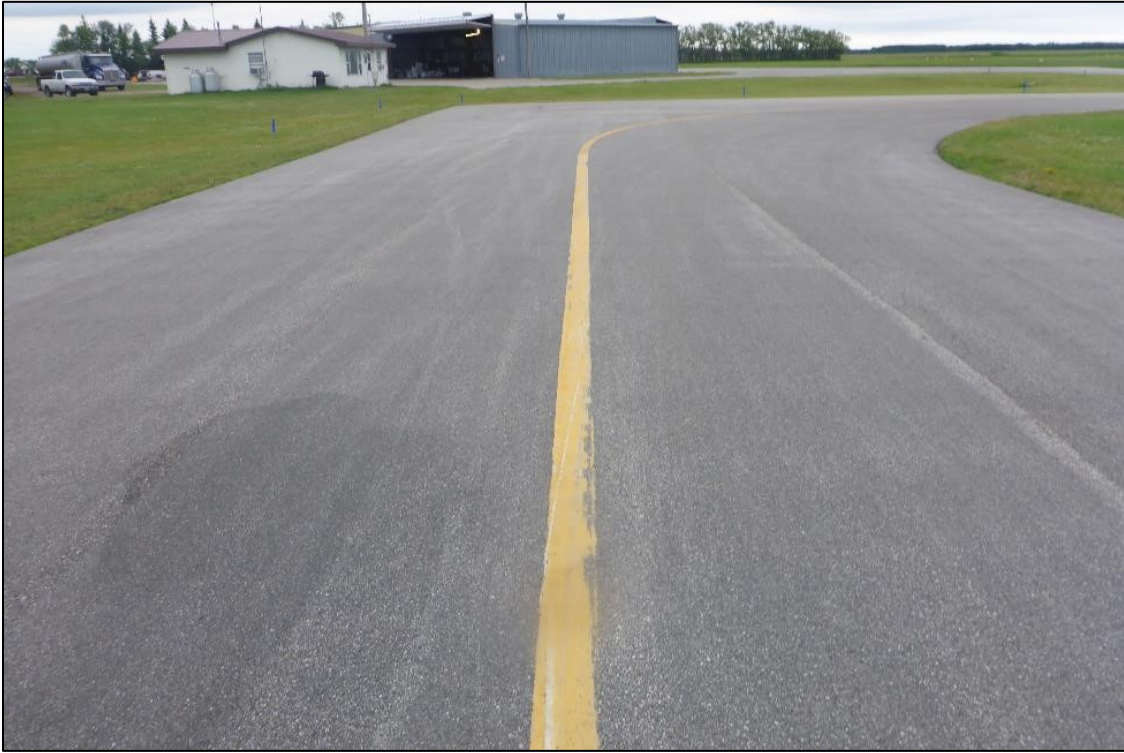
D37 CTA 001 (PCI = 98)

Network:	D37	Name:	WARREN				
Branch:	CTA	Name:	TAXIWAY A	Use:	TAXIWAY	Area:	27,620 SqFt
Section:	001	of 1	From:	100	To:	301	Last Const.: 5/1/2015
Surface:	AC	Family:	MN2018 Asphalt Runway- Taxiways	Zone:		Category:	Rank: P
Area:	27,620 SqFt	Length:	700 Ft	Width:	35 Ft		
Slabs:		Slab Length:	Ft	Slab Width:	Ft	Joint Length:	Ft
Shoulder:		Street Type:		Grade:	0	Lanes:	0
Last Insp. Date:	7/3/2018	TotalSamples:	8	Surveyed:	2		
Conditions:	PCI: 98						
Sample Number:	200	Type:	R	Area:	3500.00 SqFt	PCI:	100
<No Distress>							
Sample Number:	300	Type:	R	Area:	3500.00 SqFt	PCI:	95
48	L & T CR		L		35.00 Ft

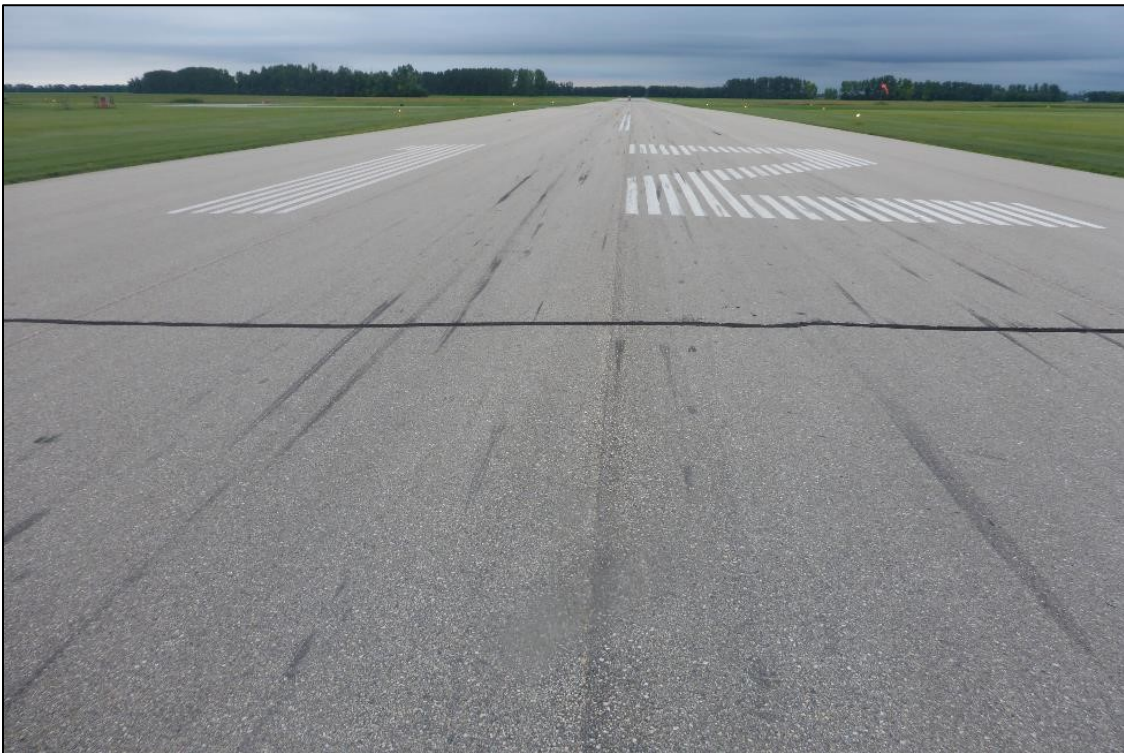
D37 RY1230 001 (PCI = 86)

Network:	D37	Name:	WARREN				
Branch:	RY1230	Name:	RUNWAY 12-30	Use:	RUNWAY	Area:	257,000 SqFt
Section:	001	of 1	From:	100	To:	163	Last Const.: 8/1/2012
Surface:	AC	Family:	MN2018 Asphalt Runway- Taxiways	Zone:	N	Category:	2 Rank: P
Area:	257,000 SqFt	Length:	3,205 Ft	Width:	75 Ft		
Slabs:		Slab Length:	Ft	Slab Width:	Ft	Joint Length:	Ft
Shoulder:		Street Type:		Grade:	0	Lanes:	0
Last Insp. Date:	7/3/2018	TotalSamples:	70	Surveyed:	7		
Conditions:	PCI: 86						
Sample Number:	105	Type:	R	Area:	3750.00 SqFt	PCI:	70
48	L & T CR		M	15.00	Ft		
41	ALLIGATOR CR		L	60.00	SqFt		
Sample Number:	114	Type:	R	Area:	3750.00 SqFt	PCI:	86
48	L & T CR		M	25.00	Ft		
48	L & T CR		L	59.00	Ft		
Sample Number:	123	Type:	R	Area:	3750.00 SqFt	PCI:	94
48	L & T CR		L	50.00	Ft		
Sample Number:	131	Type:	R	Area:	3750.00 SqFt	PCI:	76
48	L & T CR		M	60.00	Ft		
48	L & T CR		L	57.00	Ft		
48	L & T CR		H	10.00	Ft		
Sample Number:	140	Type:	R	Area:	3750.00 SqFt	PCI:	94

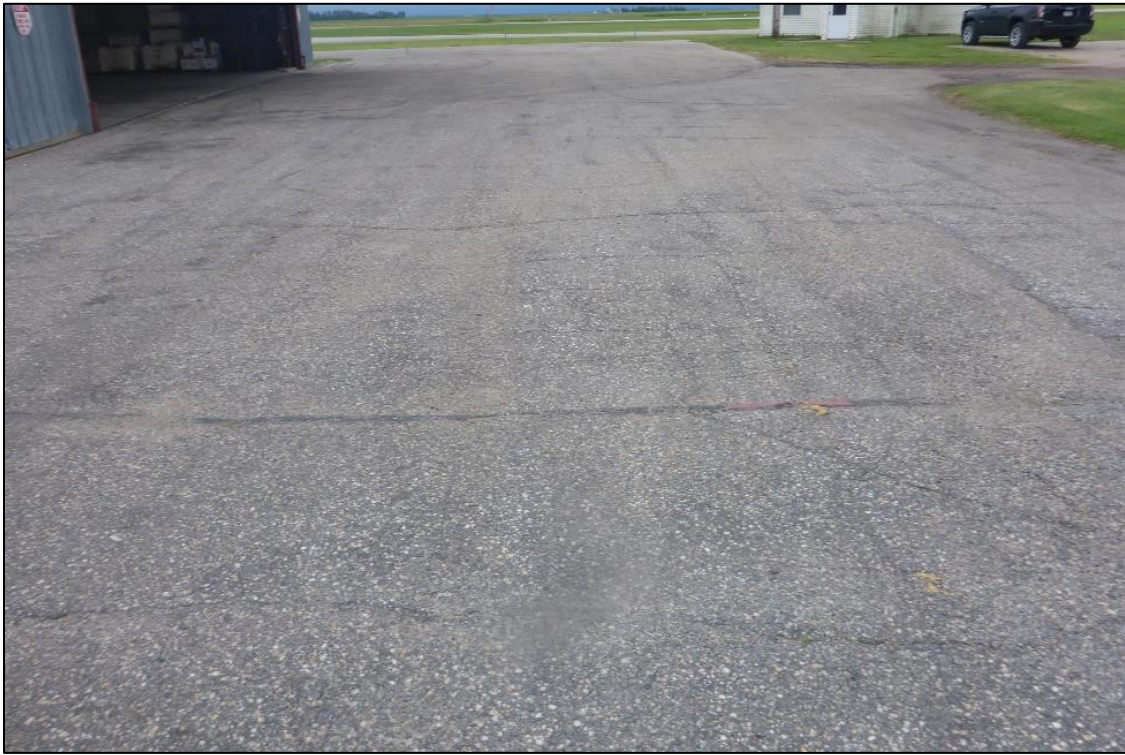
D37 TLA 001 (PCI = 21)

Network:	D37	Name:	WARREN				
Branch:	TLA	Name:	TAXILANE AREA A	Use:	TAXILANE	Area:	24,850 SqFt
Section:	001	of 2	From:	100	To:	101	Last Const.: 9/30/1988
Surface:	AC	Family:	MN2018 Asphalt Taxilanes	Zone:	N	Category:	2
Area:	13,400 SqFt	Length:	325 Ft	Width:	40 Ft	Joint Length:	Ft
Slabs:		Slab Length:	Ft	Slab Width:	Ft	Joint Length:	Ft
Shoulder:		Street Type:		Grade:	0	Lanes:	0
Last Insp. Date:	7/3/2018	TotalSamples:	2	Surveyed:	1		
Conditions:	PCI: 21						
Sample Number:	101	Type:	R	Area:	6000.00 SqFt	PCI:	21
43	BLOCK CR	M		4000.00	SqFt		
57	WEATHERING	H		5.00	SqFt		
45	DEPRESSION	L		74.00	SqFt		
43	BLOCK CR	L		1000.00	SqFt		
41	ALLIGATOR CR	M		300.00	SqFt		
48	L & T CR	M		58.00	Ft		
48	L & T CR	L		160.00	Ft		
57	WEATHERING	M		5250.00	SqFt

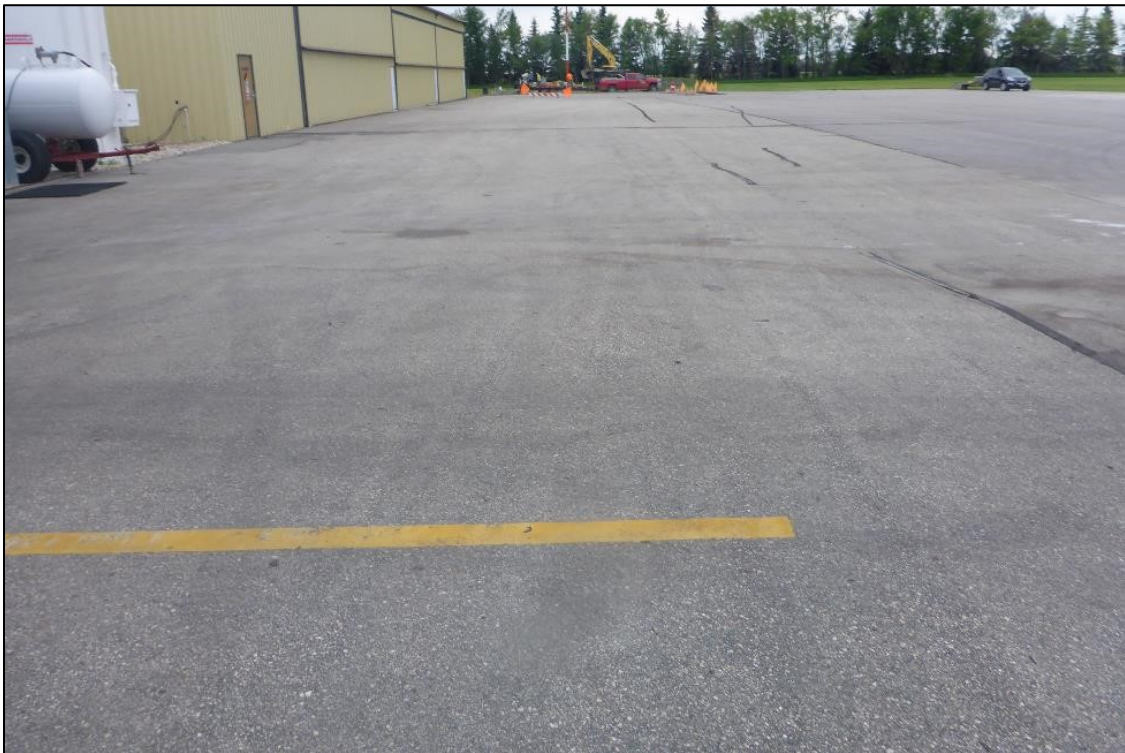
D37 TLA 002 (PCI = 90)

Network:	D37	Name:	WARREN				
Branch:	TLA	Name:	TAXILANE AREA A	Use:	TAXILANE	Area:	24,850 SqFt
Section:	002	of 2	From:	200	To:	201	Last Const.: 5/1/2012
Surface:	AAC	Family:	MN2018 Asphalt Taxilanes	Zone:	N	Category:	2
Area:	11,450 SqFt	Length:	275 Ft	Width:	40 Ft	Joint Length:	Ft
Slabs:		Slab Length:	Ft	Slab Width:	Ft	Joint Length:	Ft
Shoulder:		Street Type:		Grade:	0	Lanes:	0
Last Insp. Date:	7/3/2018	Total Samples:	4	Surveyed:	1		
Conditions:	PCI: 90						
Sample Number:	301	Type:	R	Area:	4800.00 SqFt	PCI:	90
48	L & T CR		L		136.00 Ft
