Pavement Condition Report

Paynesville Municipal Airport (PEX)

December 2018

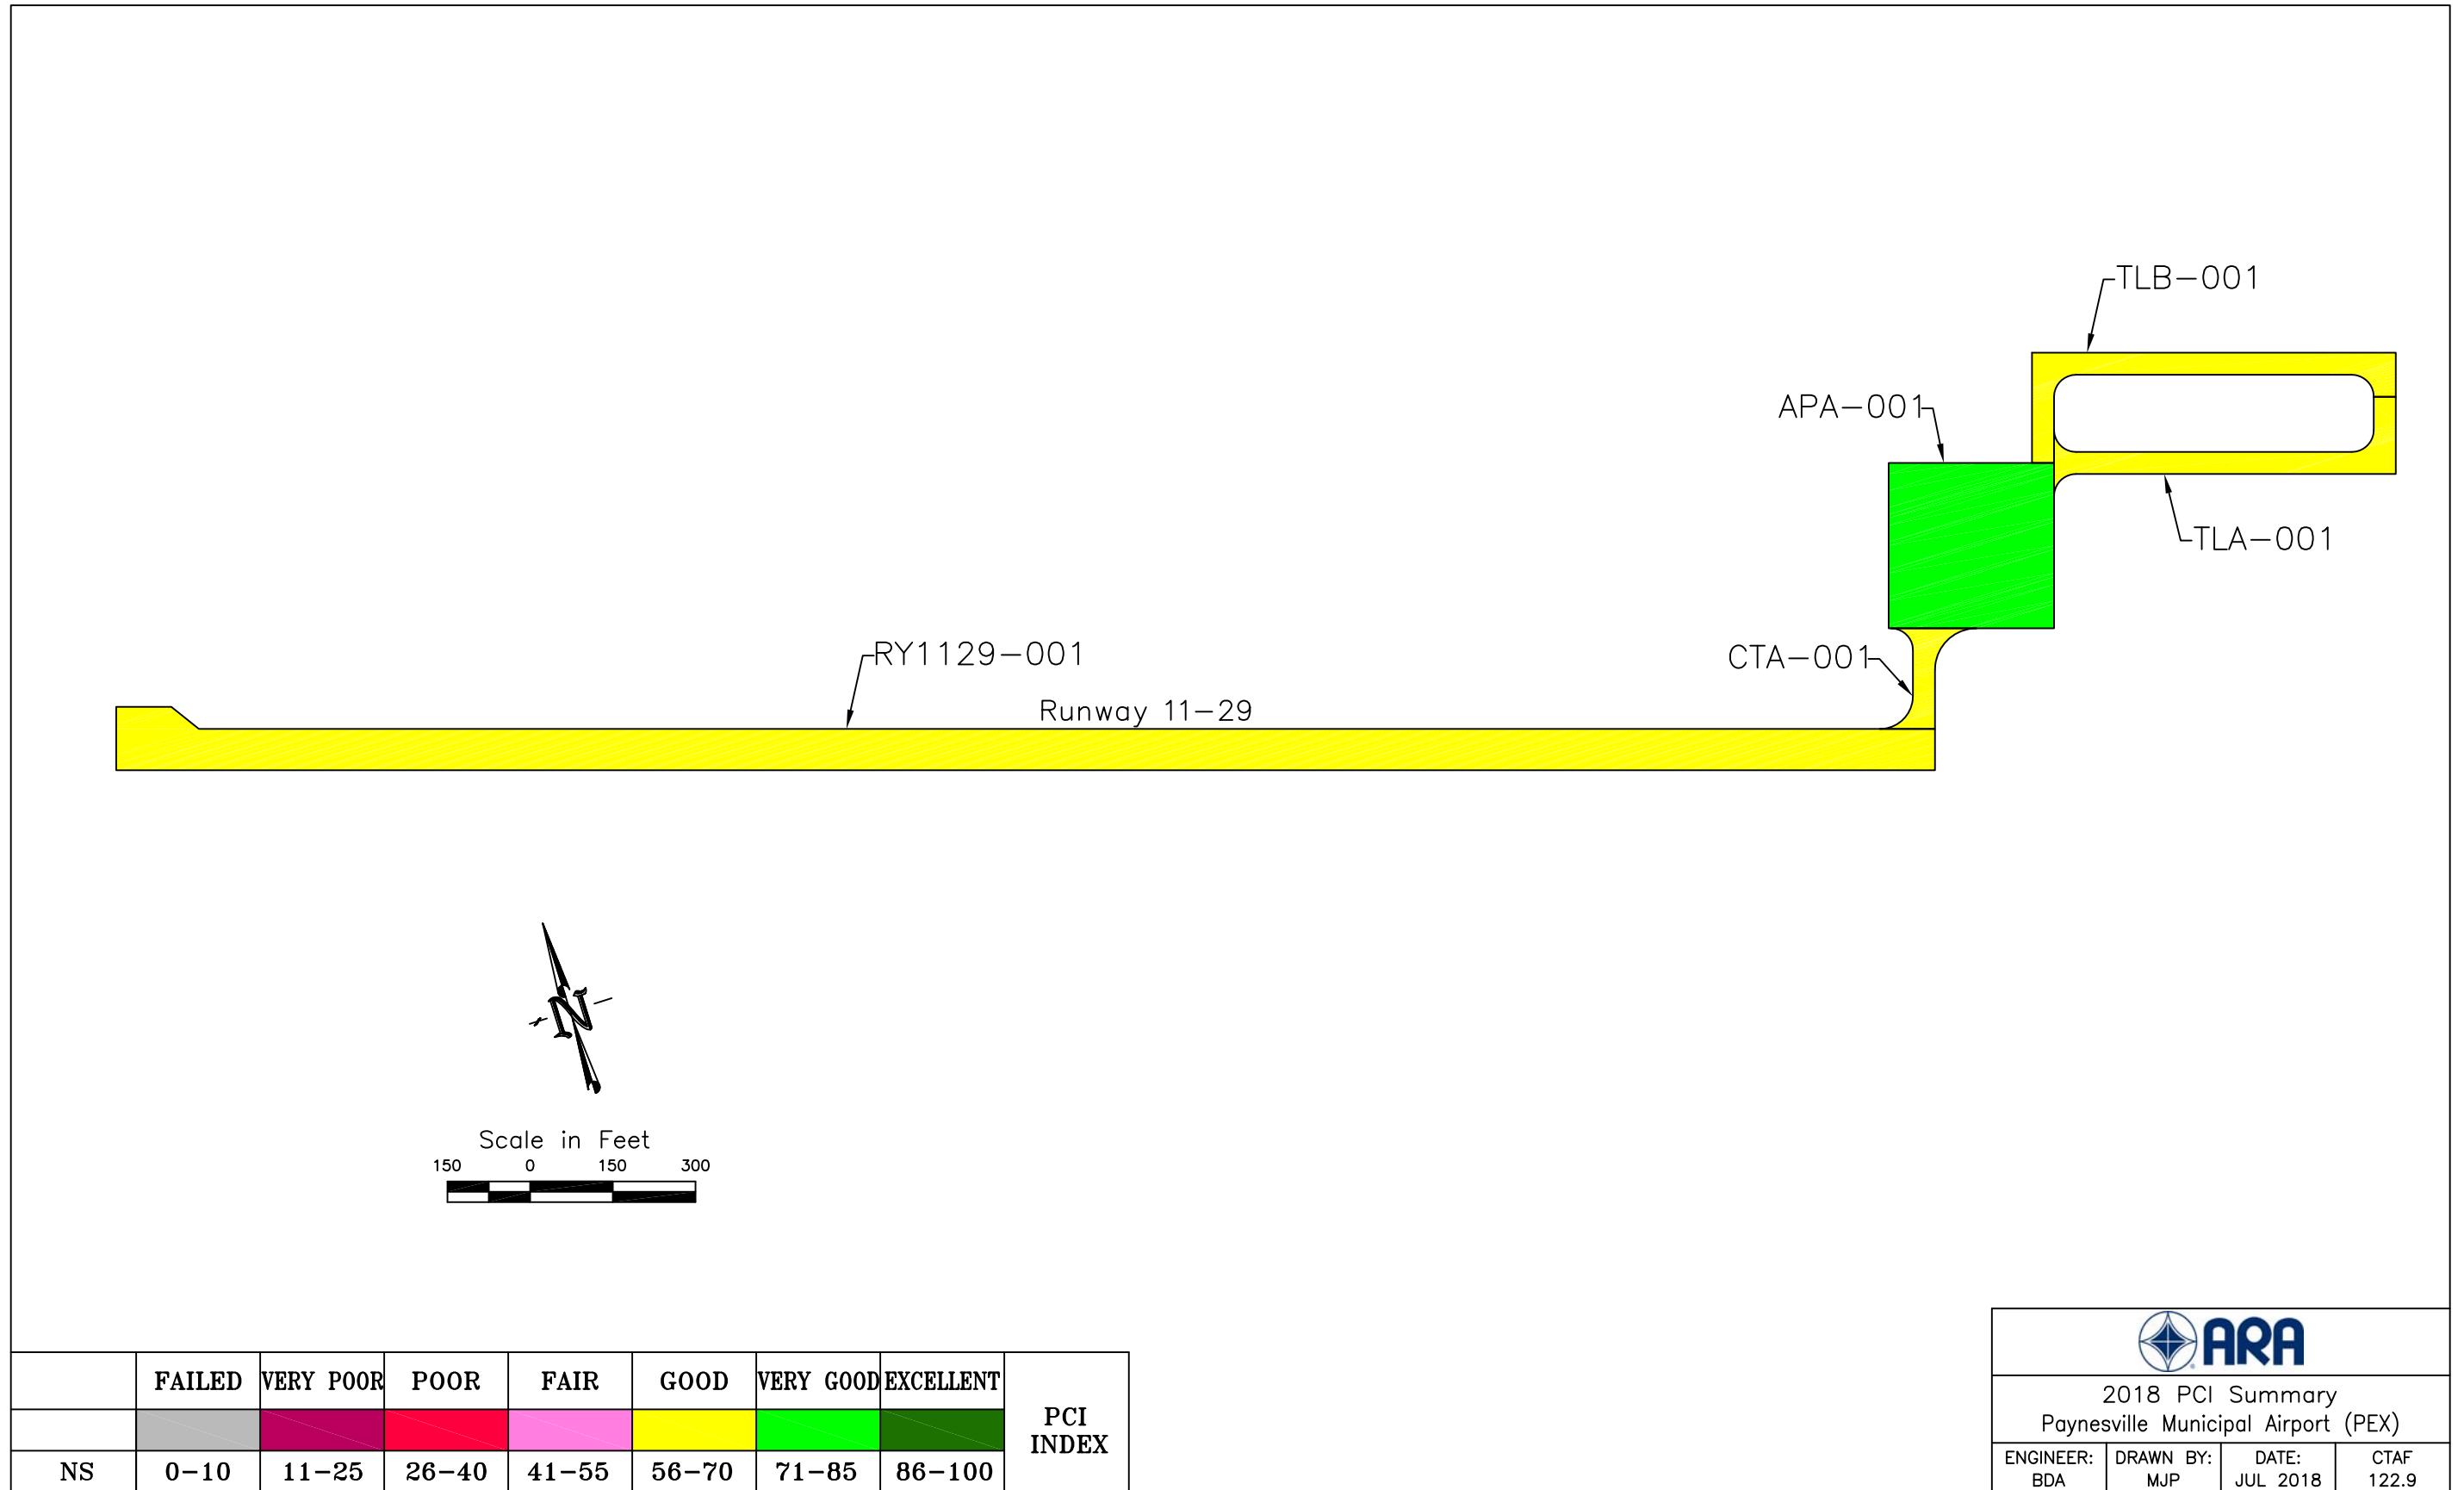
Figure 4. 2018 Pavement Condition Index Rating at Paynesville Municipal Airport (PEX).

Figures 5 and 6 present the overall PCI for PEX by area distribution and pavement use, respectively. Table 3 presents the PCI summary for each section at PEX, including the drop in PCI per year. Generally, pavement sections will deteriorate between 1 and 3 PCI points per year. Sections deteriorating at higher rates may need maintenance above the normal application rates and should be closely monitored in case major repairs become necessary earlier than expected.

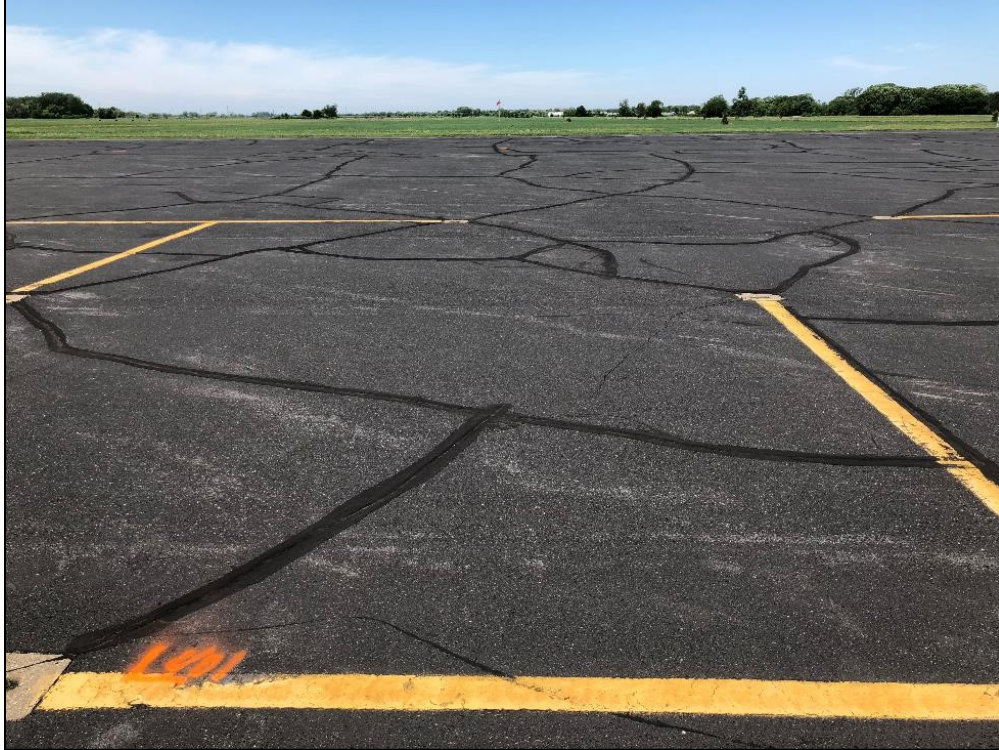
PEX APA 001 (PCI = 71)

Network:	PEX		Name:	PAYNESVILLE					
Branch:	APA	Name:	APRON AREA A	Use:	APRON	Area:	90,000 SqFt		
Section:	001	of 1	From:	100	To:	602	Last Const.:	10/31/2003	
Surface:	AC	Family:	MN2018 Asphalt Aprons	Zone:	W	Category:	2	Rank:	S
Area:	90,000 SqFt	Length:	300 Ft	Width:	300 Ft				
Slabs:		Slab Length:	Ft	Slab Width:	Ft	Joint Length:	Ft		
Shoulder:		Street Type:		Grade:	0	Lanes:	0		
Last Insp. Date:	5/29/2018		TotalSamples:	18	Surveyed:	4			
Conditions:	PCI:	71							
Sample Number:	201	Type:	R	Area:	5000.00 SqFt	PCI:	73		
48	L & T CR		L	665.00	Ft				
Sample Number:	302	Type:	R	Area:	5000.00 SqFt	PCI:	71		
48	L & T CR		L	734.00	Ft				
Sample Number:	401	Type:	R	Area:	5000.00 SqFt	PCI:	72		
48	L & T CR		L	707.00	Ft				
Sample Number:	500	Type:	R	Area:	5000.00 SqFt	PCI:	66		
57	WEATHERING		H	15.00	SqFt				
48	L & T CR		L	738.00	Ft

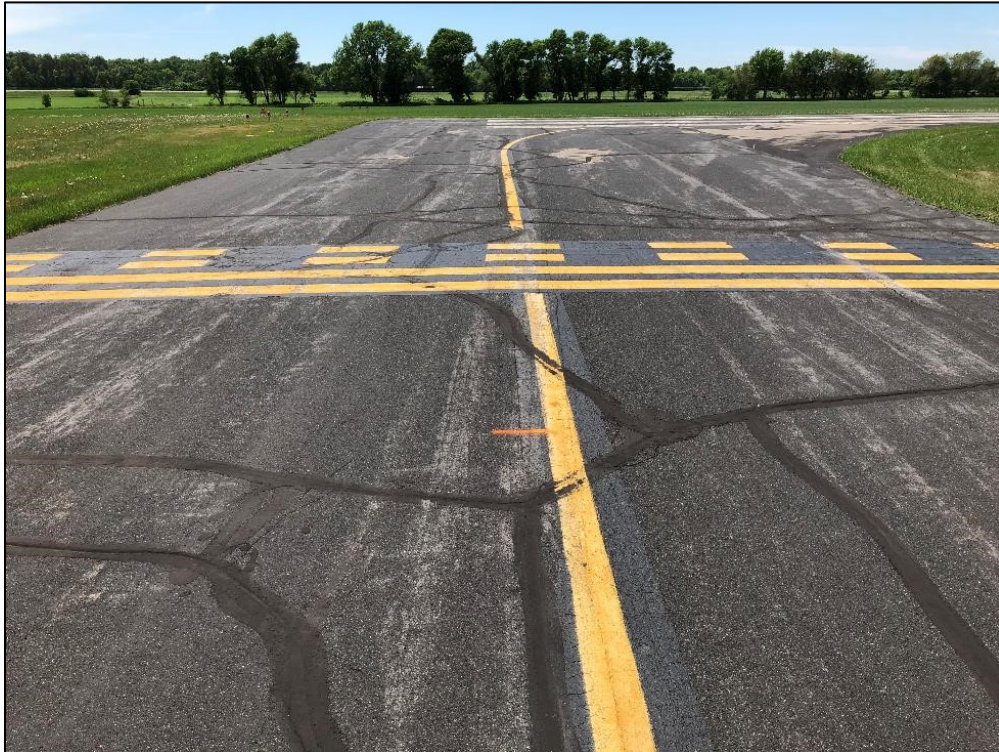
PEX CTA 001 (PCI = 58)

Network:	PEX	Name:	PAYNESVILLE						
Branch:	CTA	Name:	CONNECTION TAXIWAY A	Use:	TAXIWAY	Area:	9,600 SqFt		
Section:	001	of 1	From:	100	To:	101	Last Const.:	10/31/2003	
Surface:	AC	Family:	MN2018 Asphalt Runway- Taxiways	Zone:	W	Category:	2	Rank:	P
Area:	9,600 SqFt	Length:	183 Ft	Width:	40 Ft				
Slabs:		Slab Length:	Ft	Slab Width:	Ft	Joint Length:	Ft		
Shoulder:		Street Type:		Grade:	0	Lanes:	0		
Last Insp. Date:	5/29/2018	TotalSamples:	2	Surveyed:	1				
Conditions:	PCI: 58								
Sample Number:	100	Type:	R	Area:	4755.00 SqFt	PCI:	58		
48	L & T CR		L	615.00	Ft				
48	L & T CR		M	11.00	Ft				
41	ALLIGATOR CR		M	12.00	SqFt				
57	WEATHERING		H	350.00	SqFt

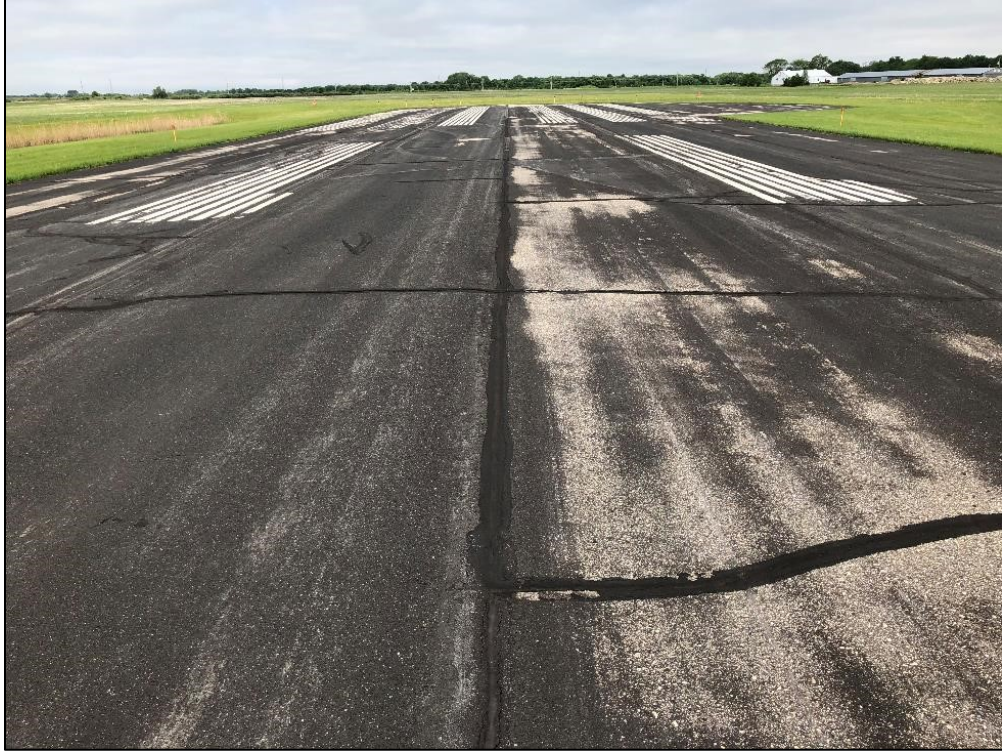
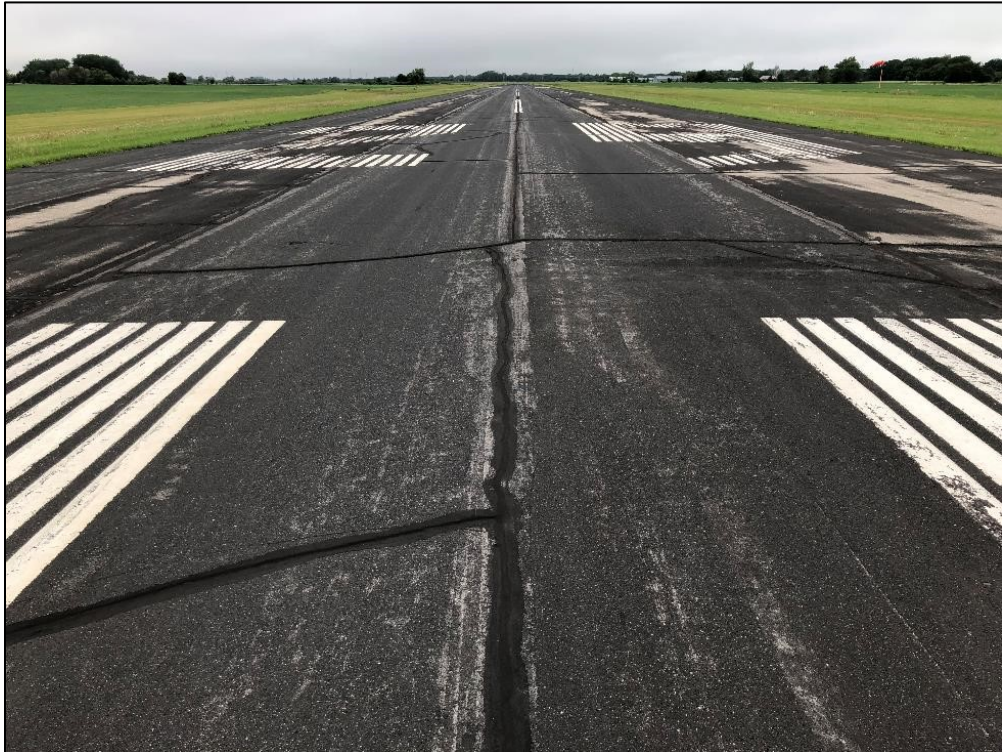
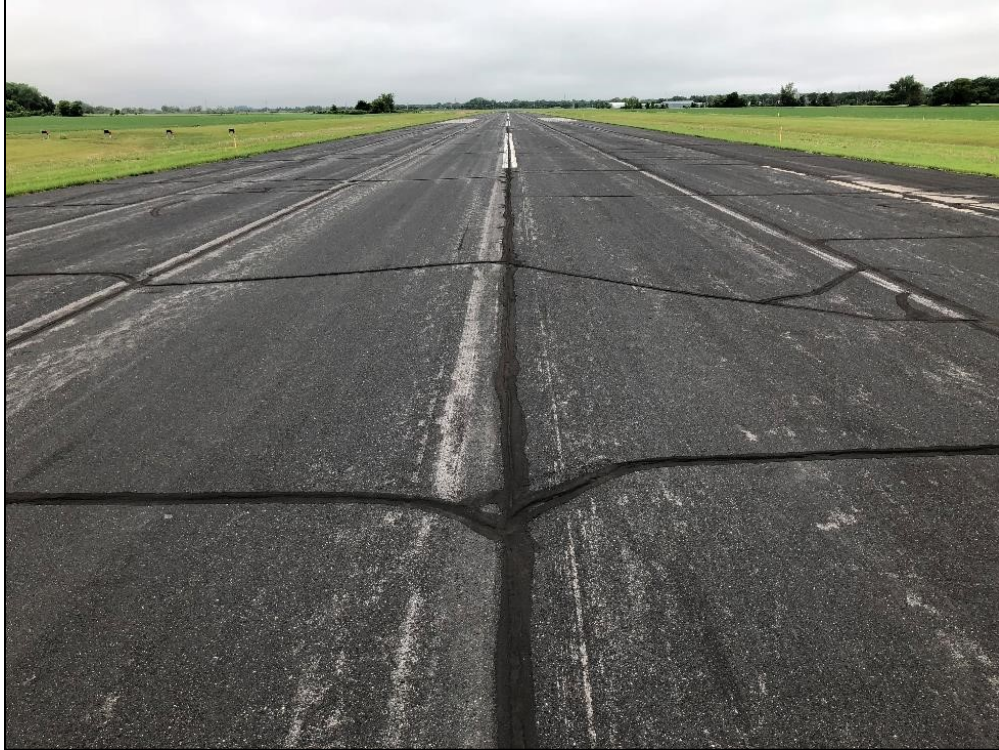
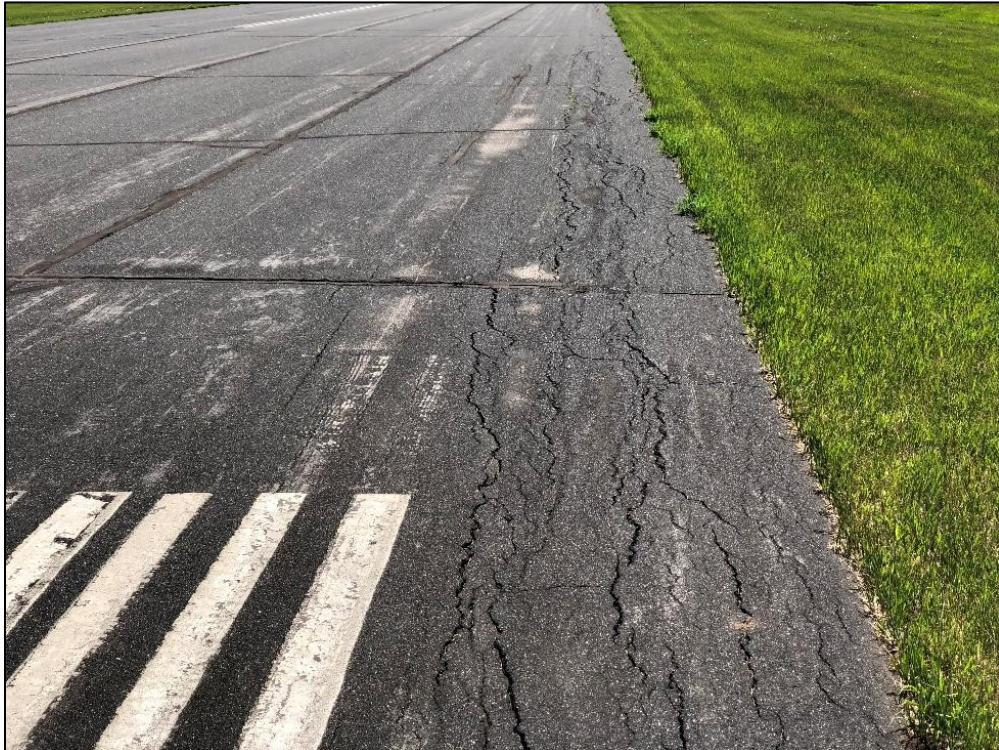
PEX RY1129 001 (PCI = 62)

Network:	PEX	Name:	PAYNESVILLE						
Branch:	RY1129	Name:	RUNWAY 11-29	Use:	RUNWAY	Area:	252,700 SqFt		
Section:	001	of 1	From:	100	To:	165	Last Const.:	10/31/2003	
Surface:	AC	Family:	MN2018 Asphalt Runway- Taxiways	Zone:	W	Category:	2	Rank:	P
Area:	252,700 SqFt	Length:	3,300 Ft	Width:	75 Ft				
Slabs:	Slab Length:	Ft	Slab Width:	Ft	Joint Length:	Ft			
Shoulder:	Street Type:	Grade:	0	Lanes:	0				
Last Insp. Date:	5/29/2018	TotalSamples:	67	Surveyed:	7				
Conditions:	PCI: 62								
Sample Number:	106	Type:	R	Area:	3750.00 SqFt	PCI:	66		
48	L & T CR	L		390.00	Ft				
57	WEATHERING	H		100.00	SqFt				
48	L & T CR	M		12.00	Ft				
Sample Number:	115	Type:	R	Area:	3750.00 SqFt	PCI:	70		
57	WEATHERING	H		10.00	SqFt				
48	L & T CR	L		421.00	Ft				
Sample Number:	124	Type:	R	Area:	3750.00 SqFt	PCI:	70		
48	L & T CR	M		5.00	Ft				
48	L & T CR	L		417.00	Ft				
57	WEATHERING	L		100.00	SqFt				
Sample Number:	133	Type:	R	Area:	3750.00 SqFt	PCI:	72

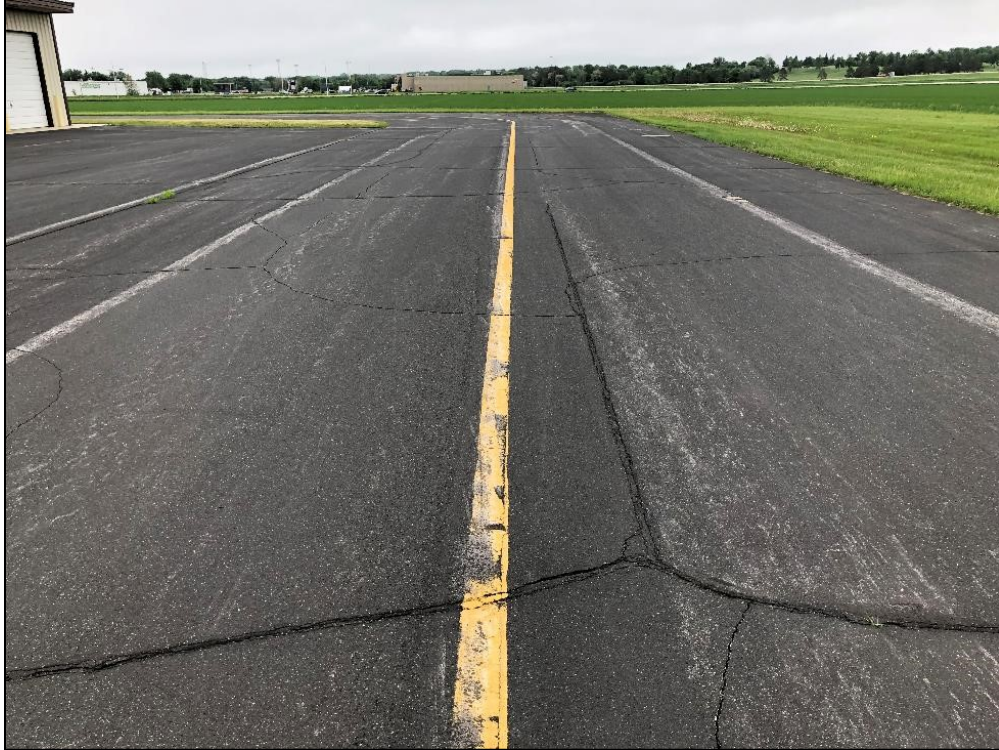
PEX TLA 001 (PCI = 67)

Network:	PEX	Name:	PAYNESVILLE				
Branch:	TLA	Name:	TAXILANE A	Use:	TAXILANE	Area:	28,800 SqFt
Section:	001	of 1	From:	100	To:	106	Last Const.: 10/31/2003
Surface:	AC	Family:	MN2018 Asphalt Taxilanes	Zone:	W	Category:	2
Area:	28,800 SqFt	Length:	720 Ft	Width:	40 Ft	Joint Length:	Ft
Slabs:		Slab Length:	Ft	Slab Width:	Ft	Joint Length:	Ft
Shoulder:		Street Type:		Grade:	0	Lanes:	0
Last Insp. Date:	5/29/2018	TotalSamples:	7	Surveyed:	2		
Conditions:	PCI: 67						
Sample Number:	101	Type:	R	Area:	4000.00 SqFt	PCI:	66
48	L & T CR		M	56.00	Ft		
48	L & T CR		L	590.00	Ft		
Sample Number:	104	Type:	R	Area:	4000.00 SqFt	PCI:	68
48	L & T CR		L	527.00	Ft		
48	L & T CR		M	84.00	Ft

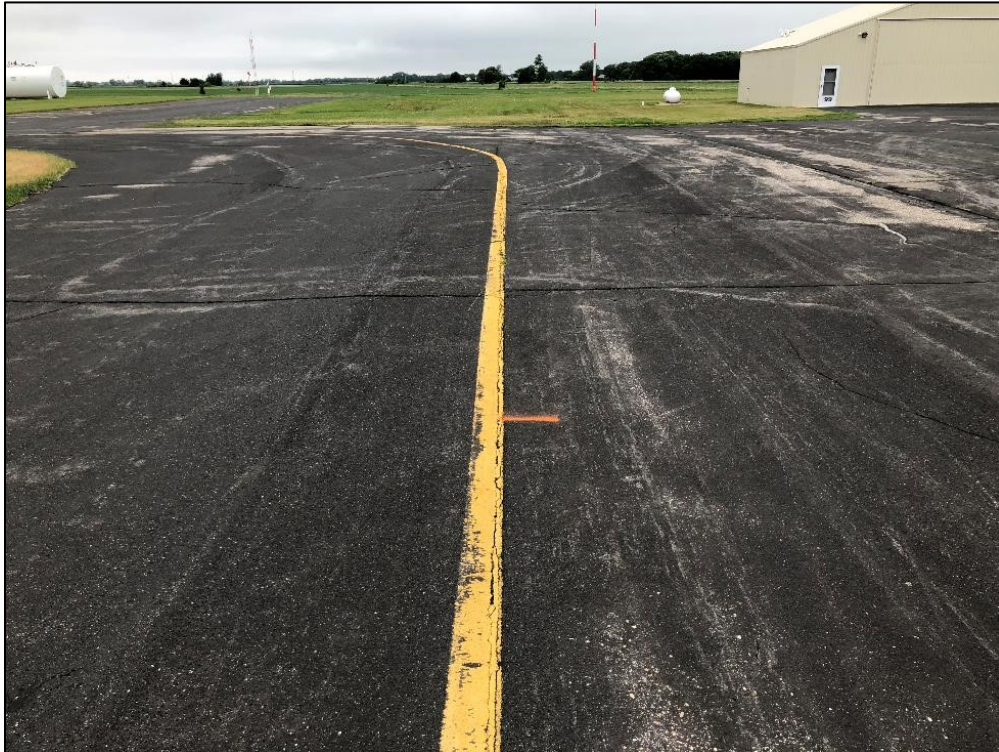
PEX TLB 001 (PCI = 61)

Network:	PEX	Name:	PAYNESVILLE						
Branch:	TLB	Name:	TAXILANE B	Use:	TAXILANE	Area:	34,400 SqFt		
Section:	001	of 1	From:	200	To:	208	Last Const.:	10/31/2003	
Surface:	AC	Family:	MN2018 Asphalt Taxilanes	Zone:	W	Category:	2	Rank:	T
Area:	34,400 SqFt	Length:	860 Ft	Width:	40 Ft	Joint Length:	Ft		
Slabs:		Slab Length:	Ft	Slab Width:	Ft	Joint Length:	Ft		
Shoulder:		Street Type:		Grade:	0	Lanes:	0		
Last Insp. Date:	5/29/2018	TotalSamples:	9	Surveyed:	2				
Conditions:	PCI: 61								
Sample Number:	202	Type:	R	Area:	4000.00 SqFt	PCI:	65		
48	L & T CR		M	108.00	Ft				
57	WEATHERING		H	40.00	SqFt				
48	L & T CR		L	467.00	Ft				
Sample Number:	207	Type:	R	Area:	4000.00 SqFt	PCI:	57		
57	WEATHERING		H	10.00	SqFt				
48	L & T CR		M	62.00	Ft				
43	BLOCK CR		L	200.00	SqFt				
48	L & T CR		L	580.00	Ft
