Pavement Condition Report

Perham Municipal Airport (16D)

December 2019

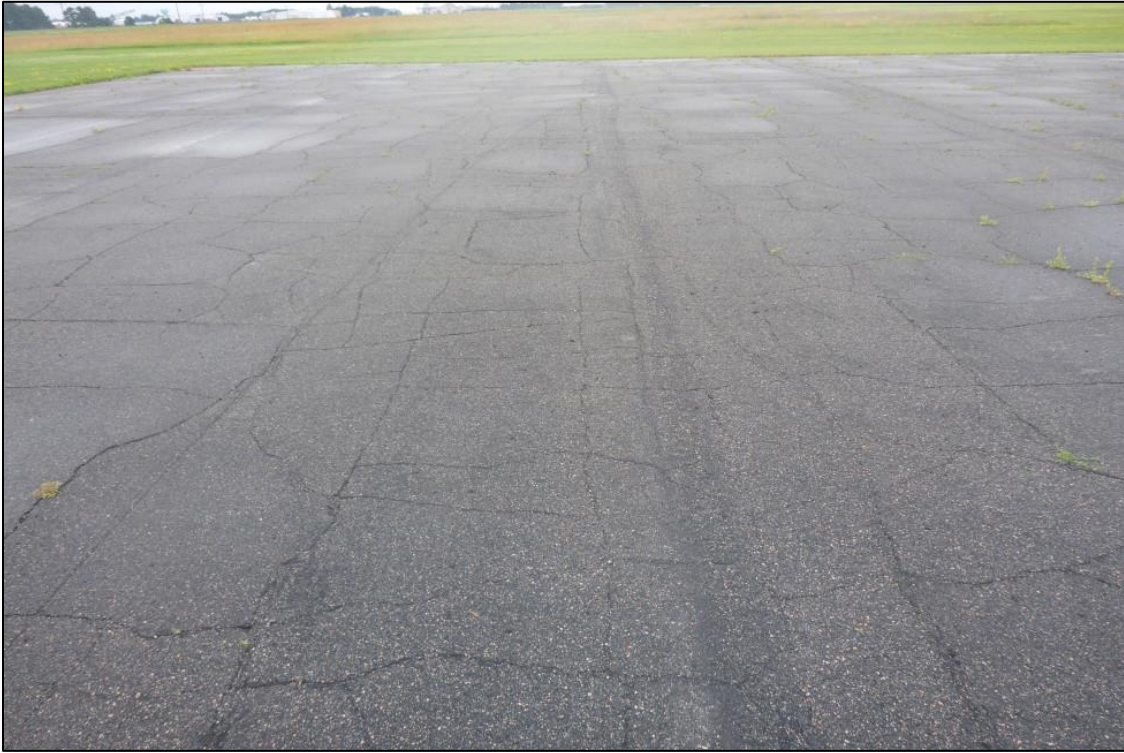
16D APA 001 (PCI = 54)

Conditions: PCI: 54

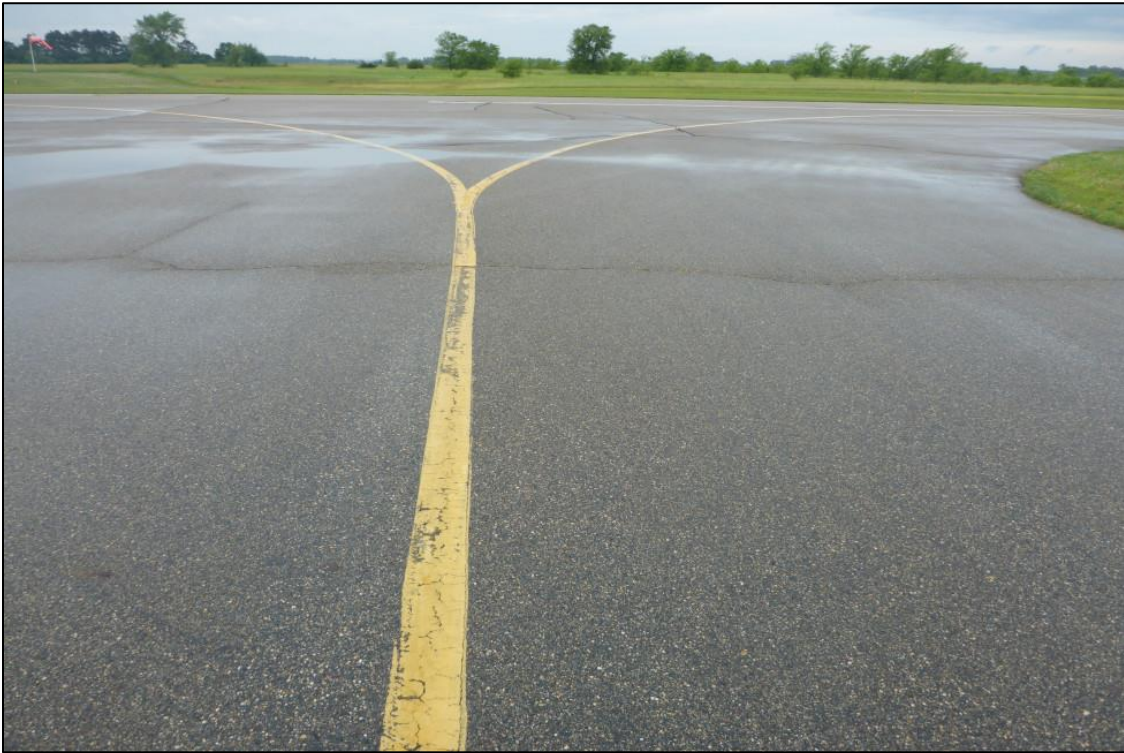
16D CTA 001 (PCI = 81)

Network:	16D	Name:	PERHAM						
Branch:	CTA	Name:	CONNECTING TAXIWAY A	Use:	TAXIWAY	Area:	21,675 SqFt		
Section:	001	of 2	From:	100	To:	101	Last Const.: 9/27/2010		
Surface:	AAC	Family:	MN2018 Asphalt Runway- Taxiways	Zone:	W	Category:	3	Rank:	P
Area:	3,675 SqFt	Length:	75 Ft	Width:	40 Ft				
Slabs:		Slab Length:	Ft	Slab Width:	Ft	Joint Length:	Ft		
Shoulder:		Street Type:		Grade:	0	Lanes:	0		
Section Comments:									
Last Insp. Date:	7/16/2019	TotalSamples:	1	Surveyed:	1				
Conditions:	PCI: 81								
Inspection Comments:									
Sample Number:	100	Type:	R	Area:	3675.00 SqFt	PCI:	81		
Sample Comments: p513									
48	L & T CR	L	178.00 Ft						
57	WEATHERING	L	1500.00 SqFt

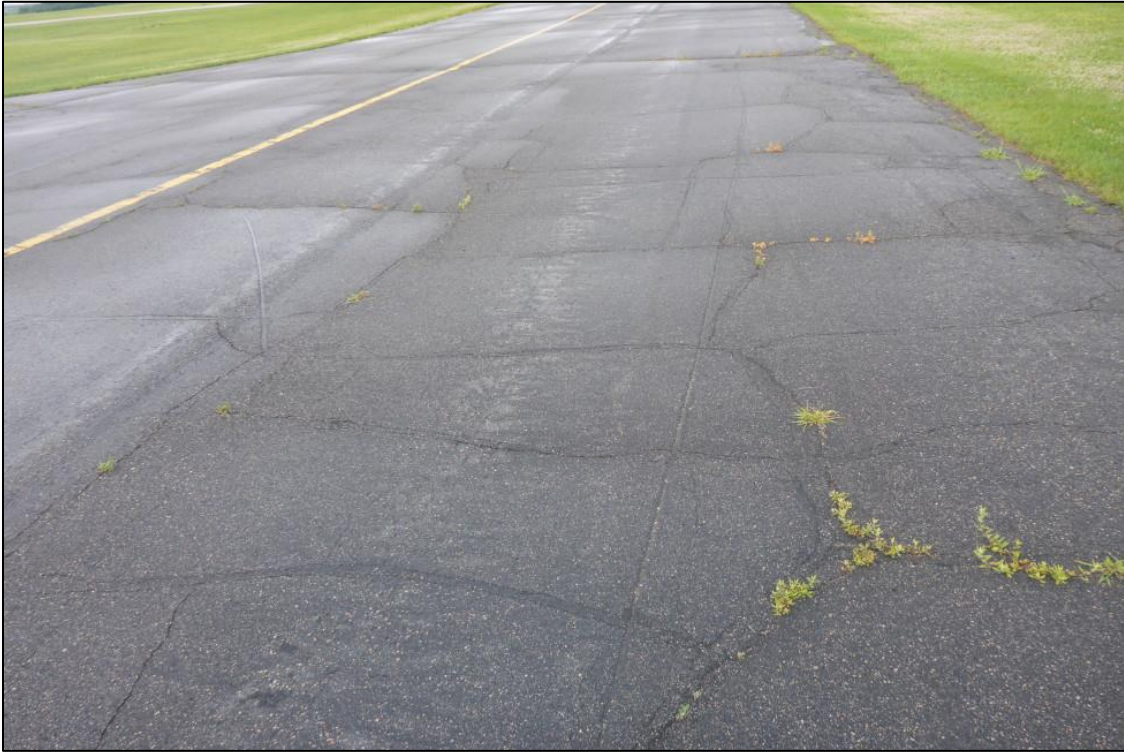
16D CTA 002 (PCI = 62)

Network:	16D	Name:	PERHAM						
Branch:	CTA	Name:	CONNECTING TAXIWAY A	Use:	TAXIWAY	Area:	21,675 SqFt		
Section:	002	of 2	From:	101	To:	104	Last Const.:	9/30/1981	
Surface:	AC	Family:	MN2018 Asphalt Runway- Taxiways	Zone:	W	Category:	3	Rank:	P
Area:	18,000 SqFt	Length:	450 Ft	Width:	40 Ft				
Slabs:		Slab Length:	Ft	Slab Width:	Ft	Joint Length:	Ft		
Shoulder:		Street Type:		Grade:	0	Lanes:	0		
Section Comments:									
Last Insp. Date:	7/16/2019	TotalSamples:	4	Surveyed:	1				
Conditions:	PCI: 62								
Inspection Comments:									
Sample Number:	102	Type:	R	Area:	4000.00 SqFt	PCI:	62		
Sample Comments: p514									
43	BLOCK CR	L	3300.00	SqFt					
43	BLOCK CR	M	200.00	SqFt

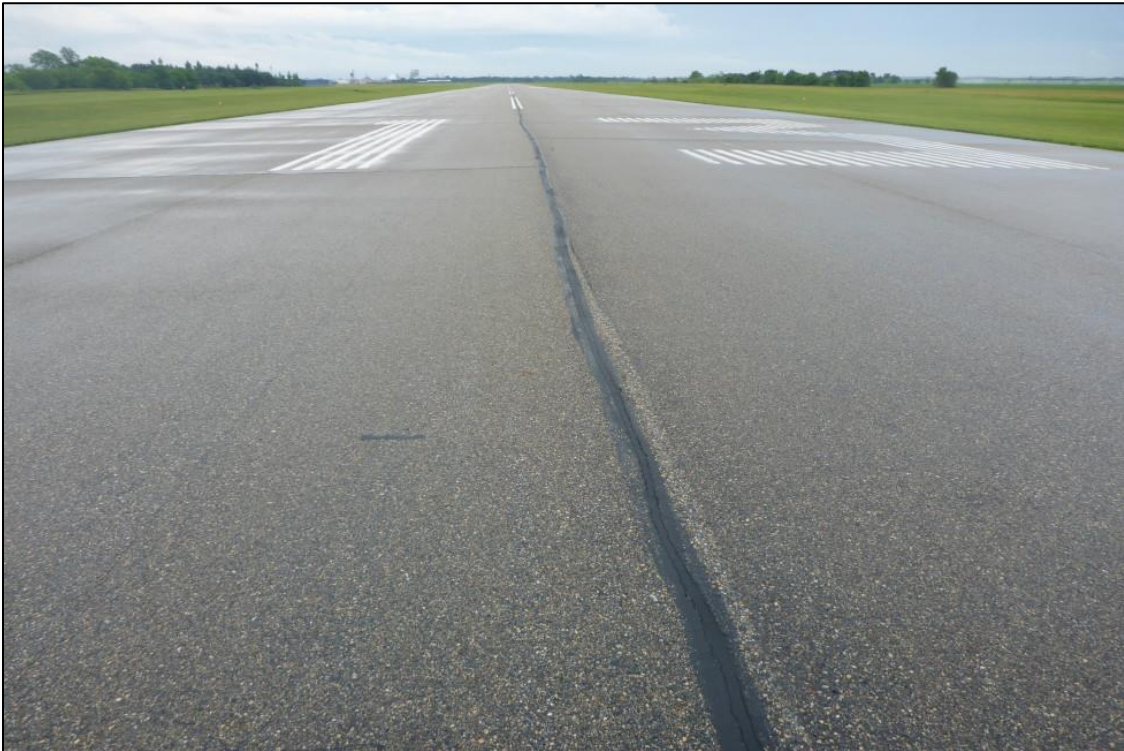
16D RY1331 001 (PCI = 79)

Network:	16D	Name:	PERHAM						
Branch:	RY1331	Name:	RUNWAY 13-31	Use:	RUNWAY	Area:	318,750 SqFt		
Section:	001	of 1	From:	100	To:	181	Last Const.: 9/27/2010		
Surface:	AAC	Family:	MN2018 Asphalt Runway- Taxiways	Zone:	W	Category:	3	Rank:	P
Area:	318,750 SqFt	Length:	4,100 Ft	Width:	75 Ft				
Slabs:		Slab Length:	Ft	Slab Width:	Ft	Joint Length:	Ft		
Shoulder:		Street Type:		Grade:	0	Lanes:	0		
Section Comments:									
Last Insp. Date:	7/16/2019	TotalSamples:	86	Surveyed:	9				
Conditions:	PCI: 79								
Inspection Comments:									
Sample Number:	104	Type:	R	Area:	3750.00 SqFt	PCI:	85		
Sample Comments:	p510 numbers								
48	L & T CR	L	105.00	Ft					
48	L & T CR	M	30.00	Ft					
Sample Number:	113	Type:	R	Area:	3750.00 SqFt	PCI:	83		
Sample Comments:									
48	L & T CR	L	136.00	Ft					
57	WEATHERING	L	2000.00	SqFt					
Sample Number:	122	Type:	R	Area:	3750.00 SqFt	PCI:	80		
Sample Comments:									
48	L & T CR	L	125.00	Ft

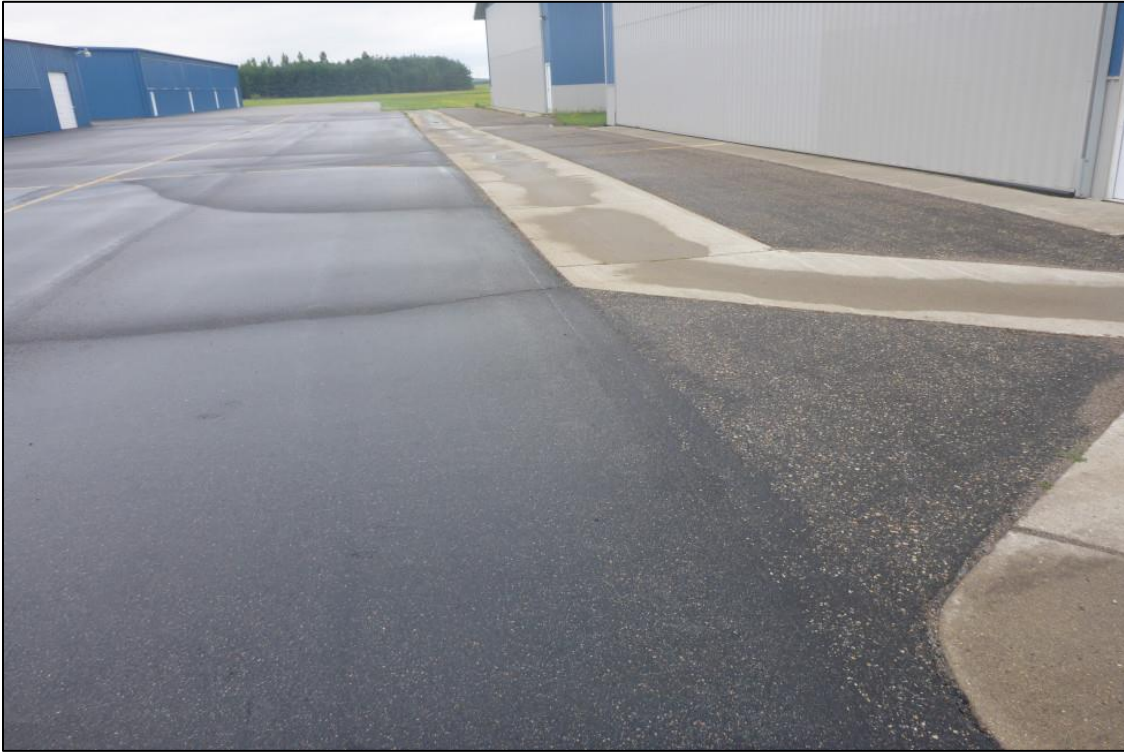
16D TLA 001 (PCI = 75)

Network:	16D	Name:	PERHAM						
Branch:	TLA	Name:	TAXILANE A	Use:	TAXILANE	Area:	57,650 SqFt		
Section:	001	of 3	From:	100	To:	202	Last Const.:	9/1/2007	
Surface:	AAC	Family:	MN2018 Asphalt Taxilanes	Zone:	W	Category:	3	Rank:	T
Area:	33,050 SqFt	Length:	255 Ft	Width:	120 Ft				
Slabs:		Slab Length:	Ft	Slab Width:	Ft	Joint Length:	Ft		
Shoulder:		Street Type:		Grade:	0	Lanes:	0		
Section Comments:									
Last Insp. Date:	7/16/2019	TotalSamples:	6	Surveyed:	2				
Conditions:	PCI: 75								
Inspection Comments:									
Sample Number:	101	Type:	R	Area:	5000.00 SqFt	PCI:	73		
Sample Comments:	p516 older slurry seal b4 last insp.								
48	L & T CR	L	466.00	Ft					
48	L & T CR	M	87.00	Ft					
Sample Number:	201	Type:	R	Area:	7000.00 SqFt	PCI:	77		
Sample Comments:	p517 57M was in an area that did not get sealed								
48	L & T CR	L	291.00	Ft					
48	L & T CR	M	24.00	Ft					
57	WEATHERING	M	700.00	SqFt

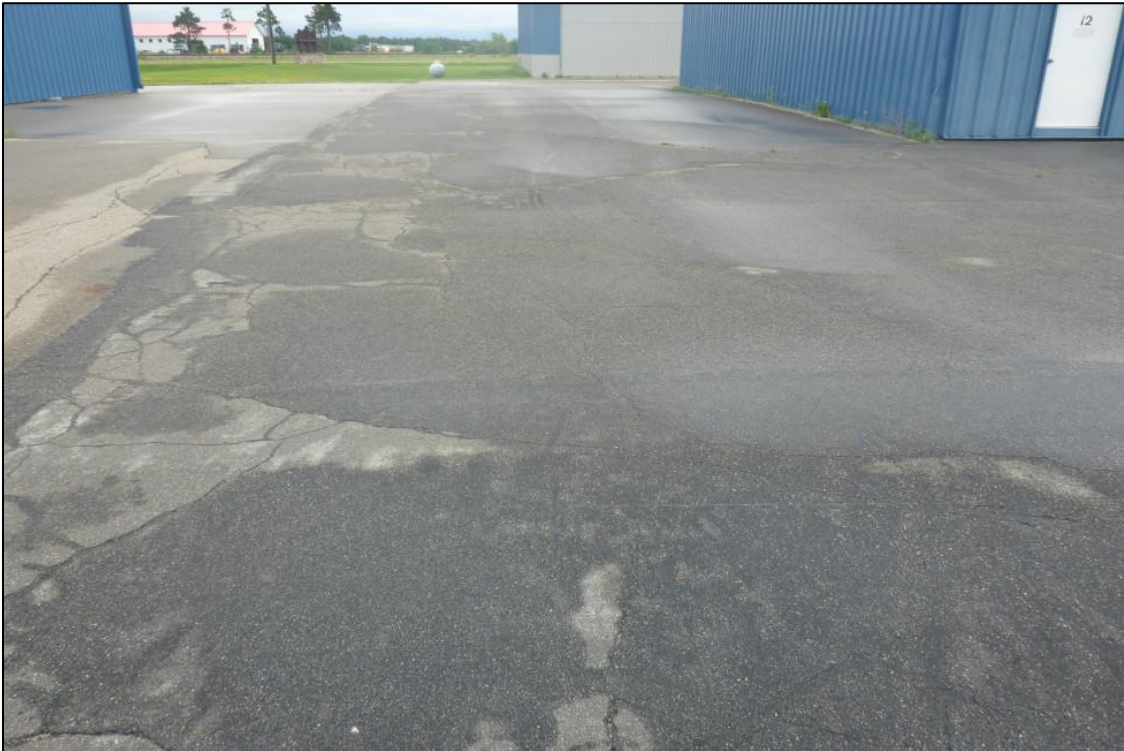
16D TLA 002 (PCI = 56)

⁶Higher than expected 3-year drop in PCI between inspections for TLA-002 is due to the development of Alligator and Block cracking in significant quantities

Network:	16D	Name:	PERHAM						
Branch:	TLA	Name:	TAXILANE A	Use:	TAXILANE	Area:	57,650 SqFt		
Section:	002	of 3	From:	100	To:	100	Last Const.:	9/30/1997	
Surface:	AC	Family:	MN2018 Asphalt Taxilanes	Zone:	W	Category:	3	Rank:	T
Area:	4,400 SqFt	Length:	100 Ft	Width:	30 Ft				
Slabs:	Slab Length:	Ft	Slab Width:	Ft	Joint Length:	Ft			
Shoulder:	Street Type:		Grade:	0	Lanes:	0			
Section Comments:									
Last Insp. Date:	7/16/2019	TotalSamples:	1	Surveyed:	1				
Conditions:	PCI: 56								
Inspection Comments:									
Sample Number:	100	Type:	R	Area:	2500.00 SqFt	PCI:	56		
Sample Comments: p519,520									
41	ALLIGATOR CR	M	24.00	SqFt					
43	BLOCK CR	L	1650.00	SqFt					
48	L & T CR	L	72.00	Ft

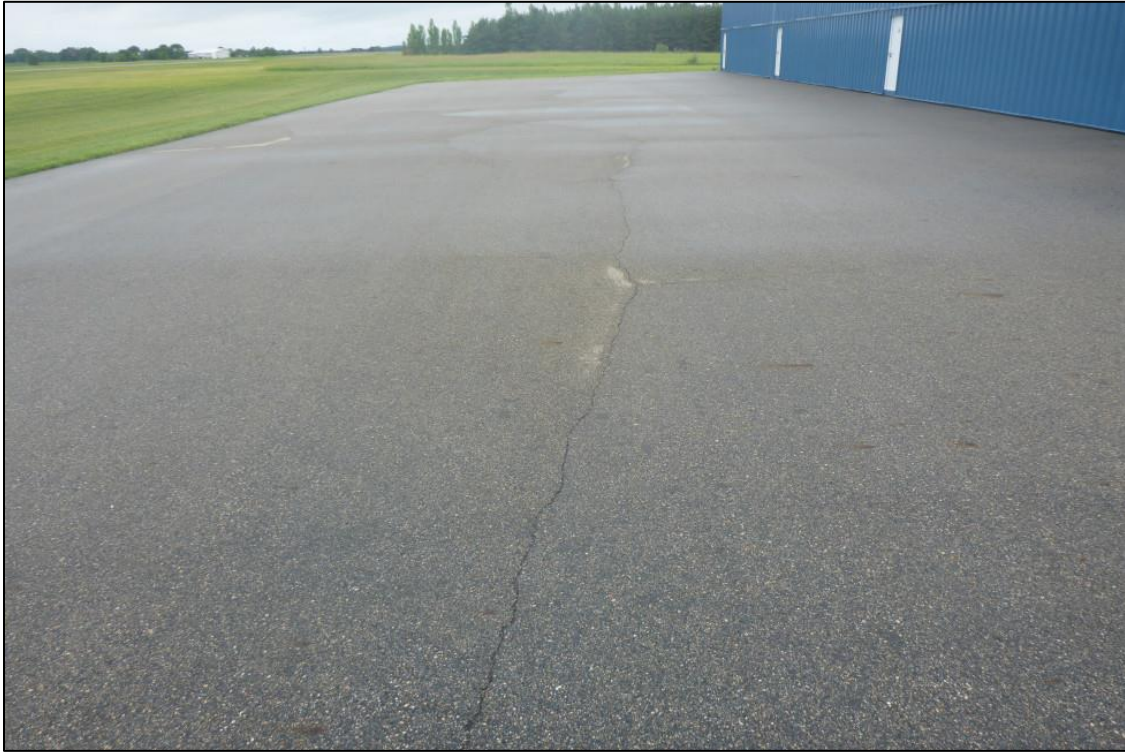
16D TLA 003 (PCI = 78)

Network:	16D	Name:	PERHAM					
Branch:	TLA	Name:	TAXILANE A	Use:	TAXILANE	Area:	57,650 SqFt	
Section:	003	of 3	From:	A	To:	B	Last Const.:	10/1/2014
Surface:	AC	Family:	MN2018 Asphalt Taxilanes	Zone:		Category:	Rank:	T
Area:	20,200 SqFt	Length:	175 Ft	Width:	100 Ft			
Slabs:		Slab Length:	Ft	Slab Width:	Ft	Joint Length:	Ft	
Shoulder:		Street Type:		Grade:	0	Lanes:	0	
Section Comments:								
Last Insp. Date:	7/16/2019	TotalSamples:	4	Surveyed:	2			
Conditions:	PCI: 78							
Inspection Comments:								
Sample Number:	103	Type:	R	Area:	5000.00 SqFt	PCI:	77	
Sample Comments: p518								
48	L & T CR	L	363.00	Ft				
48	L & T CR	M	7.00	Ft				
Sample Number:	203	Type:	R	Area:	5000.00 SqFt	PCI:	80	
Sample Comments:								
48	L & T CR	L	253.00	Ft				
48	L & T CR	M	31.00	Ft
