Pavement Condition Report

Bigfork Municipal Airport (FOZ)

December 2019

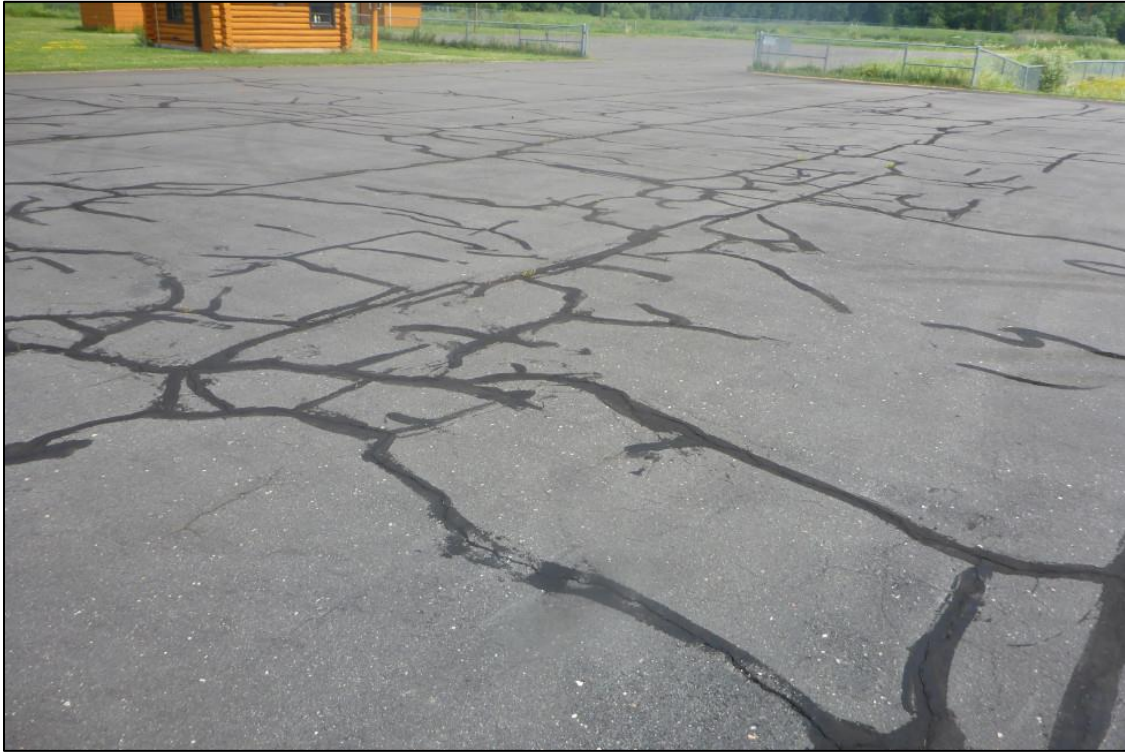
FOZ APA 001 (PCI = 54)

Conditions: PCI: 54

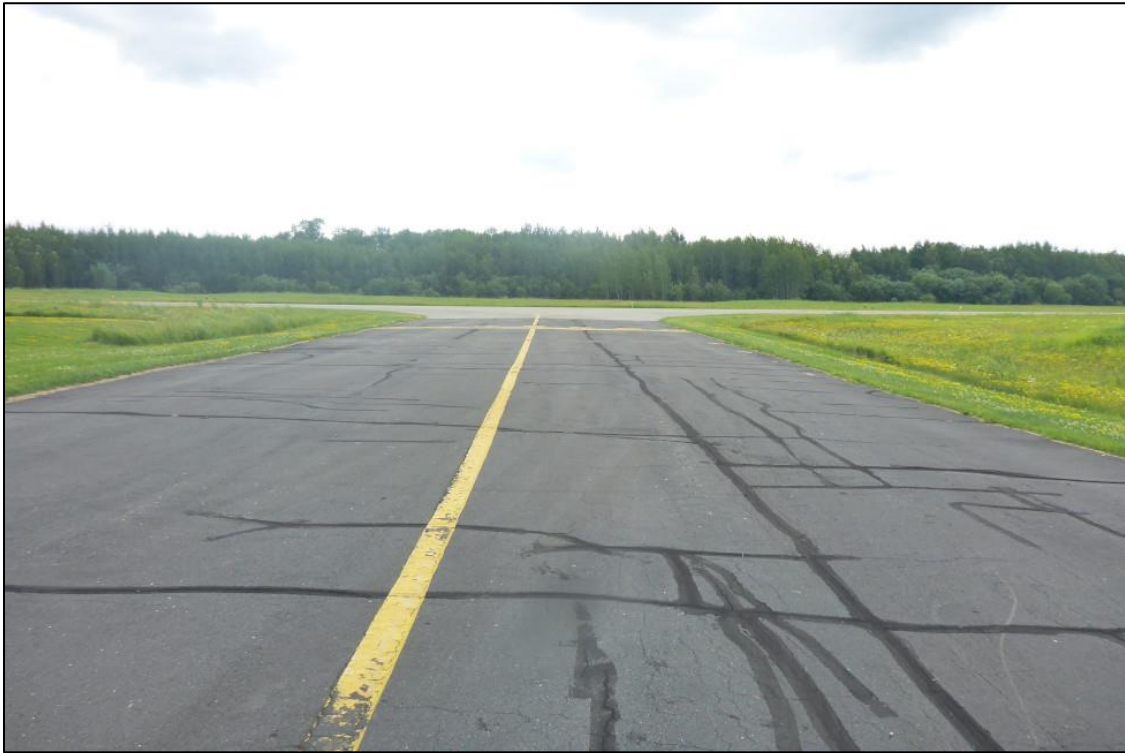
FOZ CTA 001 (PCI = 66)

Conditions: PCI: 66

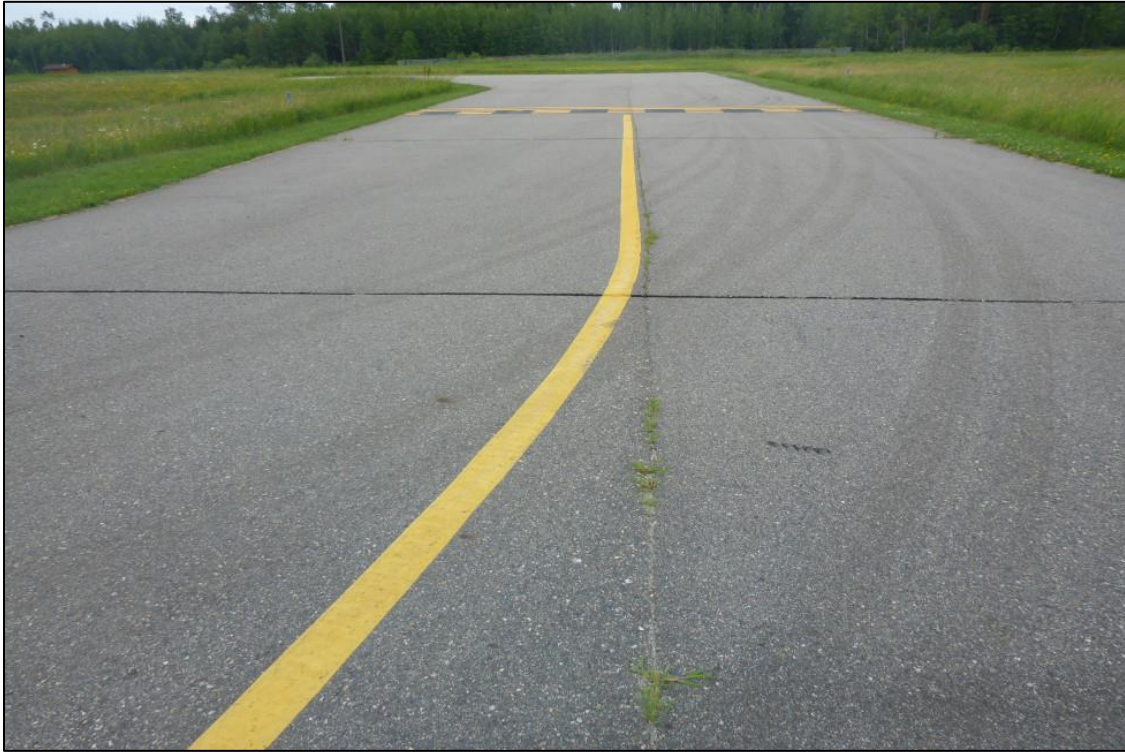
FOZ RTA33 001 (PCI = 90)

Network:	FOZ		Name:	BIGFORK					
Branch:	RTA33	Name:	Runway 33 Turnaround	Use:	TAXIWAY	Area:	10,200 SqFt		
Section:	001	of 1	From:	100	To:	103	Last Const.:	7/16/2009	
Surface:	AC	Family:	MN2018 Asphalt Runway- Taxiways	Zone:	N	Category:	3	Rank:	S
Area:	10,200 SqFt	Length:	220 Ft	Width:	35 Ft				
Slabs:		Slab Length:	Ft	Slab Width:	Ft	Joint Length:	Ft		
Shoulder:		Street Type:		Grade:	0	Lanes:	0		
Section Comments:									
Last Insp. Date:	7/16/2019	TotalSamples:	3	Surveyed:	1				
Conditions:	PCI: 90								
Inspection Comments:									
Sample Number:	101	Type:	R	Area:	3500.00 SqFt	PCI:	90		
Sample Comments:	pic 629								
48	L & T CR	L	89.00 Ft						
57	WEATHERING	L	100.00 SqFt

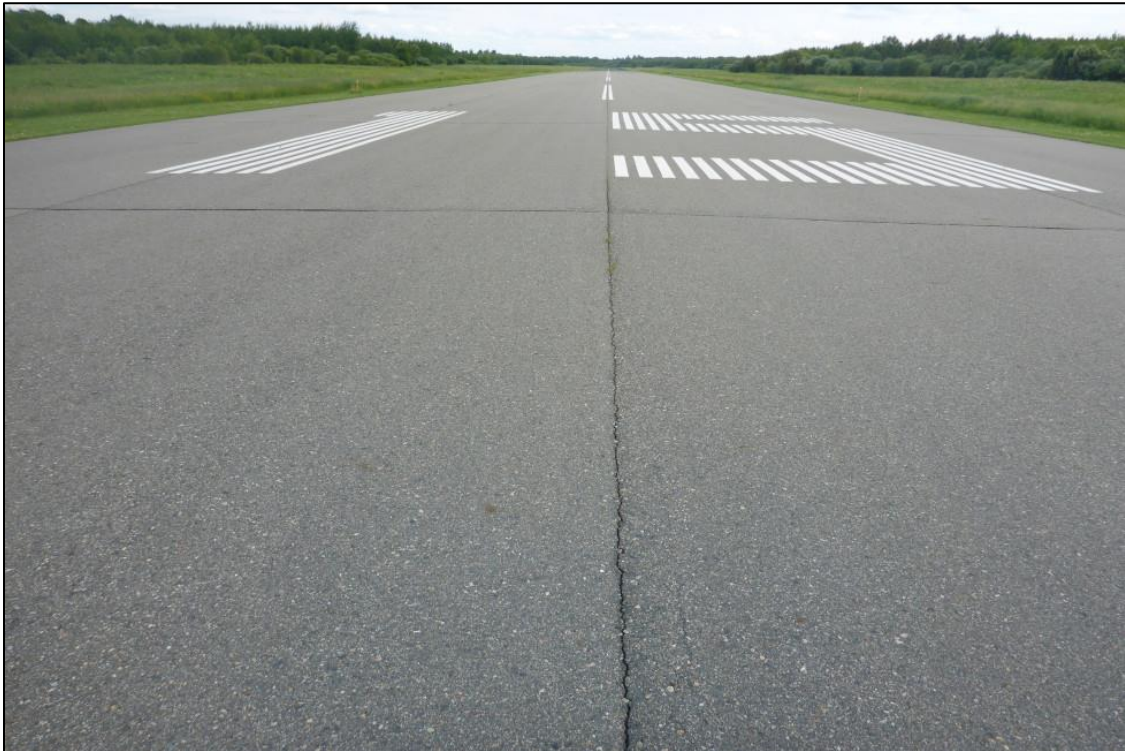
FOZ RY1533 001 (PCI = 77)

Network:	FOZ		Name:	BIGFORK					
Branch:	RY1533	Name:	RUNWAY 15-33	Use:	RUNWAY	Area:	303,700 SqFt		
Section:	001	of 1	From:	100	To:	179	Last Const.:	7/16/2009	
Surface:	AC	Family:	MN2018 Asphalt Runway- Taxiways	Zone:	N	Category:	3	Rank:	P
Area:	303,700 SqFt	Length:	4,000 Ft	Width:	75 Ft				
Slabs:		Slab Length:	Ft	Slab Width:	Ft	Joint Length:	Ft		
Shoulder:		Street Type:		Grade:	0	Lanes:	0		
Section Comments:									
Last Insp. Date:	7/16/2019		TotalSamples:	80		Surveyed:	9		
Conditions:	PCI: 77								
Inspection Comments:									
Sample Number:	103	Type:	R	Area:	3750.00 SqFt	PCI:	80		
Sample Comments:	pic 630								
48	L & T CR	L	172.00	Ft					
48	L & T CR	M	18.00	Ft					
57	WEATHERING	L	300.00	SqFt					
Sample Number:	112	Type:	R	Area:	3750.00 SqFt	PCI:	74		
Sample Comments:									
41	ALLIGATOR CR	L	5.00	SqFt					
48	L & T CR	L	160.00	Ft					
48	L & T CR	M	60.00	Ft					
57	WEATHERING	L	500.00	SqFt

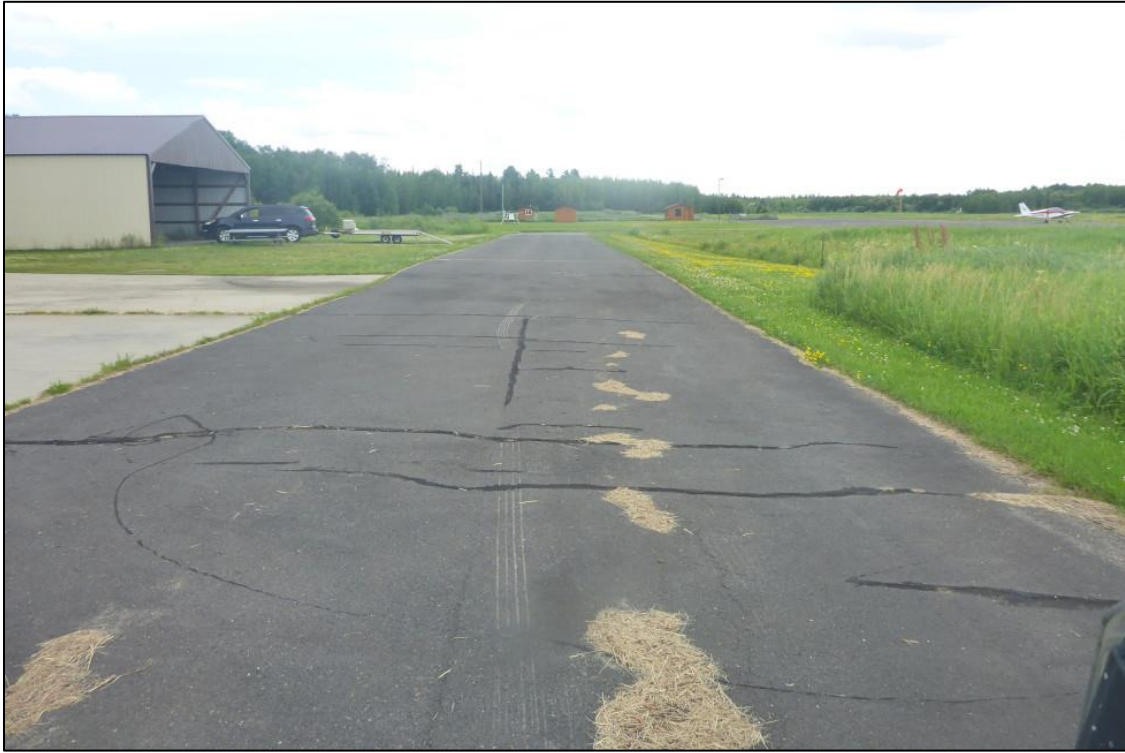
FOZ TLA 001 (PCI = 72)

Network:	FOZ	Name:	BIGFORK				
Branch:	TLA	Name:	Taxilane A	Use:	TAXILANE	Area:	10,400 SqFt
Section:	001	of 1	From:	100	To:	102	Last Const.: 7/16/2007
Surface:	AC	Family:	MN2018 Asphalt Taxilanes	Zone:	N	Category:	3
Area:	10,400 SqFt	Length:	520 Ft	Width:	20 Ft		
Slabs:		Slab Length:	Ft	Slab Width:	Ft	Joint Length:	Ft
Shoulder:		Street Type:		Grade:	0	Lanes:	0
Section Comments:	Estimated LCD						
Last Insp. Date:	7/16/2019	TotalSamples:	3	Surveyed:	1		
Conditions:	PCI: 72						
Inspection Comments:							
Sample Number:	101	Type:	R	Area:	4000.00 SqFt	PCI:	72
Sample Comments:	micro seal. p160						
48	L & T CR	L	308.00	Ft			
48	L & T CR	M	63.00	Ft			
50	PATCHING	L	30.00	SqFt
