# Pavement Condition Report

## St. James Municipal Airport (JYG)

**December 2019**

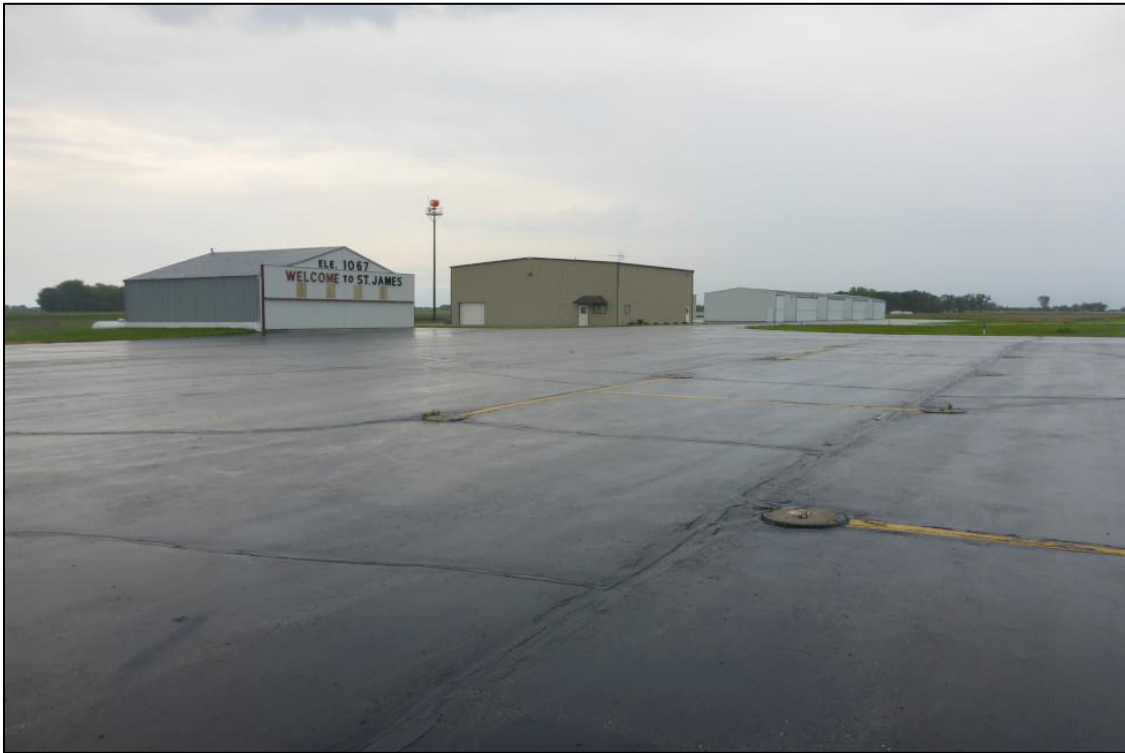
JYG APA 001 (PCI = 69)

**Conditions:** PCI: 69

**Sample Comments:** new crack seal with fines in mix to fill the subsidence and new fog seal

**Sample Comments:** p377 new crack seal with fines in mix to fill the subsidence and new fog seal

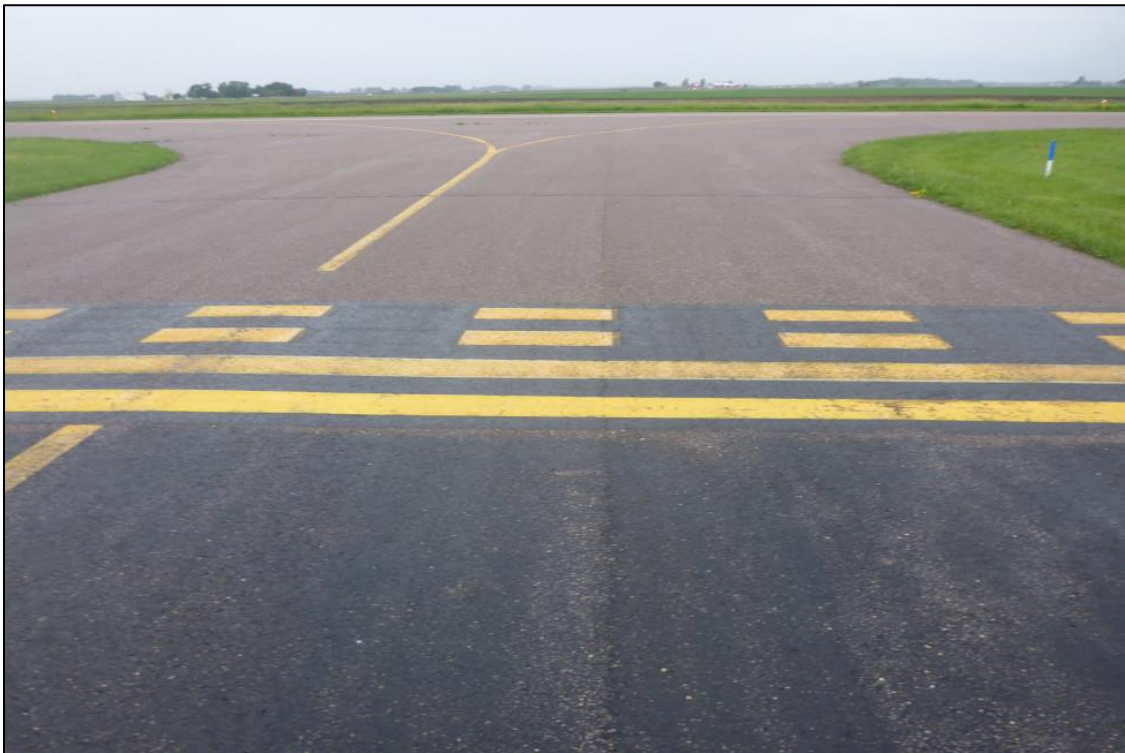
JYG CTA 001 (PCI = 79)

**Conditions:** PCI: 79

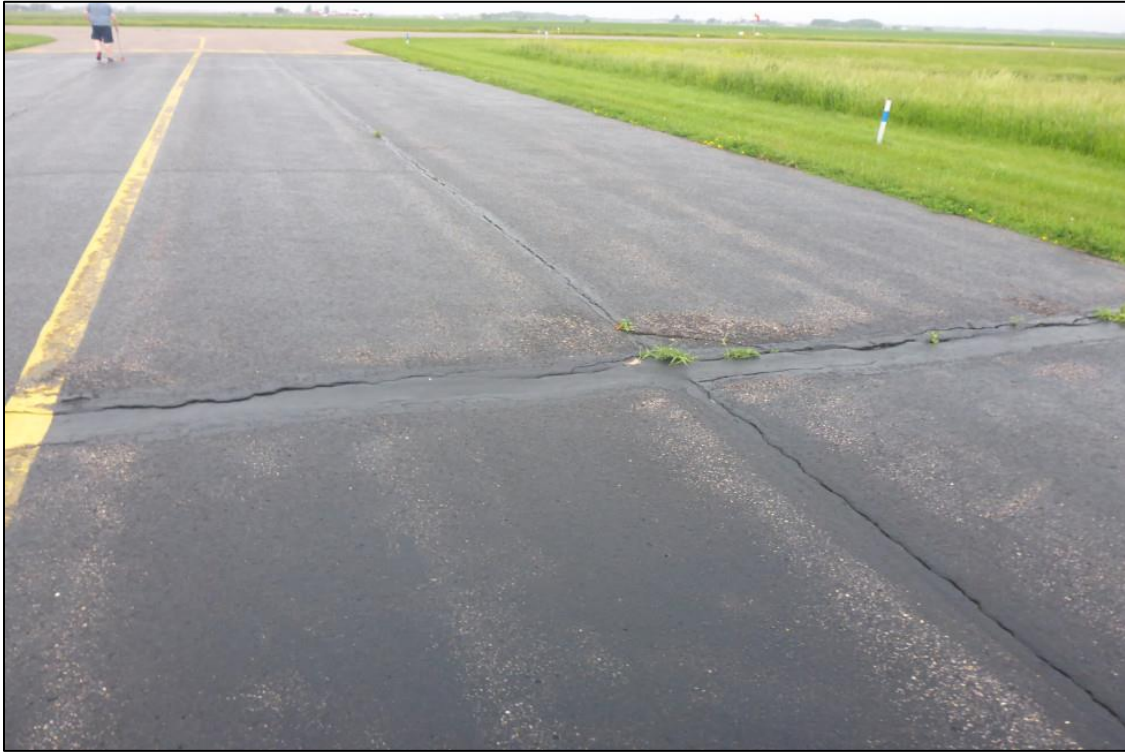
JYG CTA 002 (PCI = 70)

**Conditions:** PCI: 70

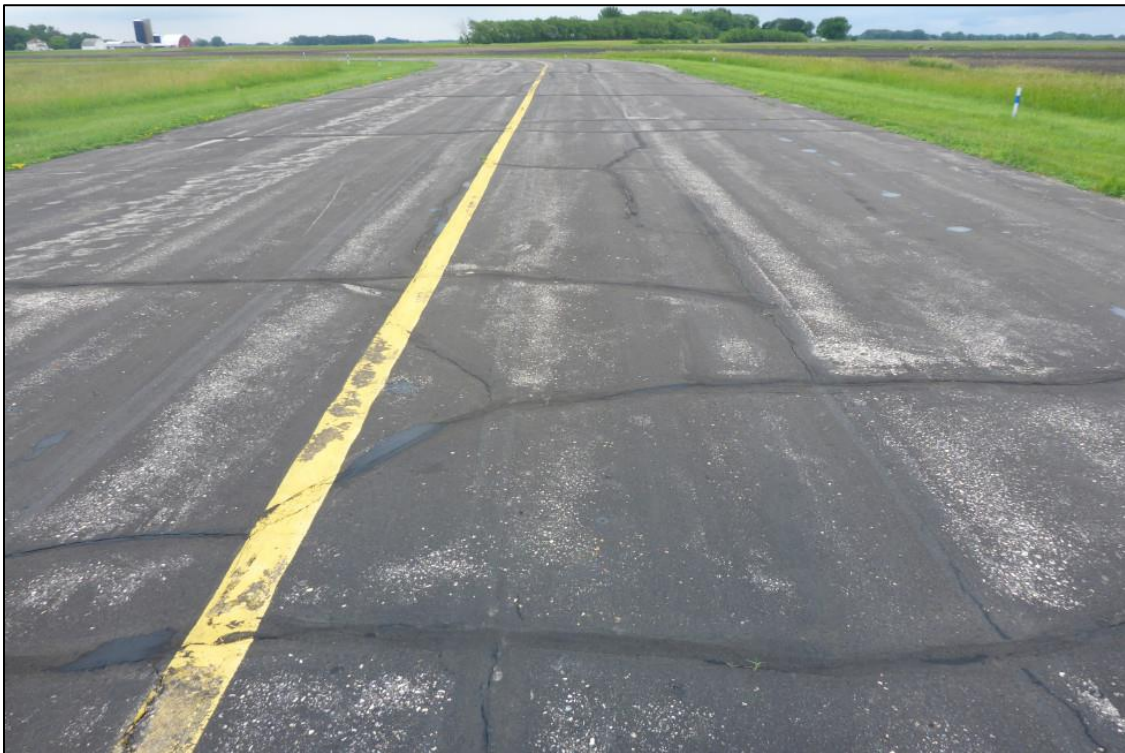
JYG PPTA 002 (PCI = 61)

**Conditions:** PCI: 61

**Sample Comments:** cs filling high cracks, unable to verify as amny feet p368

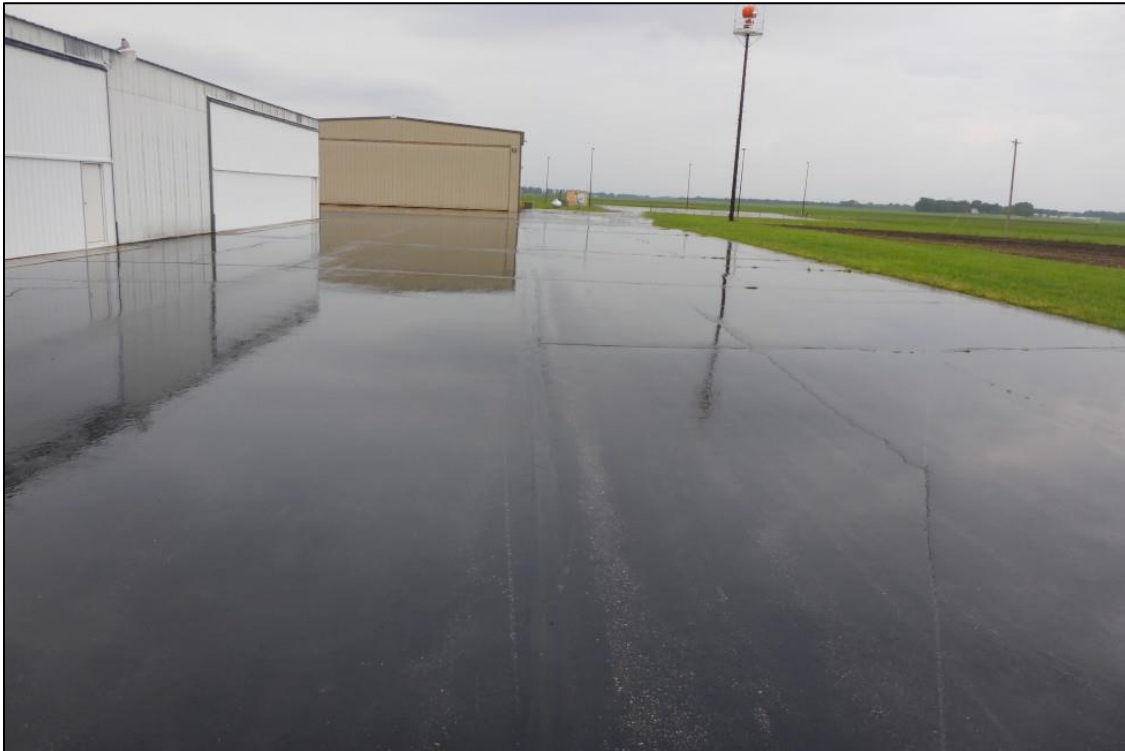
JYG TLA 002 (PCI = 72)

45	DEPRESSION	L	15.00	SqFt					
45	DEPRESSION	H	3.00	SqFt					
48	L & T CR	L	150.00	Ft					
48	L & T CR	M	124.00	Ft					
<b>Sample Number:</b>	201	<b>Type:</b>	R	<b>Area:</b>	5300.00 SqFt	<b>PCI:</b>	72		
<b>Sample Comments:</b>	new crack seal with fines in mix to fill the subsidance and new fog seal p380,381								
48	L & T CR	L	532.00	Ft					
48	L & T CR	M	59.00	Ft
