# Pavement Condition Report

## Litchfield Municipal Airport (LJF)

**December 2019**

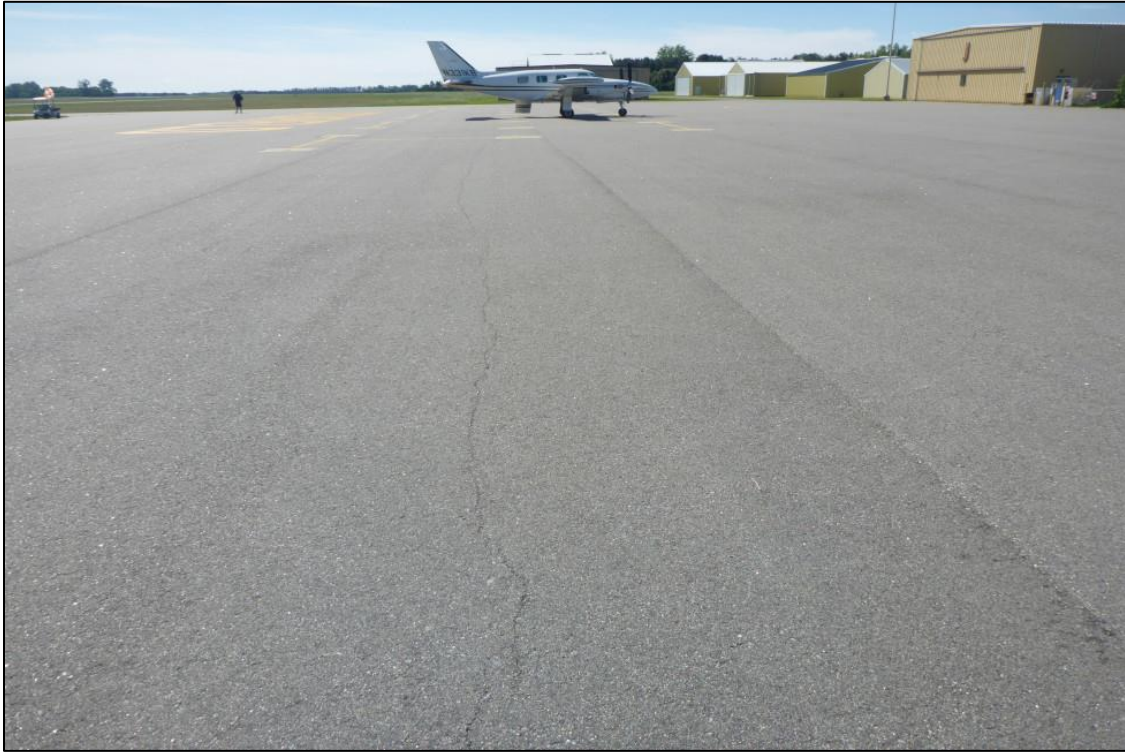
LJF APA 001 (PCI = 93)

**Conditions:** PCI: 93

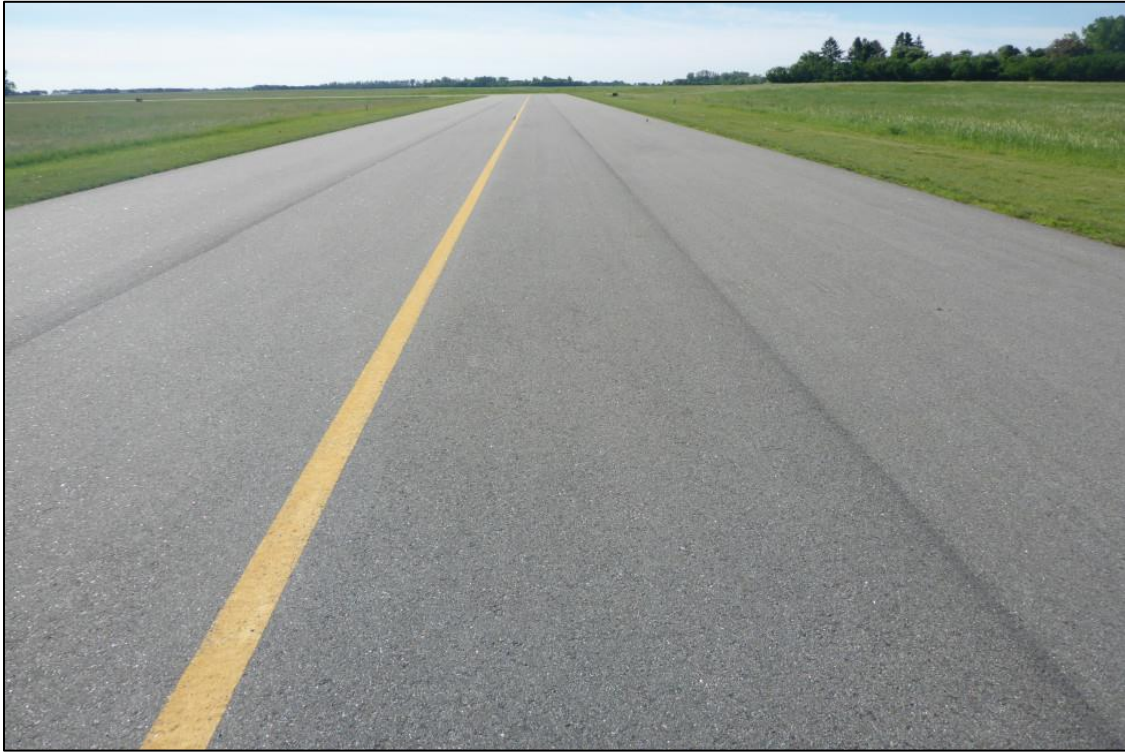
LJF PTA 001 (PCI = 92)

**Conditions:** PCI: 92

Branch	Section	Treatment	Quantity	Unit	Cost
PTA	001	Crack Sealing - AC	21	Ft	\$27
<b>Preventive PCI Before:92 After:92</b>			<b>-</b>	<b>Total</b>	<b>\$27</b>
TLA	001	Crack Sealing - AC	1,796	Ft	\$2,317
TLA	001	Patching - AC Deep	688	SqFt	\$8,301
<b>Preventive PCI Before: 44 After:60</b>			<b>-</b>	<b>Total</b>	<b>\$10,618</b>
TLA	002	Crack Sealing - AC	67	FT	\$87
<b>Preventive PCI Before: 83 After: 89</b>			<b>-</b>	<b>Total</b>	<b>\$87</b>

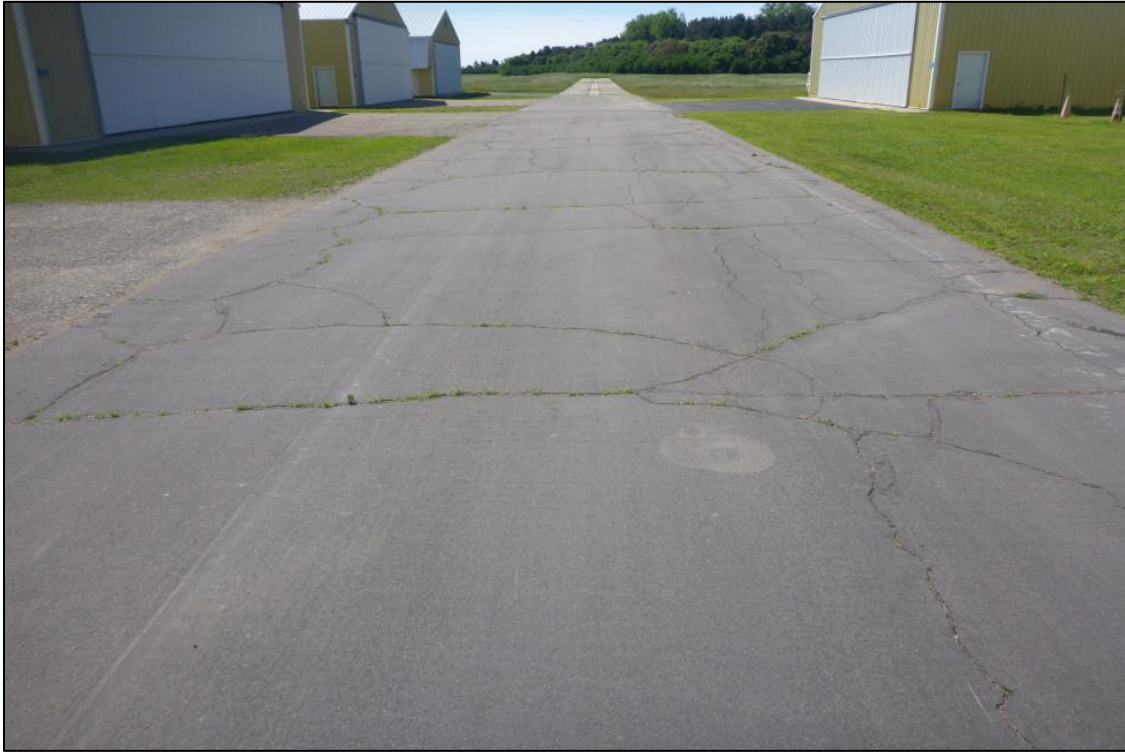
LJF TLA 001 (PCI =44)

**Conditions:** PCI: 44

Branch	Section	Distress Type	Severity	Treatment	Estimated Quantity	Unit	Cost
PTA	001	L & T CR	M	Crack Sealing - AC	21	Ft	\$27
TLA	001	BLOCK CR	M	Crack Sealing - AC	1,028	Ft	\$1,326
TLA	001	L & T CR	H	Crack Sealing - AC	65	Ft	\$83
TLA	001	L & T CR	M	Crack Sealing - AC	704	Ft	\$908
TLA	002	L & T CR	M	Crack Sealing - AC	67	Ft	\$87
				<b>Total:</b>	<b>1,884</b>	<b>Ft</b>	<b>\$2,431</b>
TLA	001	ALLIGATOR CR	M	Patching - AC Deep	688	SqFt	\$8,301
				<b>Total:</b>	<b>688</b>	<b>SqFt</b>	<b>\$8,301</b>
