Pavement Condition Report

Morris Municipal Airport – Charlie Schmidt Field (MOX)

December 2019

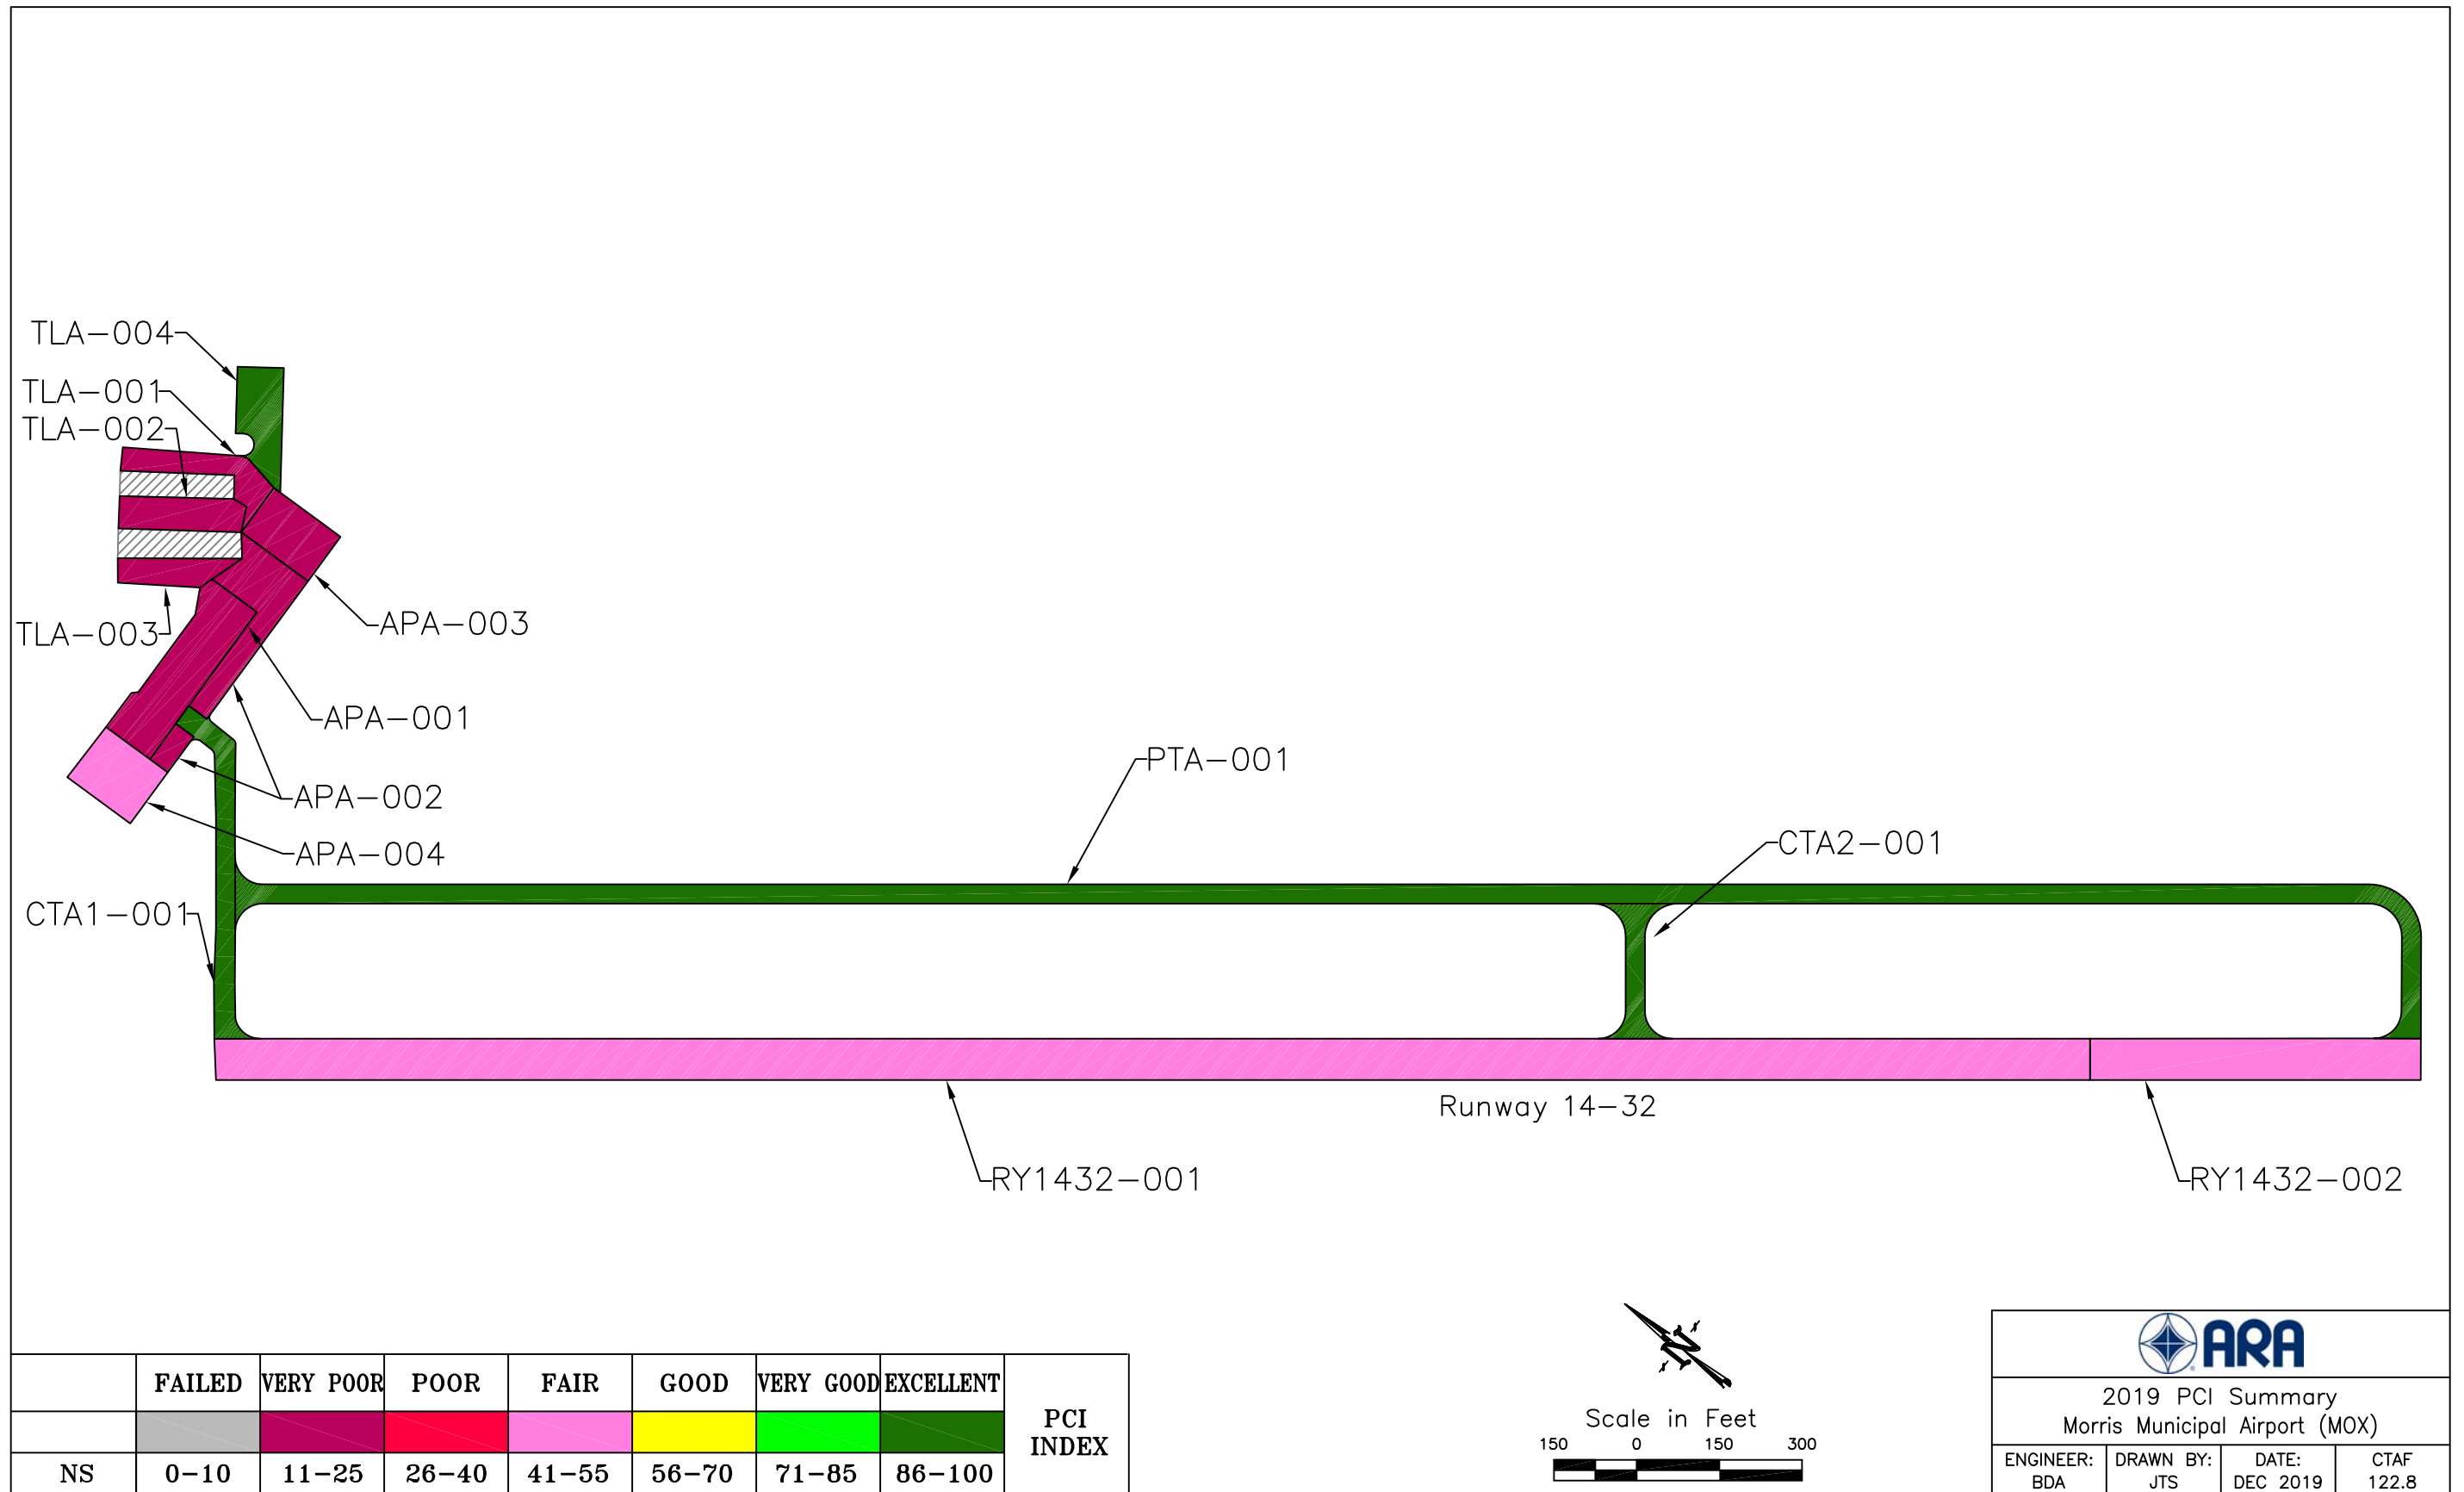
Figure 4. 2019 Pavement Condition Index Rating at Morris Municipal Airport – Charlie Schmidt Field (MOX).

⁶Increase in PCI due to major pavement reconstruction completed since the 2016 inspection.

⁷Higher than expected deterioration rate of 6.0 PCI/year due to the development of L&T cracking in significant quantities in new pavement.

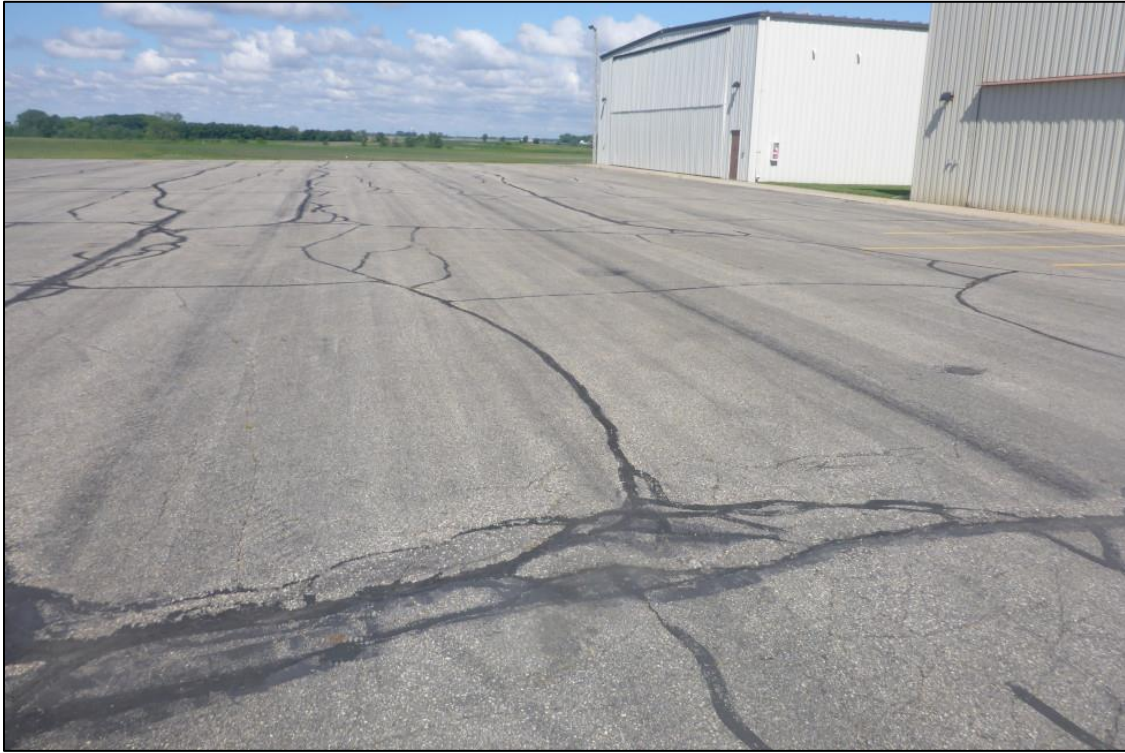
MOX APA 001 (PCI = 25)

Conditions: PCI: 25

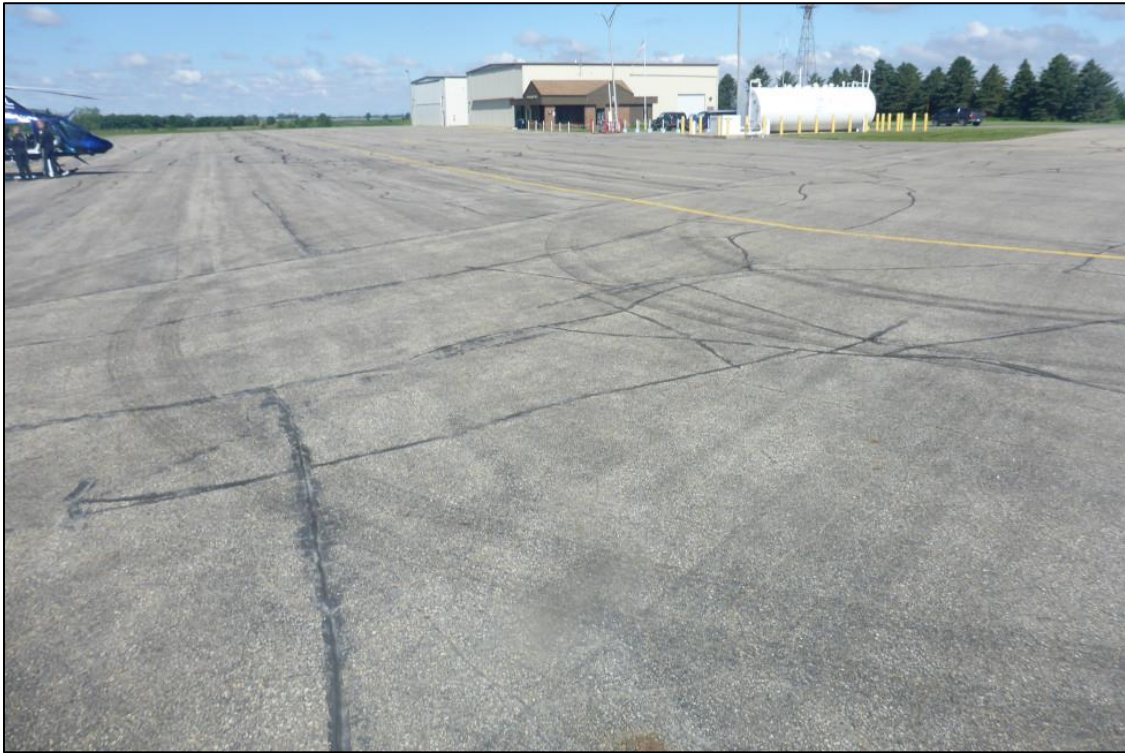
MOX APA 002 (PCI = 11)

Conditions: PCI: 11

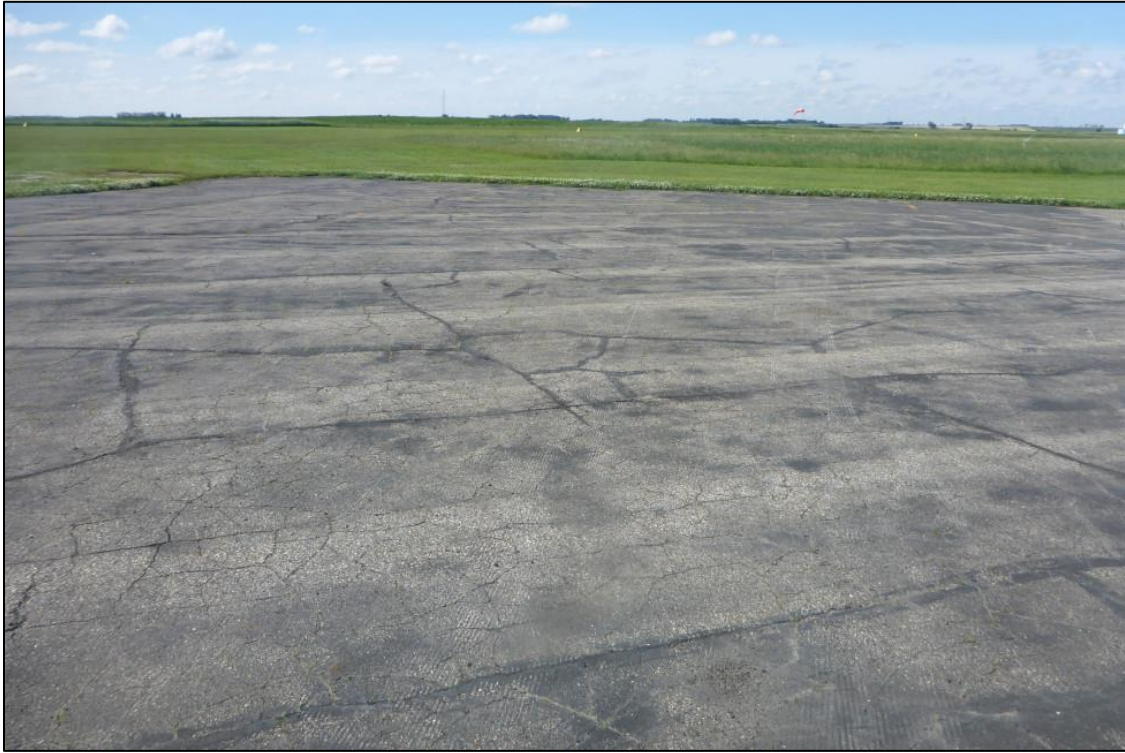
MOX APA 003 (PCI = 16)

Last Insp. Date: 6/11/2019	Total Samples: 3	Surveyed: 1
Conditions: PCI: 16

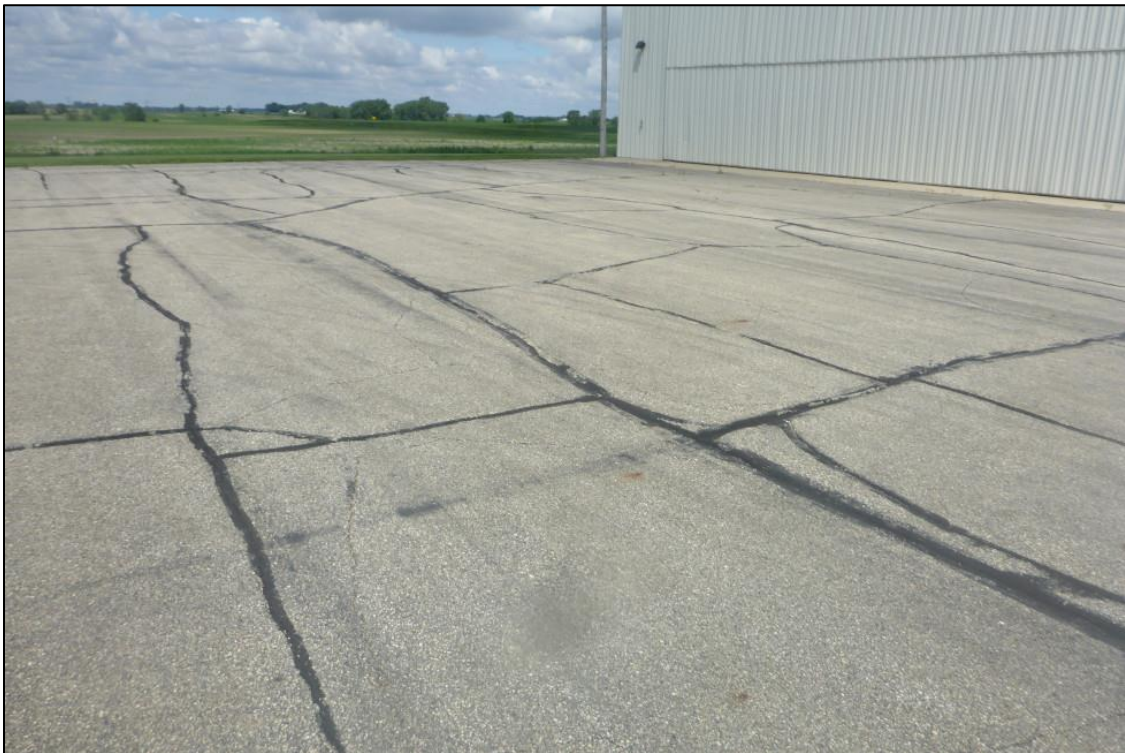
MOX APA 004 (PCI = 47)

Conditions: PCI: 47

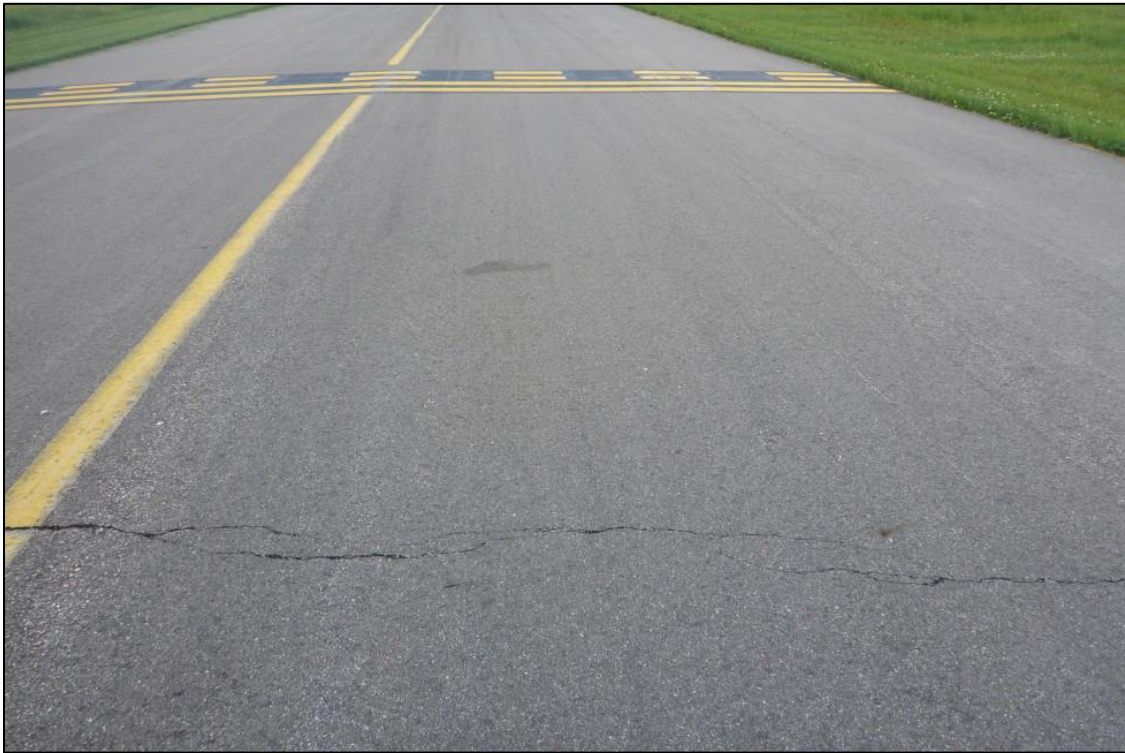
MOX CTA1 001 (PCI = 94)

Network:	MOX	Name:	MORRIS				
Branch:	CTA1	Name:	CONNECTING TAXIWAY A1	Use:	TAXIWAY	Area:	24,400 SqFt
Section:	001	of 1	From: 100	To:	105	Last Const.:	9/15/2018
Surface:	AC	Family:	MN2018 Asphalt Runway- Taxiways	Zone:	W	Category:	3
Area:	24,400 SqFt	Length:	600 Ft	Width:	40 Ft		
Slabs:		Slab Length:	Ft	Slab Width:	Ft	Joint Length:	Ft
Shoulder:		Street Type:		Grade:	0	Lanes:	0
Section Comments:							
Last Insp. Date:	6/11/2019	TotalSamples:	6	Surveyed:	3		
Conditions:	PCI: 94						
Inspection Comments:							
Sample Number:	100	Type:	R	Area:	4000.00 SqFt	PCI:	92
Sample Comments:	p 462						
48	L & T CR	M	9.00 Ft				
56	SWELLING	L	34.00 SqFt				
Sample Number:	101	Type:	R	Area:	4000.00 SqFt	PCI:	89
Sample Comments:	p 463						
48	L & T CR	L	77.00 Ft				
48	L & T CR	M	3.00 Ft				
Sample Number:	104	Type:	R	Area:	4000.00 SqFt	PCI:	100
Sample Comments:	nd						
<No Distress>

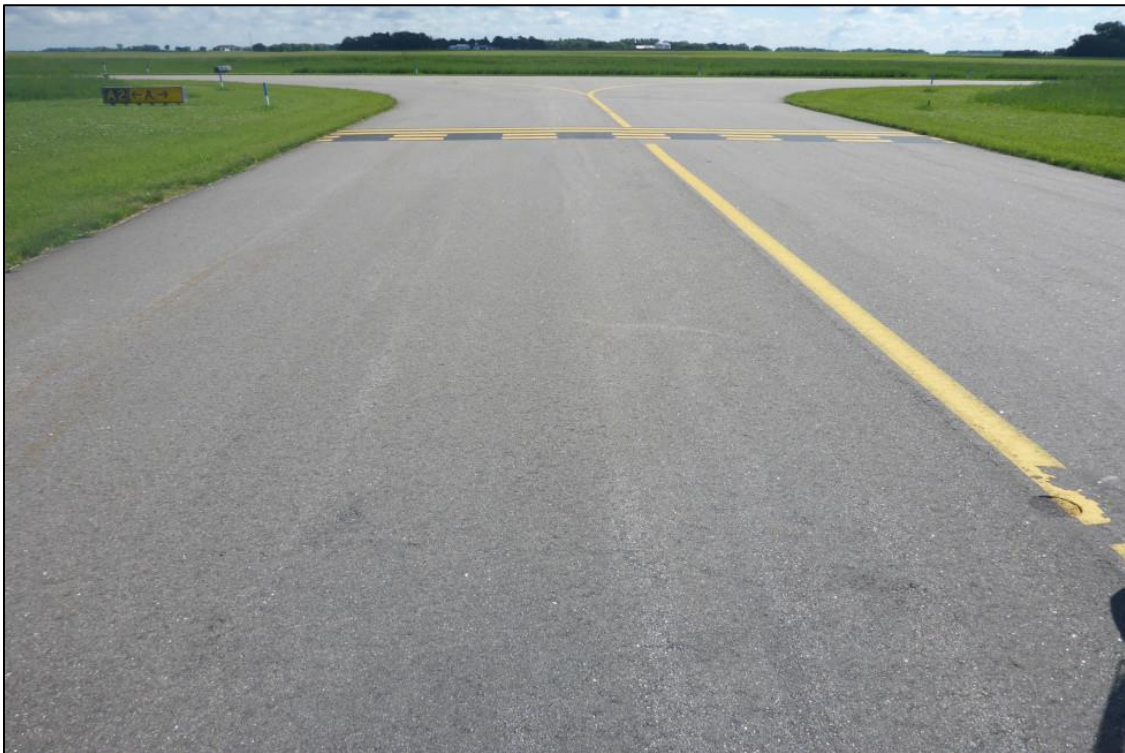
MOX CTA2 001 (PCI = 100)

Conditions: PCI: 100

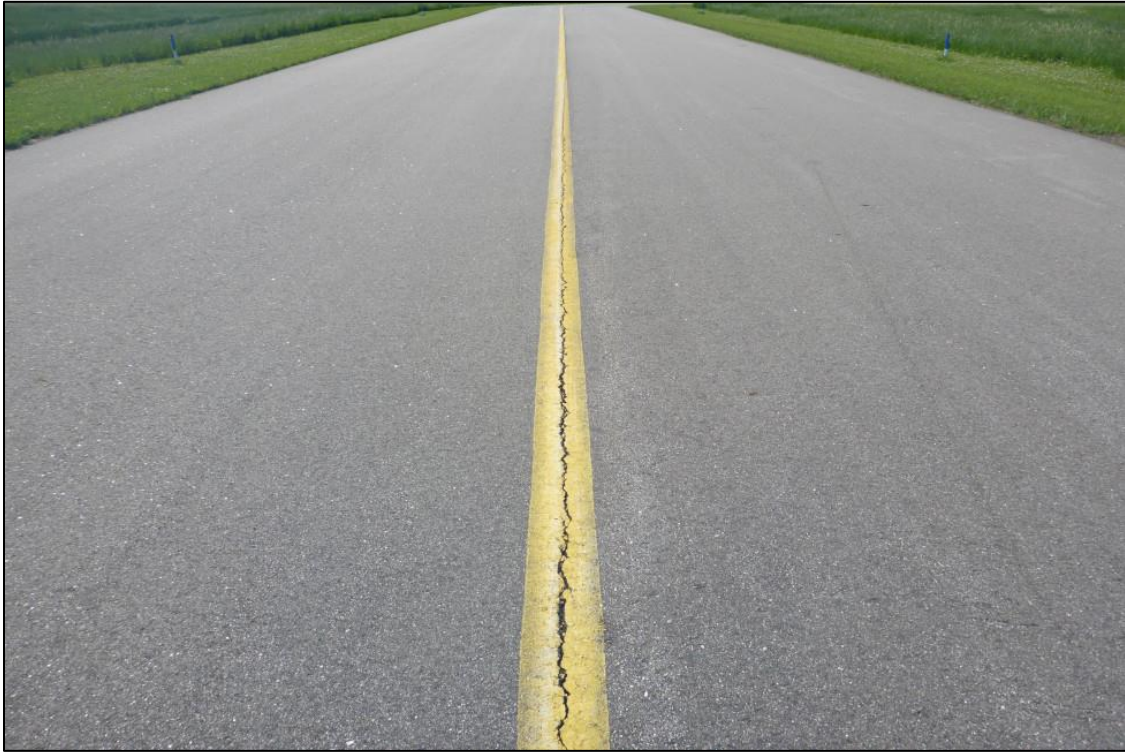
MOX PTA 001 (PCI = 97)

Conditions: PCI: 97

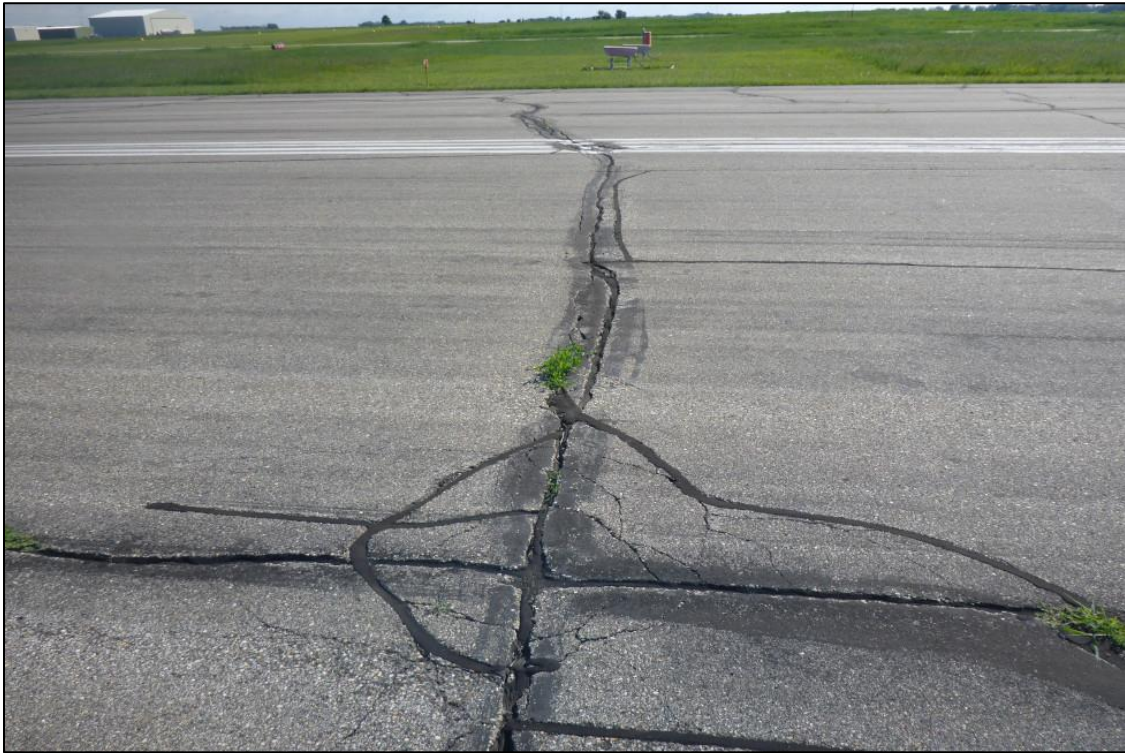
MOX RY1432 001 (PCI = 49)

Network:	MOX	Name:	MORRIS						
Branch:	RY1432	Name:	RUNWAY 14-32	Use:	RUNWAY	Area:	309,935 SqFt		
Section:	001	of 2	From:	100	To:	167	Last Const.:	9/30/1984	
Surface:	AC	Family:	MN2018 Asphalt Runway- Taxiways	Zone:	W	Category:	3	Rank:	P
Area:	255,000 SqFt	Length:	3,400 Ft	Width:	75 Ft				
Slabs:		Slab Length:	Ft	Slab Width:	Ft	Joint Length:	Ft		
Shoulder:		Street Type:		Grade:	0	Lanes:	0		
Section Comments:	maint. (R&E) patching								
Last Insp. Date:	6/11/2019	TotalSamples:	68	Surveyed:	8				
Conditions:	PCI: 49								
Inspection Comments:									
Sample Number:	106	Type:	R	Area:	3750.00 SqFt	PCI:	57		
Sample Comments:	p 453								
41	ALLIGATOR CR	M	10.00	SqFt					
48	L & T CR	L	539.00	Ft					
48	L & T CR	M	111.00	Ft					
57	WEATHERING	L	3000.00	SqFt					
Sample Number:	115	Type:	R	Area:	3750.00 SqFt	PCI:	46		
Sample Comments:	p 454								
41	ALLIGATOR CR	M	34.00	SqFt					
48	L & T CR	L	472.00	Ft

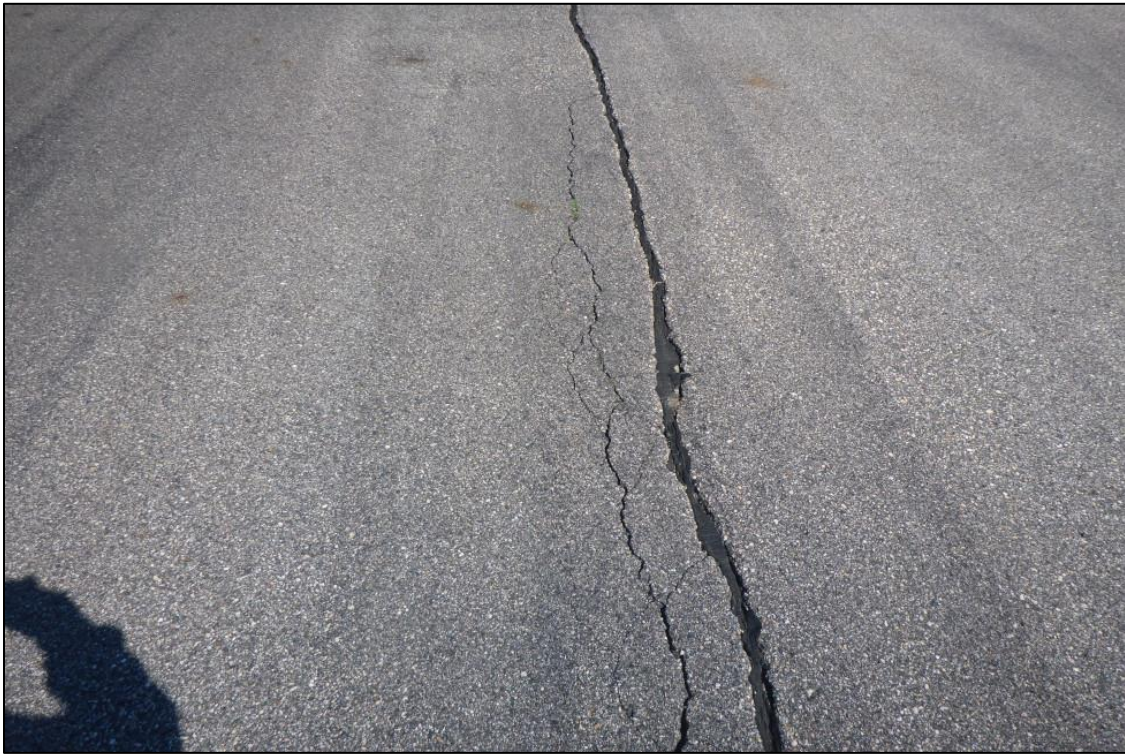
MOX RY1432 002 (PCI = 55)

Conditions: PCI: 55

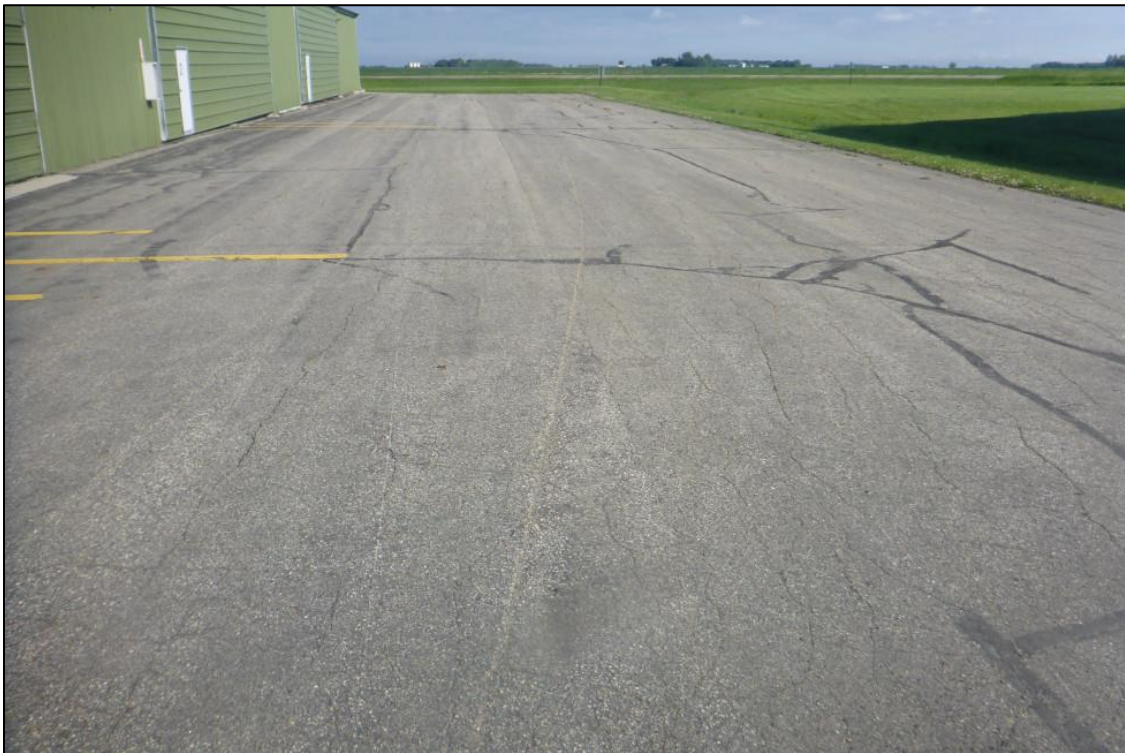
MOX TLA 001 (PCI = 19)

Network:	MOX	Name:	MORRIS						
Branch:	TLA	Name:	Taxilane A	Use:	TAXILANE	Area:	56,124 SqFt		
Section:	001	of 4	From:	100	To:	102	Last Const.:	6/1/1995	
Surface:	AC	Family:	MN2018 Asphalt Taxilanes	Zone:	W	Category:	3	Rank:	T
Area:	16,300 SqFt	Length:	200 Ft	Width:	45 Ft				
Slabs:	Slab Length:	Ft	Slab Width:	Ft	Joint Length:	Ft			
Shoulder:	Street Type:	Grade:	0	Lanes:	0				
Section Comments:	Estimated LCD								
Last Insp. Date:	6/11/2019	TotalSamples:	3	Surveyed:	1				
Conditions:	PCI: 19								
Inspection Comments:									
Sample Number:	101	Type:	R	Area:	4500.00 SqFt	PCI:	19		
Sample Comments:	p999,001								
41	ALLIGATOR CR	L	600.00	SqFt					
41	ALLIGATOR CR	M	780.00	SqFt					
43	BLOCK CR	L	2000.00	SqFt					
43	BLOCK CR	L	150.00	SqFt					
48	L & T CR	M	45.00	Ft

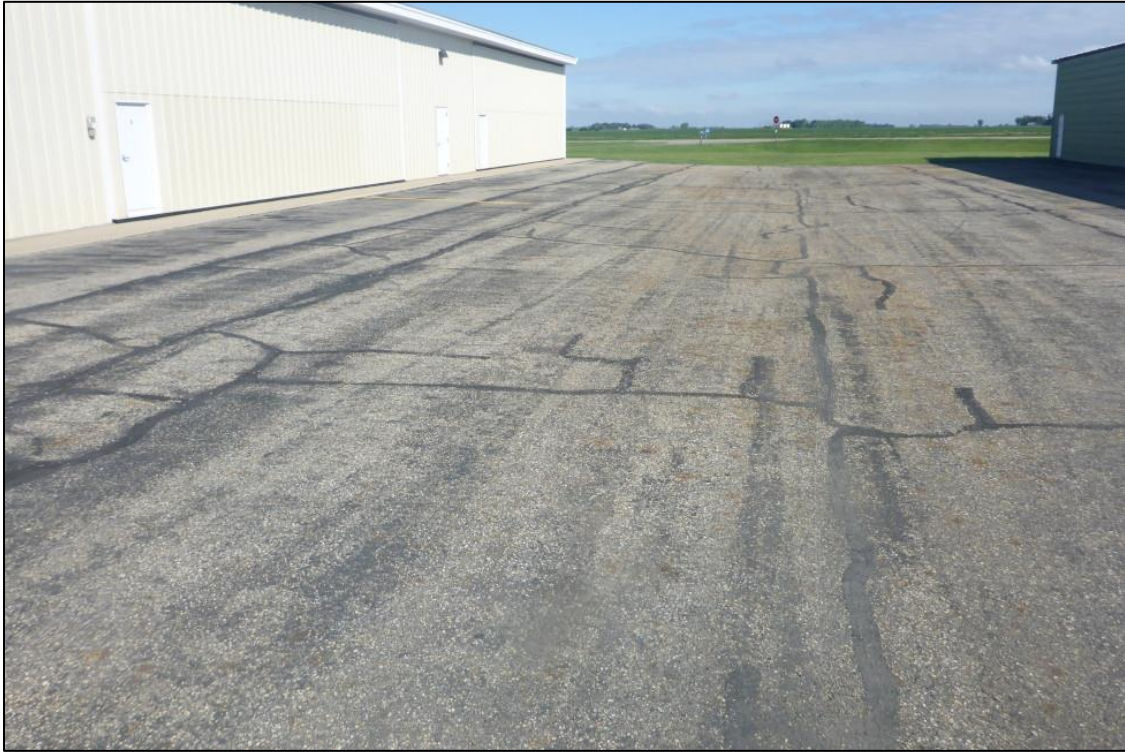
MOX TLA 002 (PCI = 13)

Conditions: PCI: 13

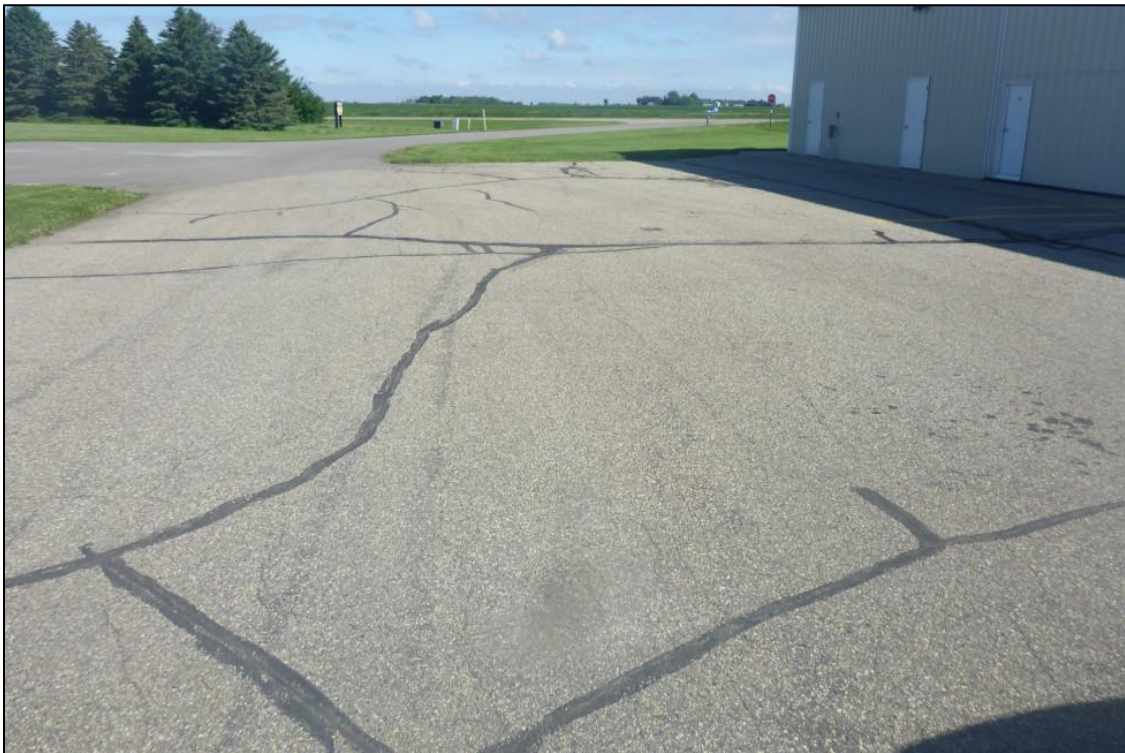
MOX TLA 003 (PCI = 11)

Network:	MOX	Name:	MORRIS						
Branch:	TLA	Name:	Taxilane A	Use:	TAXILANE	Area:	56,124 SqFt		
Section:	003	of 4	From:	300	To:	301	Last Const.:	6/1/1976	
Surface:	AC	Family:	MN2018 Asphalt Taxilanes	Zone:	W	Category:	3	Rank:	T
Area:	9,500 SqFt	Length:	190 Ft	Width:	50 Ft				
Slabs:	Slab Length:	Ft	Slab Width:	Ft	Joint Length:	Ft			
Shoulder:	Street Type:	Grade:	0	Lanes:	0				
Section Comments:	Estimated LCD								
Last Insp. Date:	6/11/2019	TotalSamples:	2	Surveyed:	1				
Conditions:	PCI: 11								
Inspection Comments:									
Sample Number:	300	Type:	R	Area:	5000.00 SqFt	PCI:	11		
Sample Comments:	p005								
41	ALLIGATOR CR	L	1900.00	SqFt					
41	ALLIGATOR CR	M	1000.00	SqFt					
45	DEPRESSION	L	20.00	SqFt					
48	L & T CR	L	250.00	Ft					
48	L & T CR	M	25.00	Ft					
50	PATCHING	L	900.00	SqFt

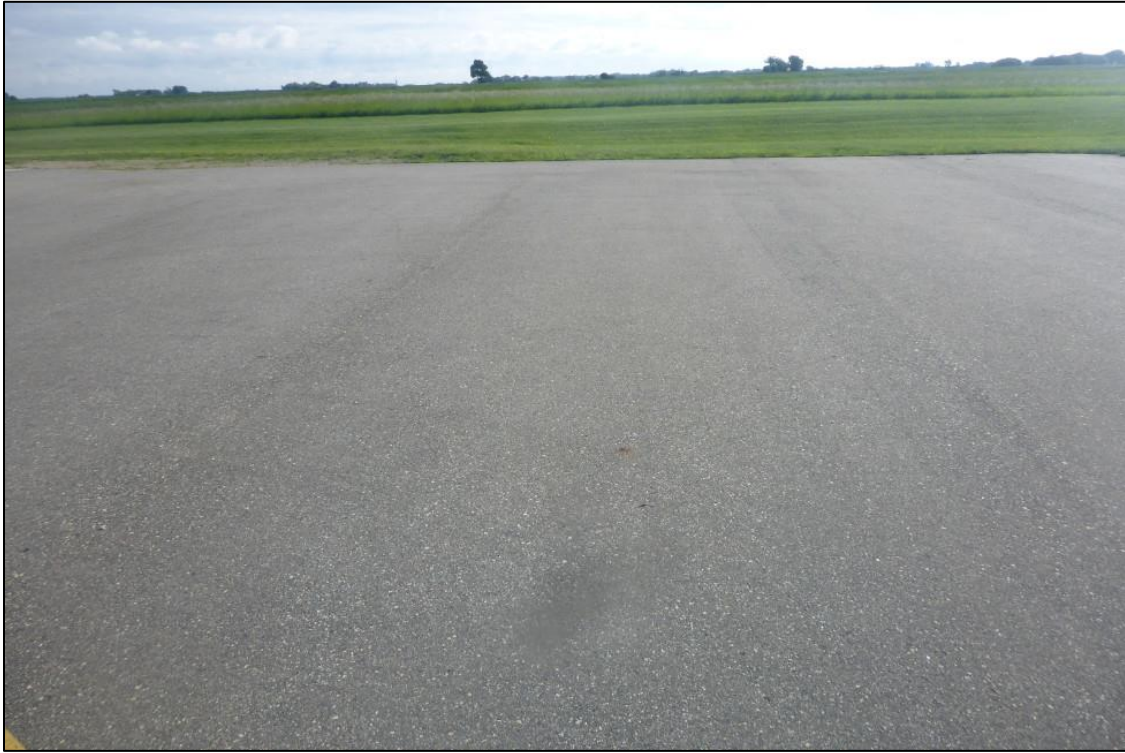
MOX TLA 004 (PCI = 98)

Conditions: PCI: 98
