Pavement Condition Report

Walker Municipal Airport (Y49)

December 2019

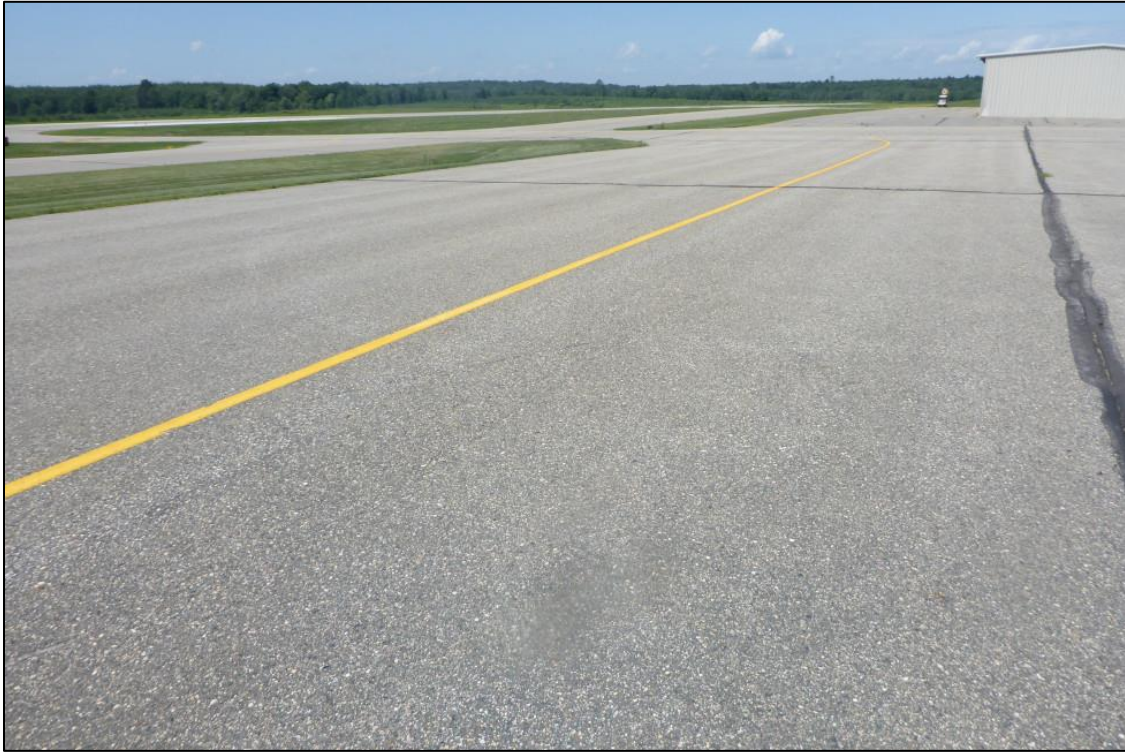
Y49 APA 001 (PCI = 72)

Conditions: PCI: 72

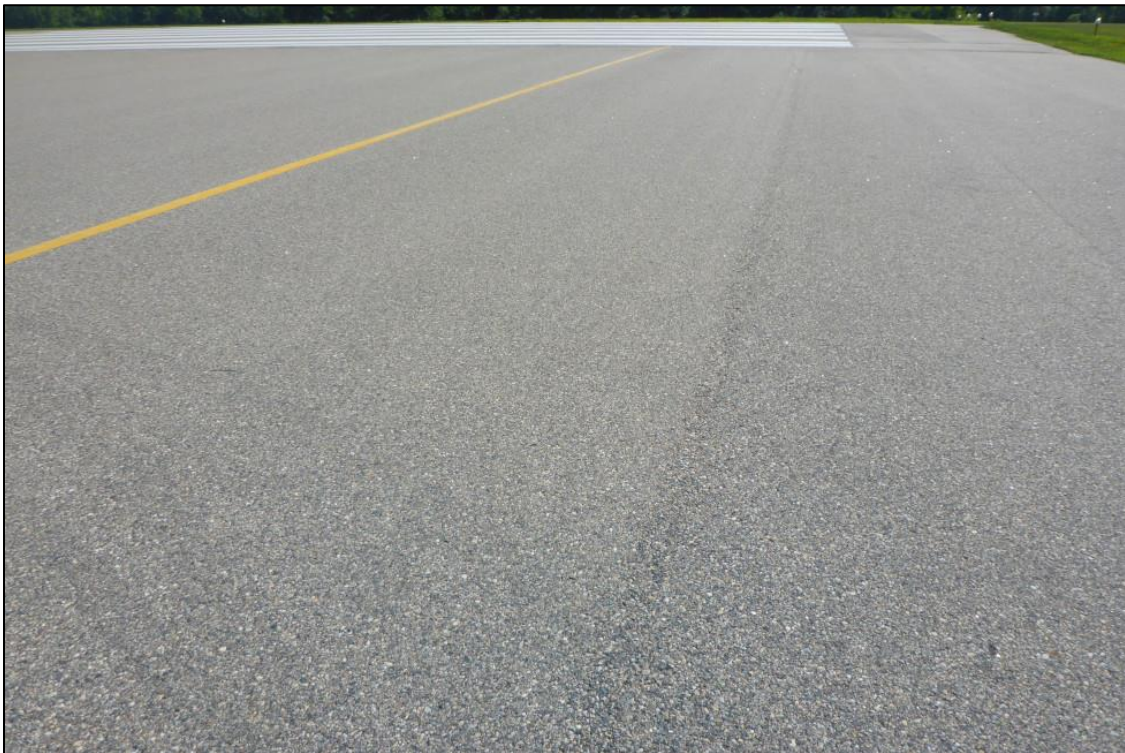
Y49 CTA1 001 (PCI = 73)

Conditions: PCI: 73

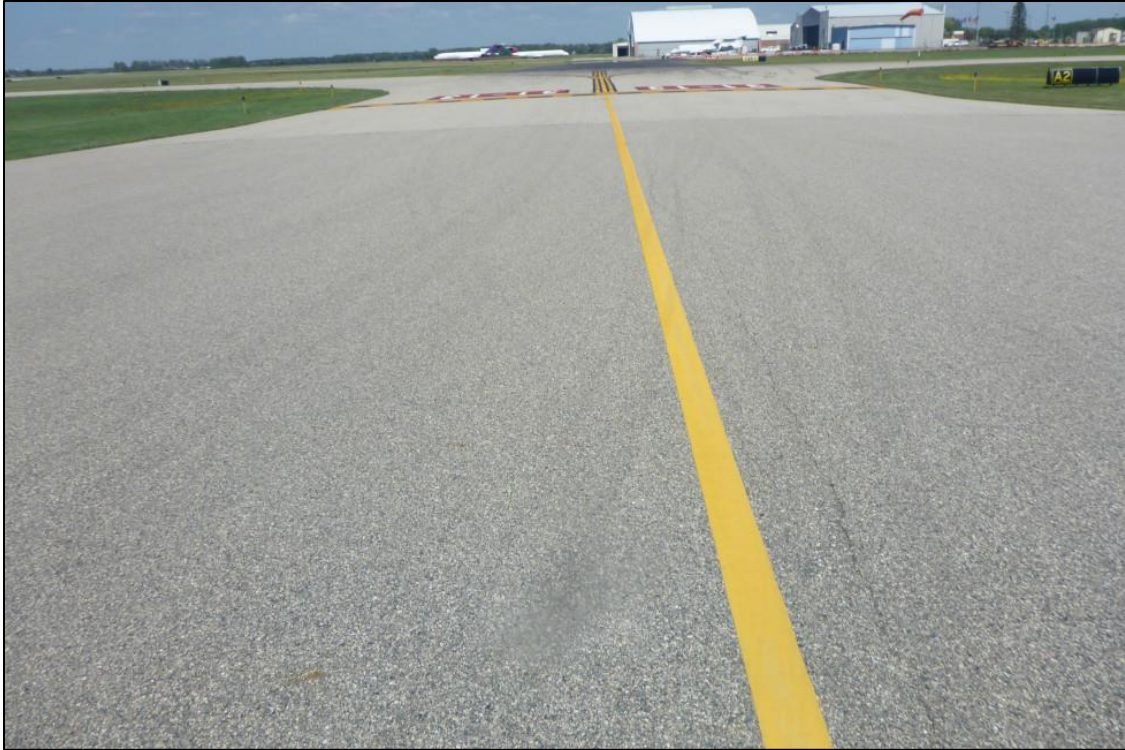
Y49 CTA2 001 (PCI = 75)

Network:	Y49	Name:	WALKER						
Branch:	CTA2	Name:	CONNECTOR TAXIWAY A2	Use:	TAXIWAY	Area:	8,400 SqFt		
Section:	001	of 1	From:	100	To:	101	Last Const.: 10/20/2007		
Surface:	AC	Family:	MN2018 Asphalt Runway- Taxiways	Zone:	N	Category:	3	Rank:	P
Area:	8,400 SqFt	Length:	200 Ft	Width:	40 Ft				
Slabs:		Slab Length:	Ft	Slab Width:	Ft	Joint Length:	Ft		
Shoulder:		Street Type:		Grade:	0	Lanes:	0		
Section Comments:									
Last Insp. Date:	7/16/2019	TotalSamples:	2	Surveyed:	1				
Conditions:	PCI: 75								
Inspection Comments:									
Sample Number:	101	Type:	R	Area:	3600.00 SqFt	PCI:	75		
Sample Comments: p238									
48	L & T CR	L	181.00	Ft					
48	L & T CR	M	35.00	Ft					
57	WEATHERING	L	3000.00	SqFt

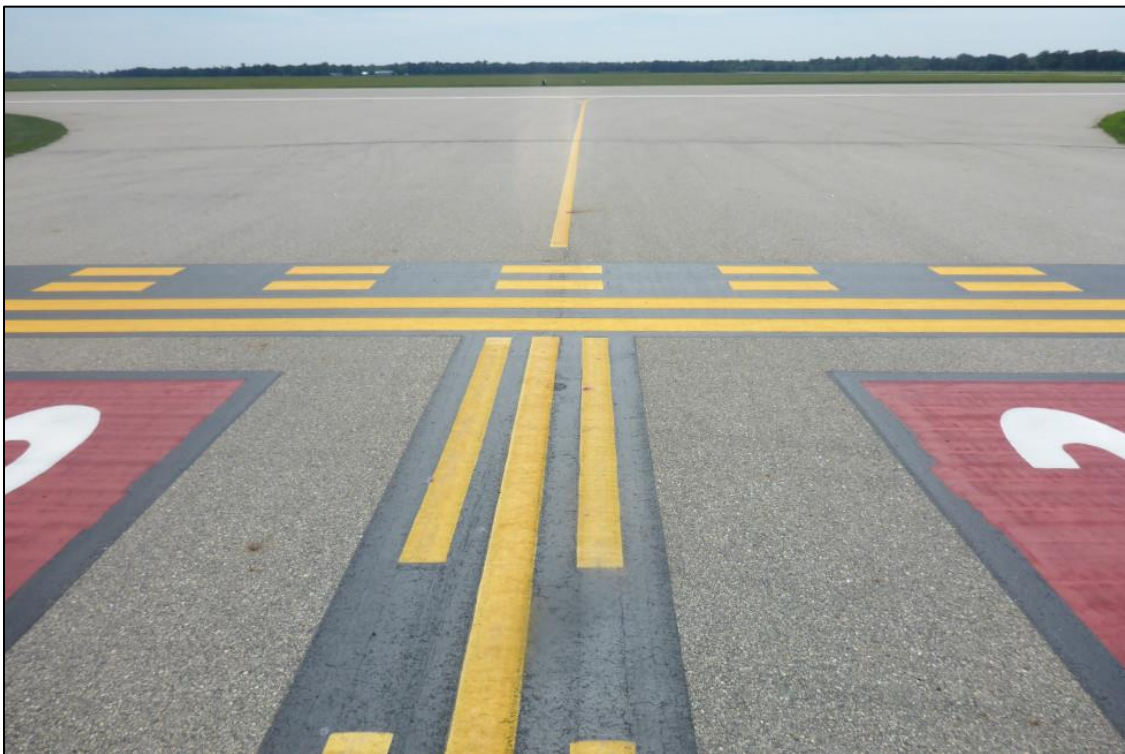
Y49 CTA3 001 (PCI = 83)

Network:	Y49	Name:	WALKER						
Branch:	CTA3	Name:	Connector Taxiway A3	Use:	TAXIWAY	Area:	7,860 SqFt		
Section:	001	of 1	From:	PTA	To:	RW 15	Last Const.:	9/28/2010	
Surface:	AC	Family:	MN2018 Asphalt Runway- Taxiways	Zone:	N	Category:	3	Rank:	P
Area:	7,860 SqFt	Length:	215 Ft	Width:	35 Ft				
Slabs:		Slab Length:	Ft	Slab Width:	Ft	Joint Length:	Ft		
Shoulder:		Street Type:		Grade:	0	Lanes:	0		
Section Comments:									
Last Insp. Date:	7/16/2019	TotalSamples:	2	Surveyed:	1				
Conditions:	PCI: 83								
Inspection Comments:									
Sample Number:	100	Type:	R	Area:	3835.00 SqFt	PCI:	83		
Sample Comments: p237									
48	L & T CR	L	120.00	Ft					
48	L & T CR	M	16.00	Ft					
57	WEATHERING	L	350.00	SqFt

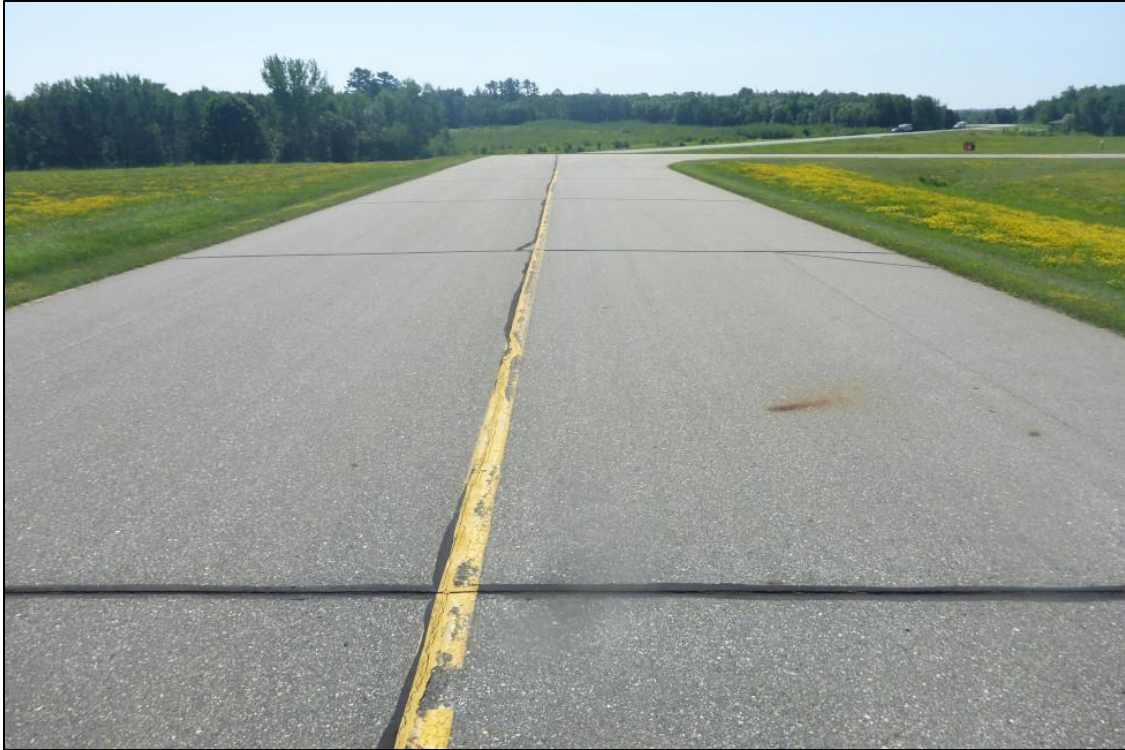
Y49 PTA 001 (PCI = 78)

Network:	Y49	Name:	WALKER						
Branch:	PTA	Name:	Parallel Taxiway A	Use:	TAXIWAY	Area:	115,500 SqFt		
Section:	001	of 2	From:	CTA1	To:	CTA2	Last Const.: 9/28/2010		
Surface:	AC	Family:	MN2018 Asphalt Runway- Taxiways	Zone:	N	Category:	3	Rank:	P
Area:	32,975 SqFt	Length:	885 Ft	Width:	35 Ft				
Slabs:		Slab Length:	Ft	Slab Width:	Ft	Joint Length:	Ft		
Shoulder:		Street Type:		Grade:	0	Lanes:	0		
Section Comments:									
Last Insp. Date:	7/16/2019	TotalSamples:	10	Surveyed:	3				
Conditions:	PCI: 78								
Inspection Comments:									
Sample Number:	101	Type:	R	Area:	3500.00 SqFt	PCI:	78		
Sample Comments: p234									
48	L & T CR	L	192.00	Ft					
48	L & T CR	M	26.00	Ft					
57	WEATHERING	L	200.00	SqFt					
Sample Number:	104	Type:	R	Area:	3500.00 SqFt	PCI:	78		
Sample Comments:									
48	L & T CR	L	196.00	Ft					
48	L & T CR	M	12.00	Ft					
57	WEATHERING	L	200.00	SqFt					
Sample Number:	107	Type:	R	Area:	3500.00 SqFt	PCI:	77

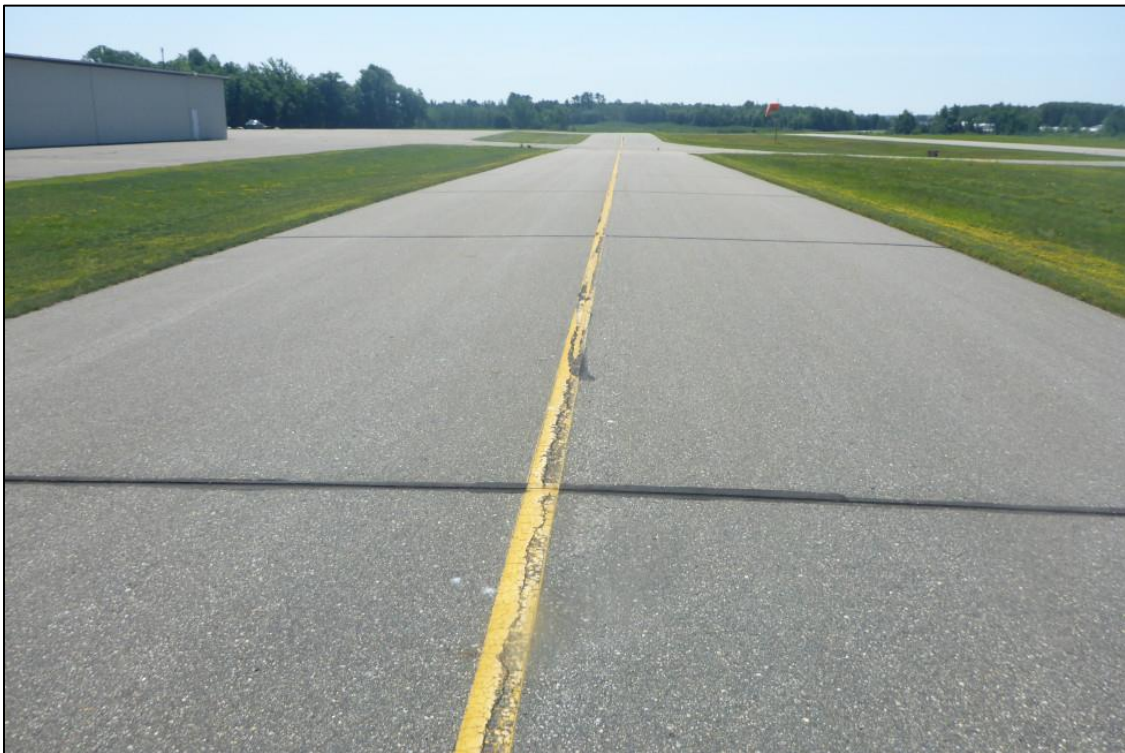
Y49 PTA 002 (PCI = 78)

Network:	Y49	Name:	WALKER						
Branch:	PTA	Name:	Parallel Taxiway A	Use:	TAXIWAY	Area:	115,500 SqFt		
Section:	002	of 2	From:	CTA2	To:	CTA3	Last Const.: 9/28/2010		
Surface:	AC	Family:	MN2018 Asphalt Runway- Taxiways	Zone:	N	Category:	3	Rank:	P
Area:	82,525 SqFt	Length:	2,255 Ft	Width:	35 Ft				
Slabs:		Slab Length:	Ft	Slab Width:	Ft	Joint Length:	Ft		
Shoulder:		Street Type:		Grade:	0	Lanes:	0		
Section Comments:									
Last Insp. Date:	7/16/2019	TotalSamples:	23	Surveyed:	4				
Conditions:	PCI: 78								
Inspection Comments:									
Sample Number:	202	Type:	R	Area:	3500.00 SqFt	PCI:	77		
Sample Comments: p235									
48	L & T CR	L	194.00	Ft					
48	L & T CR	M	11.00	Ft					
57	WEATHERING	L	400.00	SqFt					
Sample Number:	207	Type:	R	Area:	3500.00 SqFt	PCI:	78		
Sample Comments:									
48	L & T CR	L	193.00	Ft					
48	L & T CR	M	12.00	Ft					
57	WEATHERING	L	300.00	SqFt					
Sample Number:	212	Type:	R	Area:	3500.00 SqFt	PCI:	78

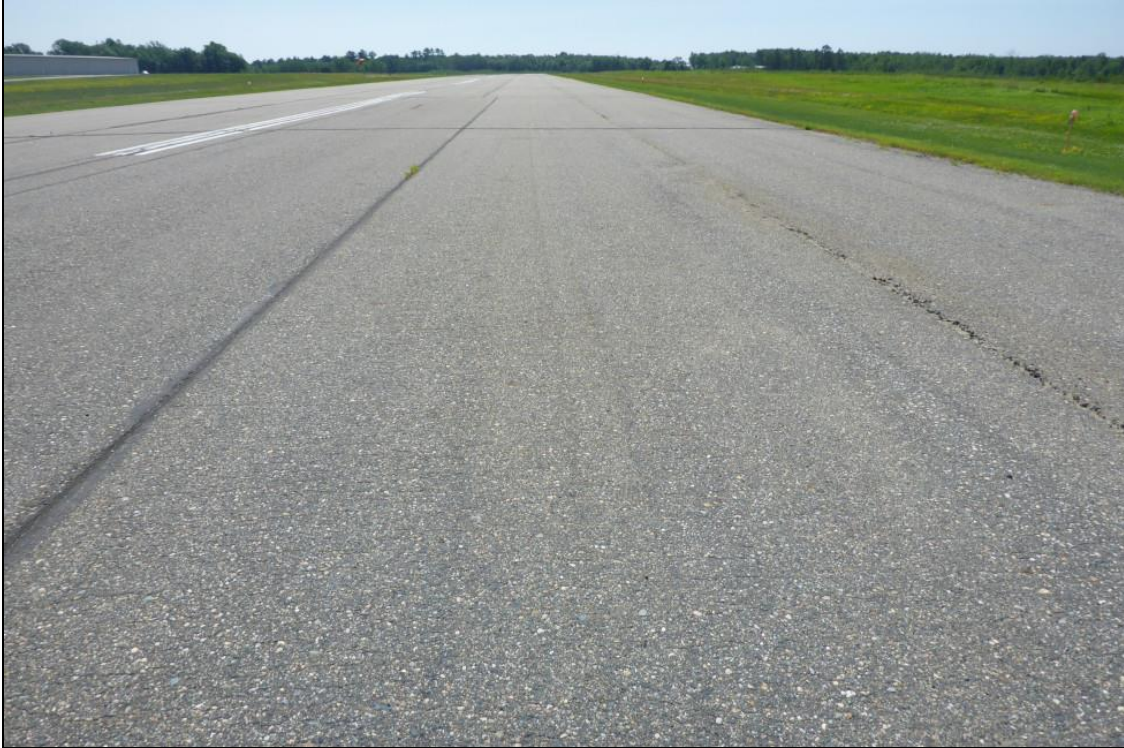
Y49 RY1533 001 (PCI = 67)

Network:	Y49	Name:	WALKER						
Branch:	RY1533	Name:	RUNWAY 15-33	Use:	RUNWAY	Area:	246,500 SqFt		
Section:	001	of 1	From:	100	To:	164	Last Const.: 6/20/2008		
Surface:	AC	Family:	MN2018 Asphalt Runway- Taxiways	Zone:	N	Category:	3	Rank:	P
Area:	246,500 SqFt	Length:	3,220 Ft	Width:	75 Ft				
Slabs:		Slab Length:	Ft	Slab Width:	Ft	Joint Length:	Ft		
Shoulder:		Street Type:		Grade:	0	Lanes:	0		
Section Comments:									
Last Insp. Date:	7/16/2019	TotalSamples:	65	Surveyed:	8				
Conditions:	PCI: 67								
Inspection Comments:									
Sample Number:	104	Type:	R	Area:	3750.00 SqFt	PCI:	70		
Sample Comments: pic 723									
48	L & T CR	L	236.00	Ft					
48	L & T CR	M	37.00	Ft					
48	L & T CR	H	8.00	Ft					
57	WEATHERING	L	1000.00	SqFt					
Sample Number:	113	Type:	R	Area:	3750.00 SqFt	PCI:	75		
Sample Comments:									
48	L & T CR	L	108.00	Ft					
48	L & T CR	M	67.00	Ft					
57	WEATHERING	L	3000.00	SqFt					
Sample Number:	122	Type:	R	Area:	3750.00 SqFt	PCI:	70

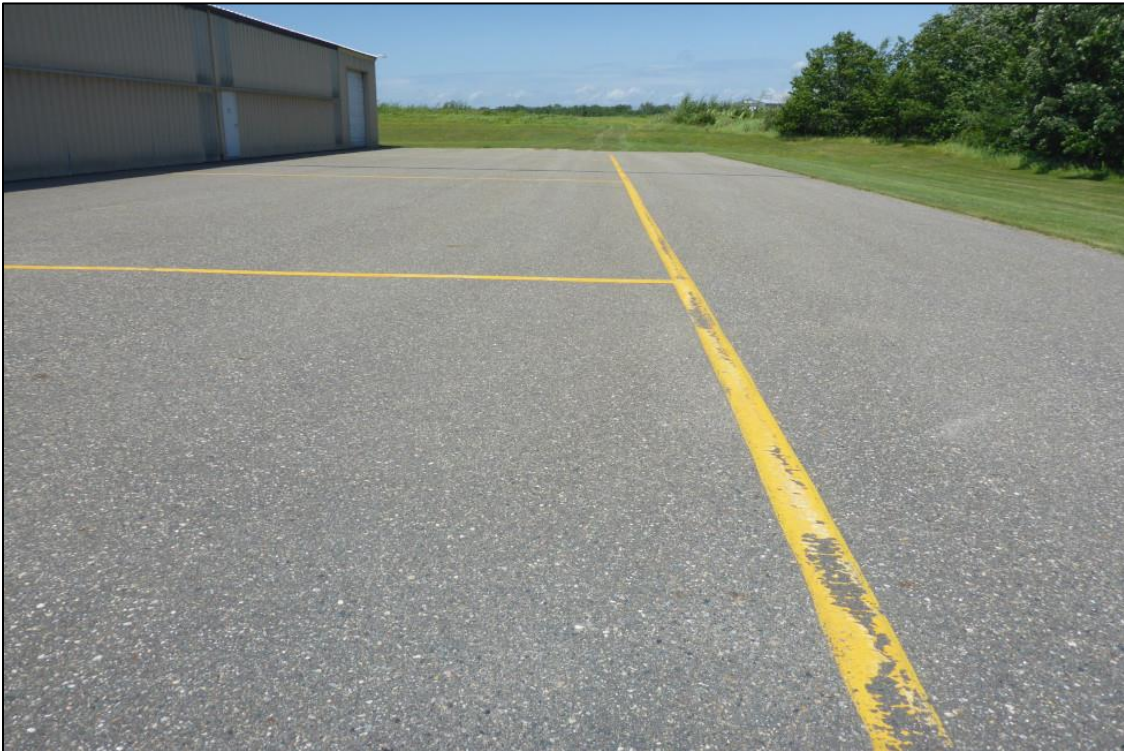
Y49 TLA 001 (PCI = 80)

Conditions: PCI: 80

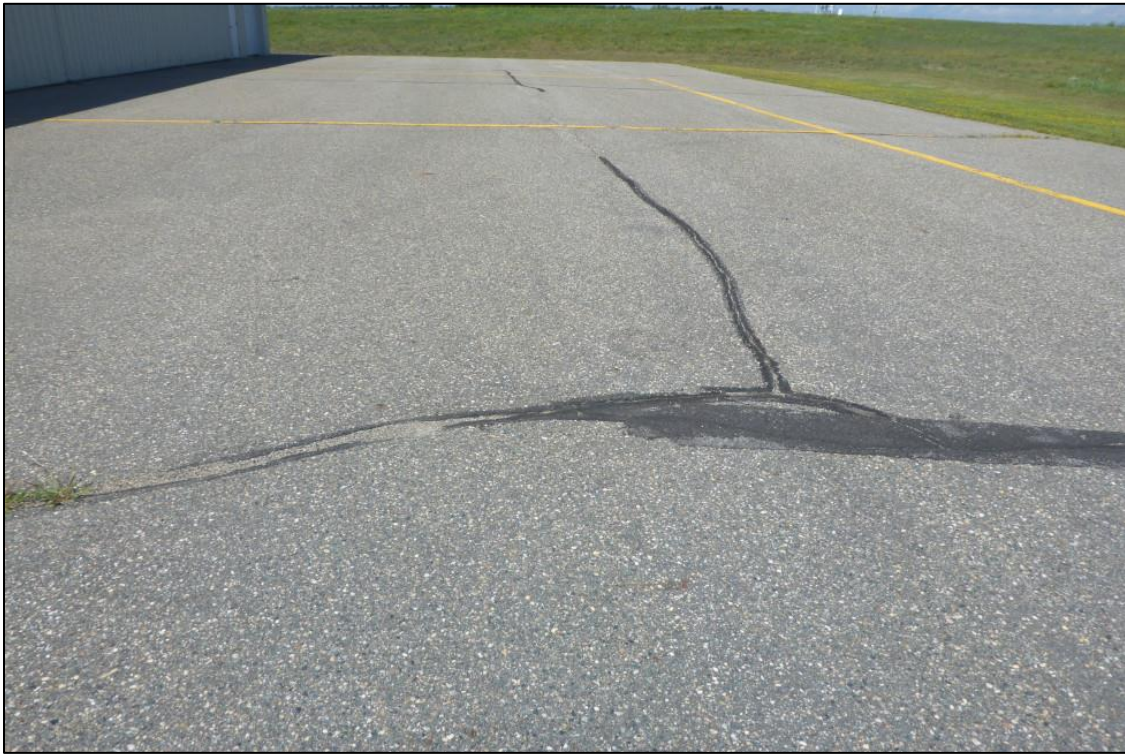
Y49 TLA 002 (PCI = 61)

Conditions: PCI: 61
