Pavement Condition Report

Red Wing Regional Airport (RGK)

December 2017

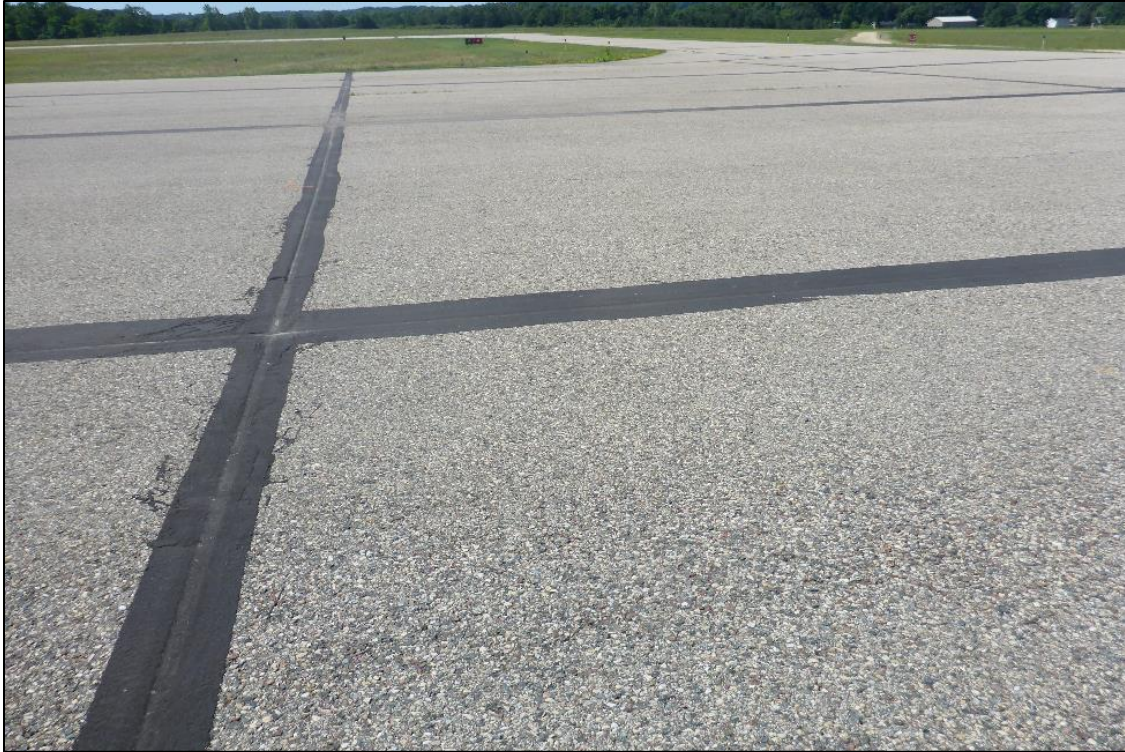
RGK APA 004 (PCI = 70)

Network:	RGK	Name:	RED WING						
Branch:	APA	Name:	APRON A	Use:	APRON	Area:	207,250 SqFt		
Section:	004	of 5	From:	100	To:	301	Last Const.:	9/30/2000	
Surface:	AC	Family:	MN2013 Asphalt Aprons	Zone:	S	Category:	1	Rank:	S
Area:	33,000 SqFt	Length:	150 Ft	Width:	220 Ft				
Slabs:	Slab Length:	Ft	Slab Width:	Ft	Joint Length:	Ft			
Shoulder:	Street Type:		Grade:	0	Lanes:	0			
Section Comments:									
Last Insp. Date:	6/23/2017	TotalSamples:	7	Surveyed:	2				
Conditions:	PCI: 70								
Inspection Comments:									
Sample Number:	101	Type:	R	Area:	5000.00 SqFt	PCI:	69		
Sample Comments:									
52	RAVELING	L	100.00	SqFt					
57	WEATHERING	M	2000.00	SqFt					
48	L & T CR	M	60.00	Ft					
48	L & T CR	L	310.00	Ft					
Sample Number:	200	Type:	R	Area:	5000.00 SqFt	PCI:	71		
Sample Comments:									
57	WEATHERING	L	2000.00	SqFt					
48	L & T CR	L	378.00	Ft					
48	L & T CR	M	24.00	Ft

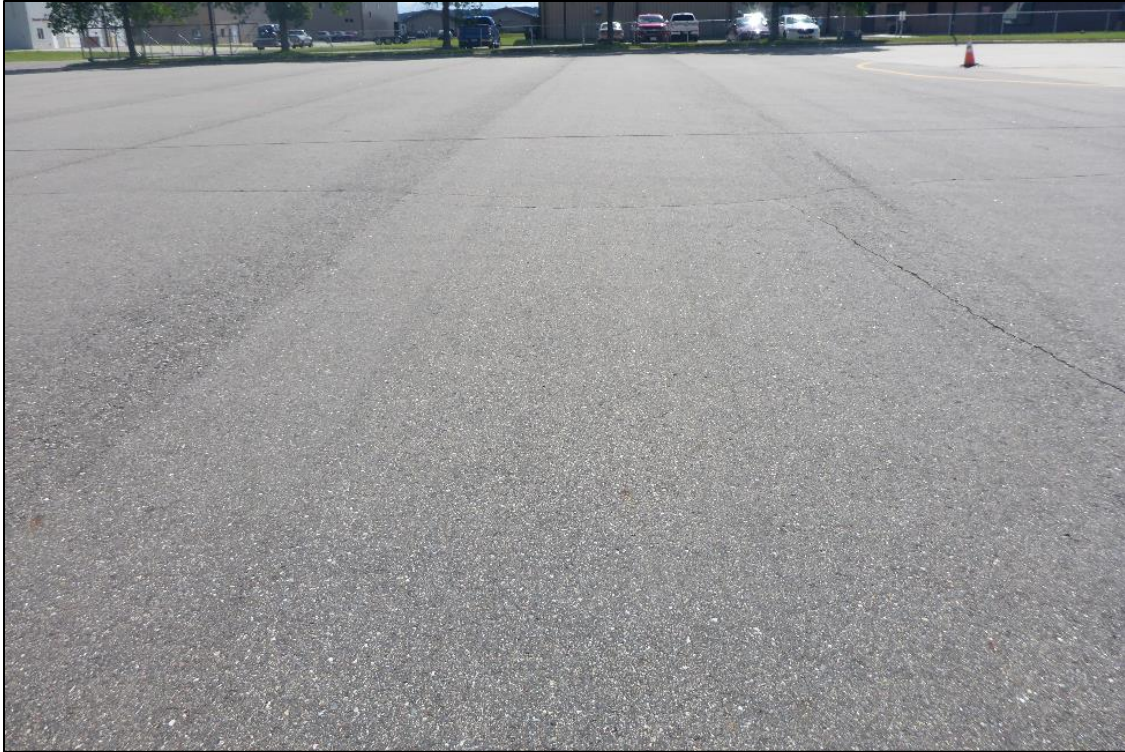
RGK APB 001 (PCI = 89)

Network:	RGK	Name:	RED WING						
Branch:	APB	Name:	APRON B	Use:	APRON	Area:	61,650 SqFt		
Section:	001	of 3	From:	507	To:	1011	Last Const.:	8/30/2013	
Surface:	AAC	Family:	MN2013 Asphalt Aprons	Zone:	S	Category:	1	Rank:	S
Area:	28,600 SqFt	Length:	230 Ft	Width:	130 Ft				
Slabs:	Slab Length:	Ft	Slab Width:	Ft	Joint Length:	Ft			
Shoulder:	Street Type:		Grade:	0	Lanes:	0			
Section Comments:									
Last Insp. Date:	6/23/2017	TotalSamples:	7	Surveyed:	2				
Conditions:	PCI: 89								
Inspection Comments:									
Sample Number:	102	Type:	R	Area:	5000.00 SqFt	PCI:	94		
Sample Comments:									
48	L & T CR	L	73.00	Ft					
Sample Number:	203	Type:	R	Area:	5000.00 SqFt	PCI:	84		
Sample Comments:									
50	PATCHING	L	236.00	SqFt					
48	L & T CR	L	172.00	Ft

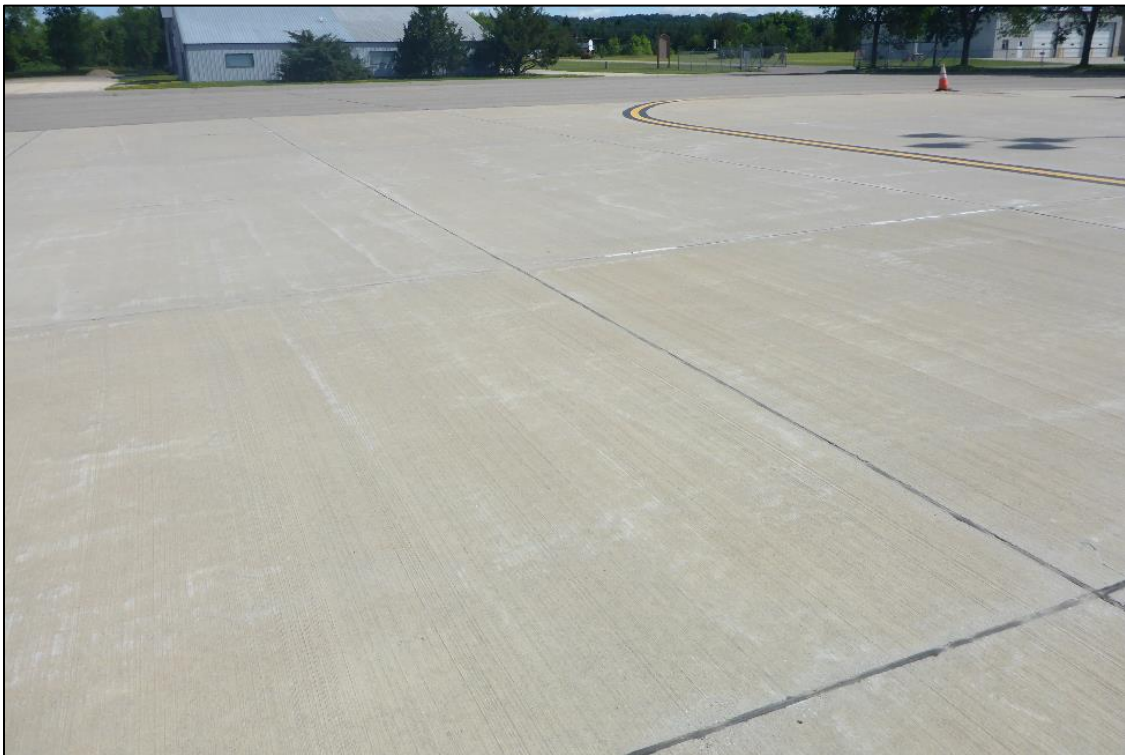
RGK APB 002 (PCI = 98)

Network:	RGK	Name:	RED WING						
Branch:	APB	Name:	APRON B	Use:	APRON	Area:	61,650 SqFt		
Section:	002	of 3	From:	100	To:	201	Last Const.:	9/30/2011	
Surface:	PCC	Family:	MN2013 PCC	Zone:	S	Category:	1	Rank:	S
Area:	16,400 SqFt	Length:	164 Ft	Width:	100 Ft				
Slabs:	112	Slab Length:	12 Ft	Slab Width:	13 Ft	Joint Length:	2,415 Ft		
Shoulder:		Street Type:		Grade:	0	Lanes:	0		
Section Comments:									
Last Insp. Date:	6/23/2017	TotalSamples:	4	Surveyed:	2				
Conditions:	PCI: 98								
Inspection Comments:									
Sample Number:	100	Type:	R	Area:	28.00 Slabs	PCI:	99		
Sample Comments:									
74	JOINT SPALL	L	1.00	Slabs					
Sample Number:	201	Type:	R	Area:	28.00 Slabs	PCI:	97		
Sample Comments:									
75	CORNER SPALL	M	1.00	Slabs

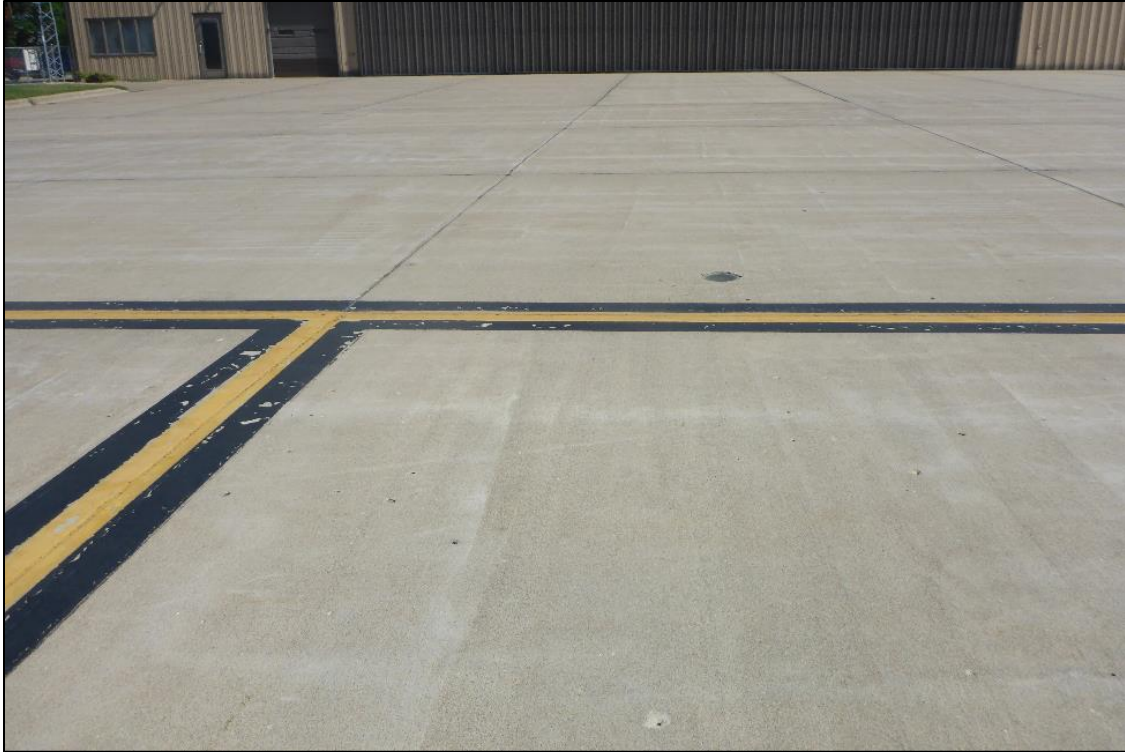
RGK APC 001 (PCI = 83)

Network:	RGK	Name:	RED WING						
Branch:	APC	Name:	APRON AREA C	Use:	APRON	Area:	227,050 SqFt		
Section:	001	of 4	From:	200	To:	303	Last Const.:	9/30/1990	
Surface:	PCC	Family:	MN2013 PCC	Zone:	S	Category:	1	Rank:	S
Area:	38,150 SqFt	Length:	315 Ft	Width:	60 Ft				
Slabs:	170	Slab Length:	15 Ft	Slab Width:	15 Ft	Joint Length:	2,145 Ft		
Shoulder:		Street Type:		Grade:	0	Lanes:	0		
Section Comments:									
Last Insp. Date:	6/23/2017	TotalSamples:	8	Surveyed:	3				
Conditions:	PCI: 83								
Inspection Comments:									
Sample Number:	100	Type:	R	Area:	24.00 Slabs	PCI:	83		
Sample Comments:									
74	JOINT SPALL	L	1.00	Slabs					
75	CORNER SPALL	L	1.00	Slabs					
75	CORNER SPALL	M	1.00	Slabs					
71	FAULTING	L	1.00	Slabs					
65	JT SEAL DMG	M	24.00	Slabs					
Sample Number:	200	Type:	R	Area:	19.00 Slabs	PCI:	80		
Sample Comments:									
75	CORNER SPALL	L	1.00	Slabs					
75	CORNER SPALL	M	1.00	Slabs

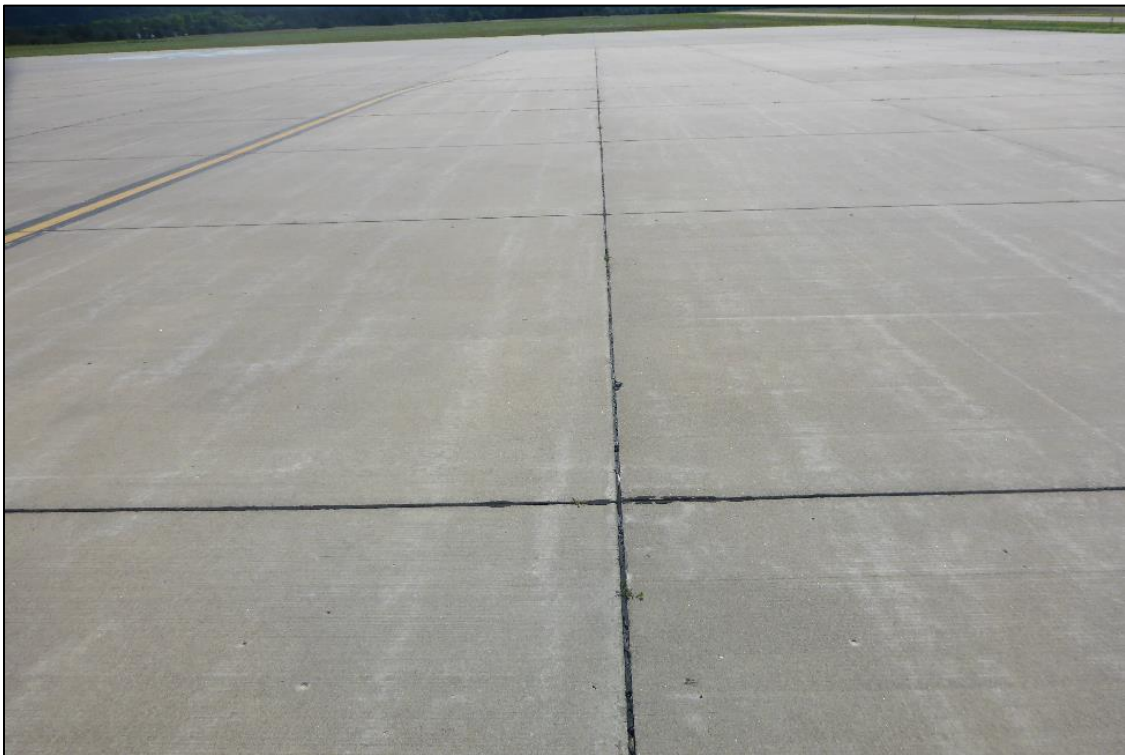
RGK APC 003 (PCI = 93)

Network:	RGK	Name:	RED WING						
Branch:	APC	Name:	APRON AREA C	Use:	APRON	Area:	227,050 SqFt		
Section:	003	of 4	From:	100	To:	311	Last Const.:	9/20/2000	
Surface:	PCC	Family:	MN2013 PCC	Zone:	S	Category:	1	Rank:	S
Area:	53,700 SqFt	Length:	200 Ft	Width:	200 Ft				
Slabs:	239	Slab Length:	15 Ft	Slab Width:	15 Ft	Joint Length:	4,933 Ft		
Shoulder:		Street Type:		Grade:	0	Lanes:	0		
Section Comments:									
Last Insp. Date:	6/23/2017	TotalSamples:	14	Surveyed:	5				
Conditions:	PCI: 93								
Inspection Comments:									
Sample Number:	100	Type:	R	Area:	28.00 Slabs	PCI:	95		
Sample Comments:									
75	CORNER SPALL	M	1.00	Slabs					
65	JT SEAL DMG	L	28.00	Slabs					
Sample Number:	101	Type:	R	Area:	11.00 Slabs	PCI:	95		
Sample Comments:									
74	JOINT SPALL	L	2.00	Slabs					
Sample Number:	108	Type:	R	Area:	21.00 Slabs	PCI:	89		
Sample Comments:									
65	JT SEAL DMG	M	21.00	Slabs					
75	CORNER SPALL	L	2.00	Slabs
