Pavement Condition Report

Grand Rapids - Itasca County Airport (GPZ)

December 2016

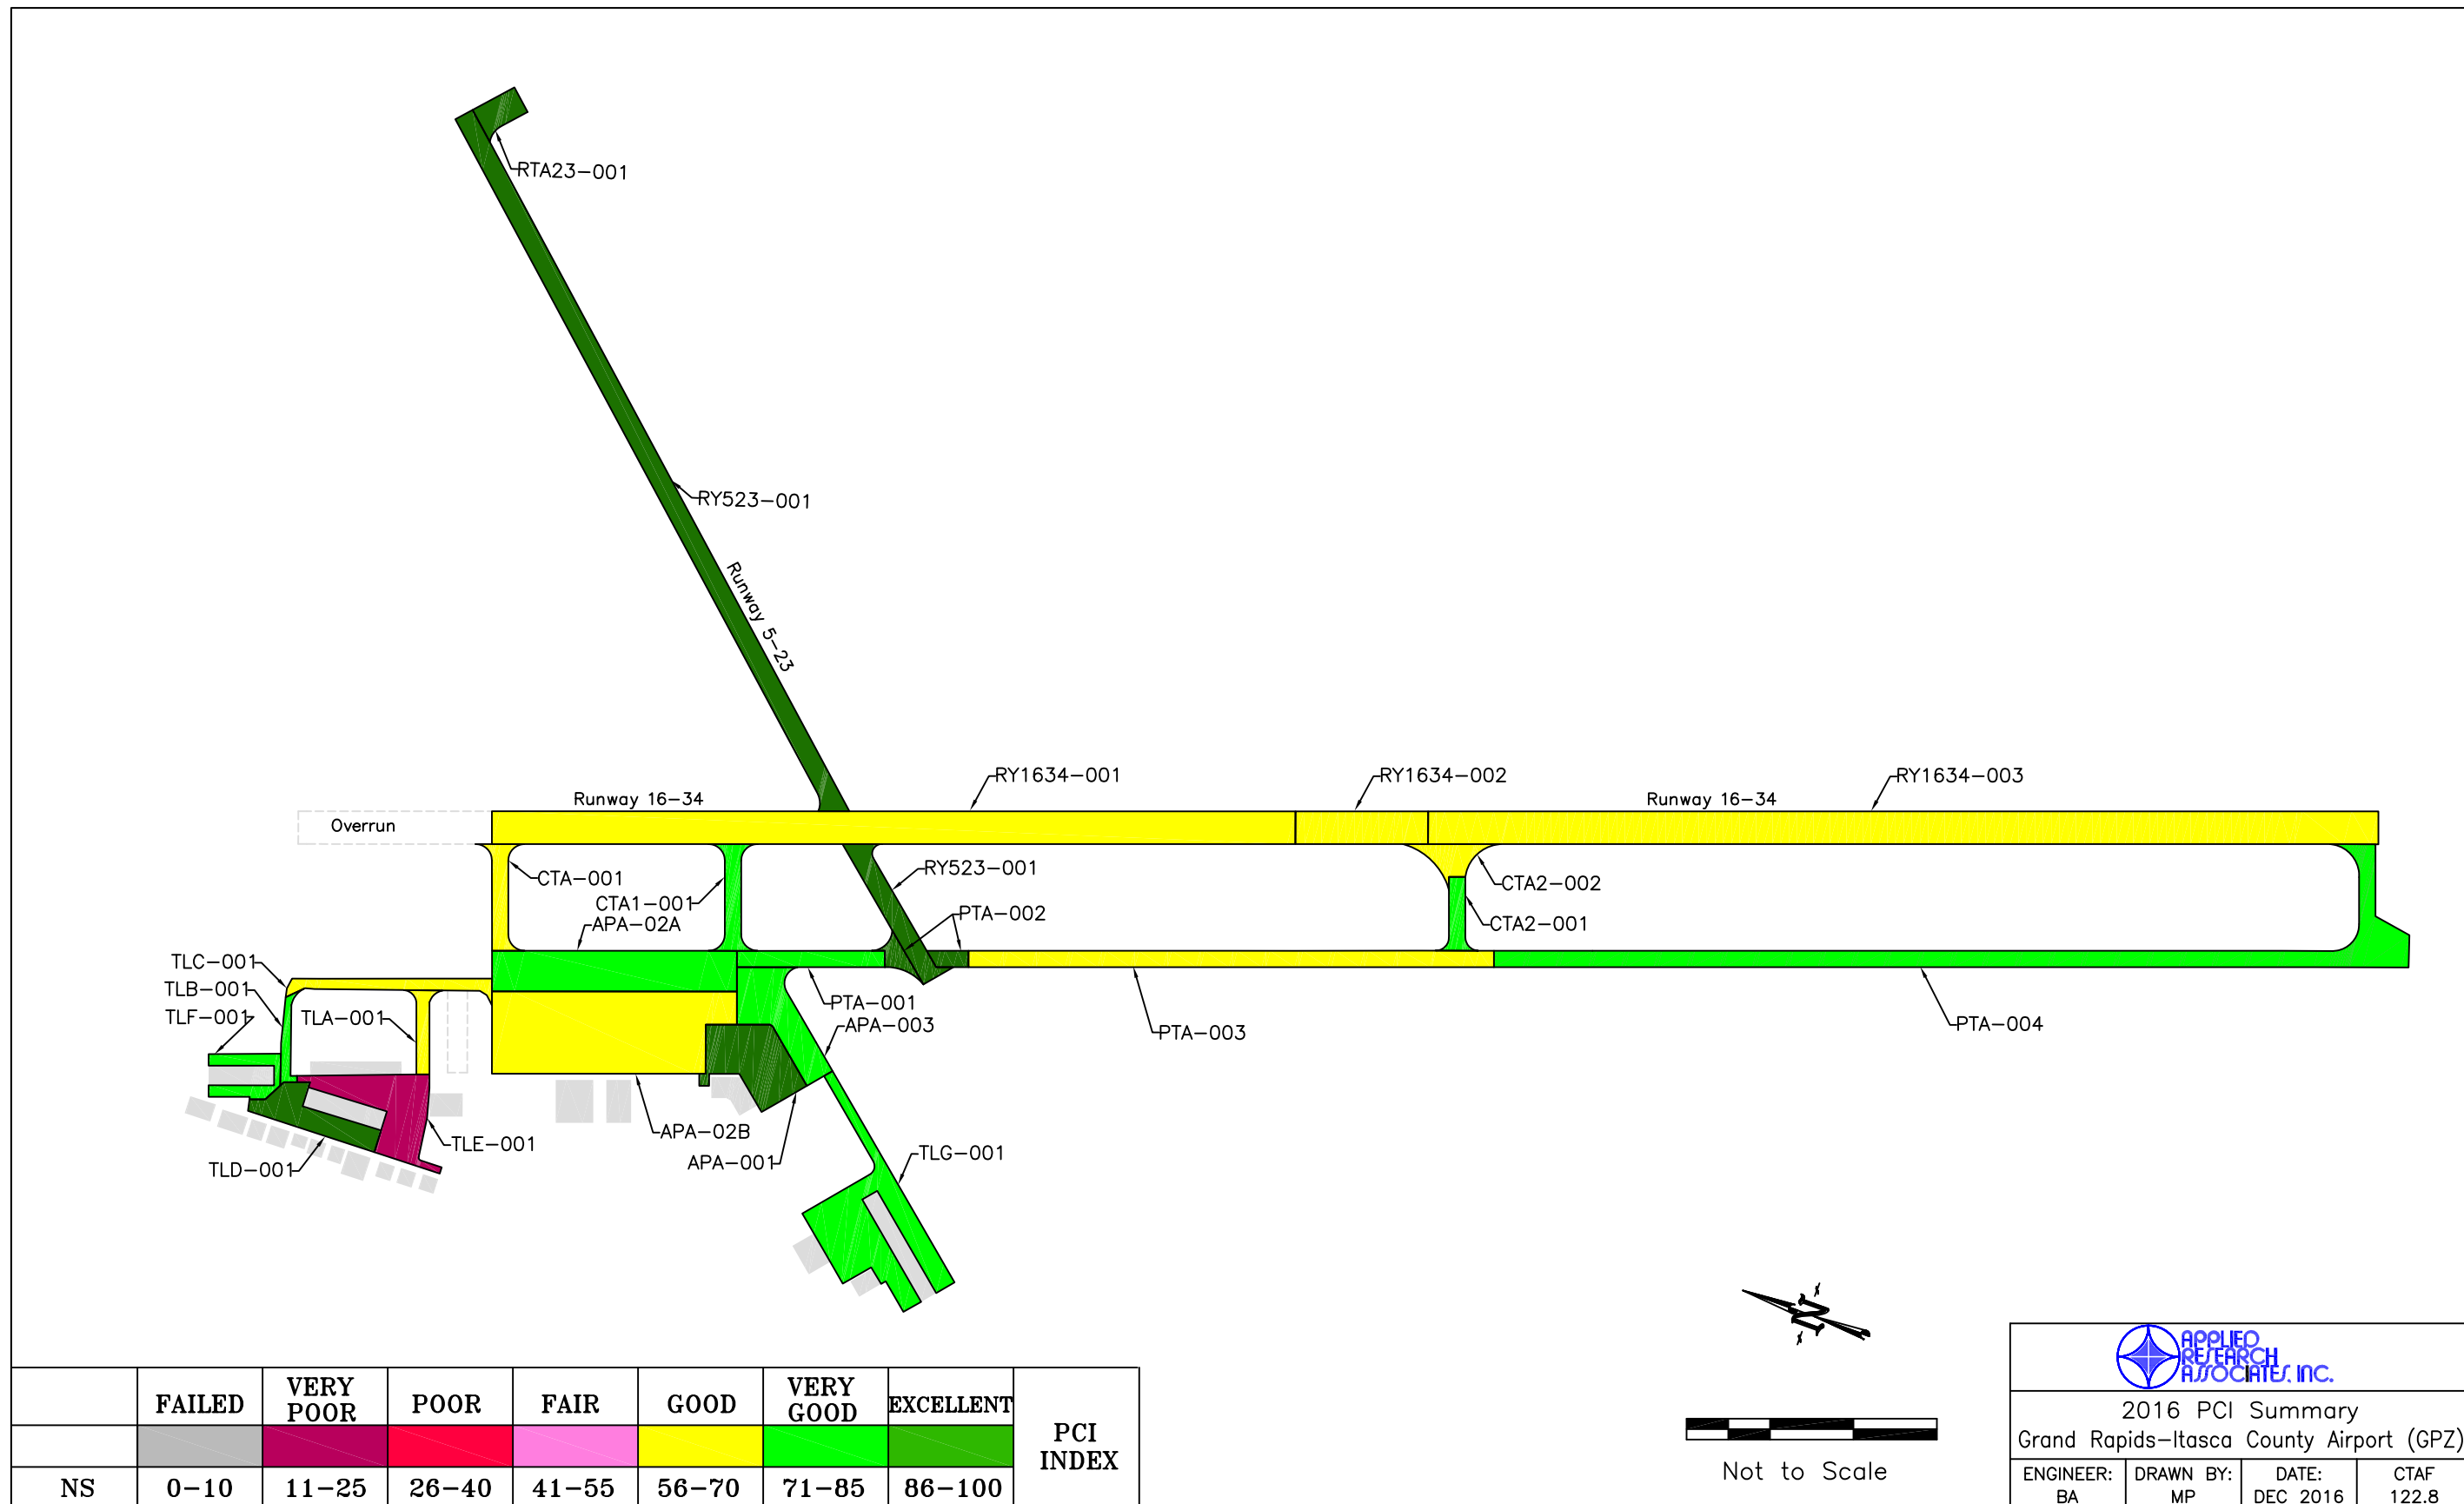
Figure 4. 2016 Pavement Condition Index Rating at Grand Rapids-Itasca County Airport (GPZ).

The results of the 2016 PCI inspection are presented in figure 4. The overall area-weighted, inspected PCI for GPZ is 69. When summarizing PCI values, an area-weighted calculation is used instead of a straight mathematical average because the area-weighted calculations eliminate the skewing of the PCI due to the disparity of the section sizes.

Maintenance such as crack sealing and patching occurred at the airport since the last inspection resulting in higher PCI values for some sections.
