Pavement Condition Report

Le Sueur Municipal Airport (12Y)

December 2017

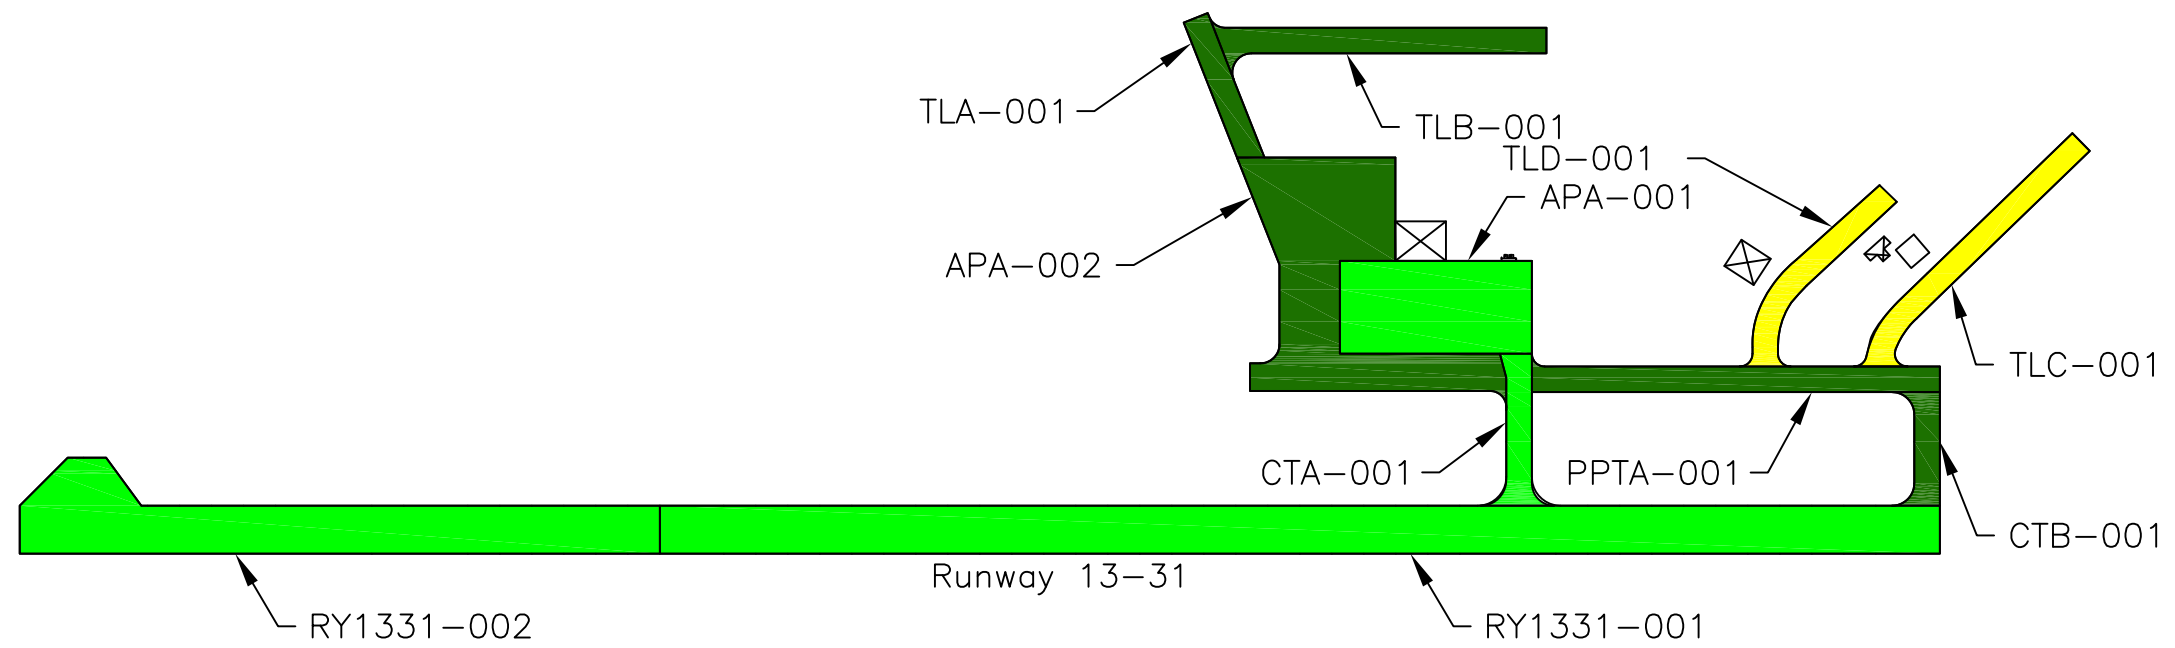
Figure 4. 2017 Pavement Condition Index Rating at Le Sueur Municipal Airport (12Y).

The results of the 2017 PCI inspection are presented in figure 4. The overall area-weighted, inspected PCI for 12Y is 82. When summarizing PCI values, an area-weighted calculation is used instead of a straight mathematical average because the area-weighted calculations eliminate the skewing of the PCI due to the disparity of the section sizes.
