Pavement Condition Report

Austin Municipal Airport (AUM)

December 2017

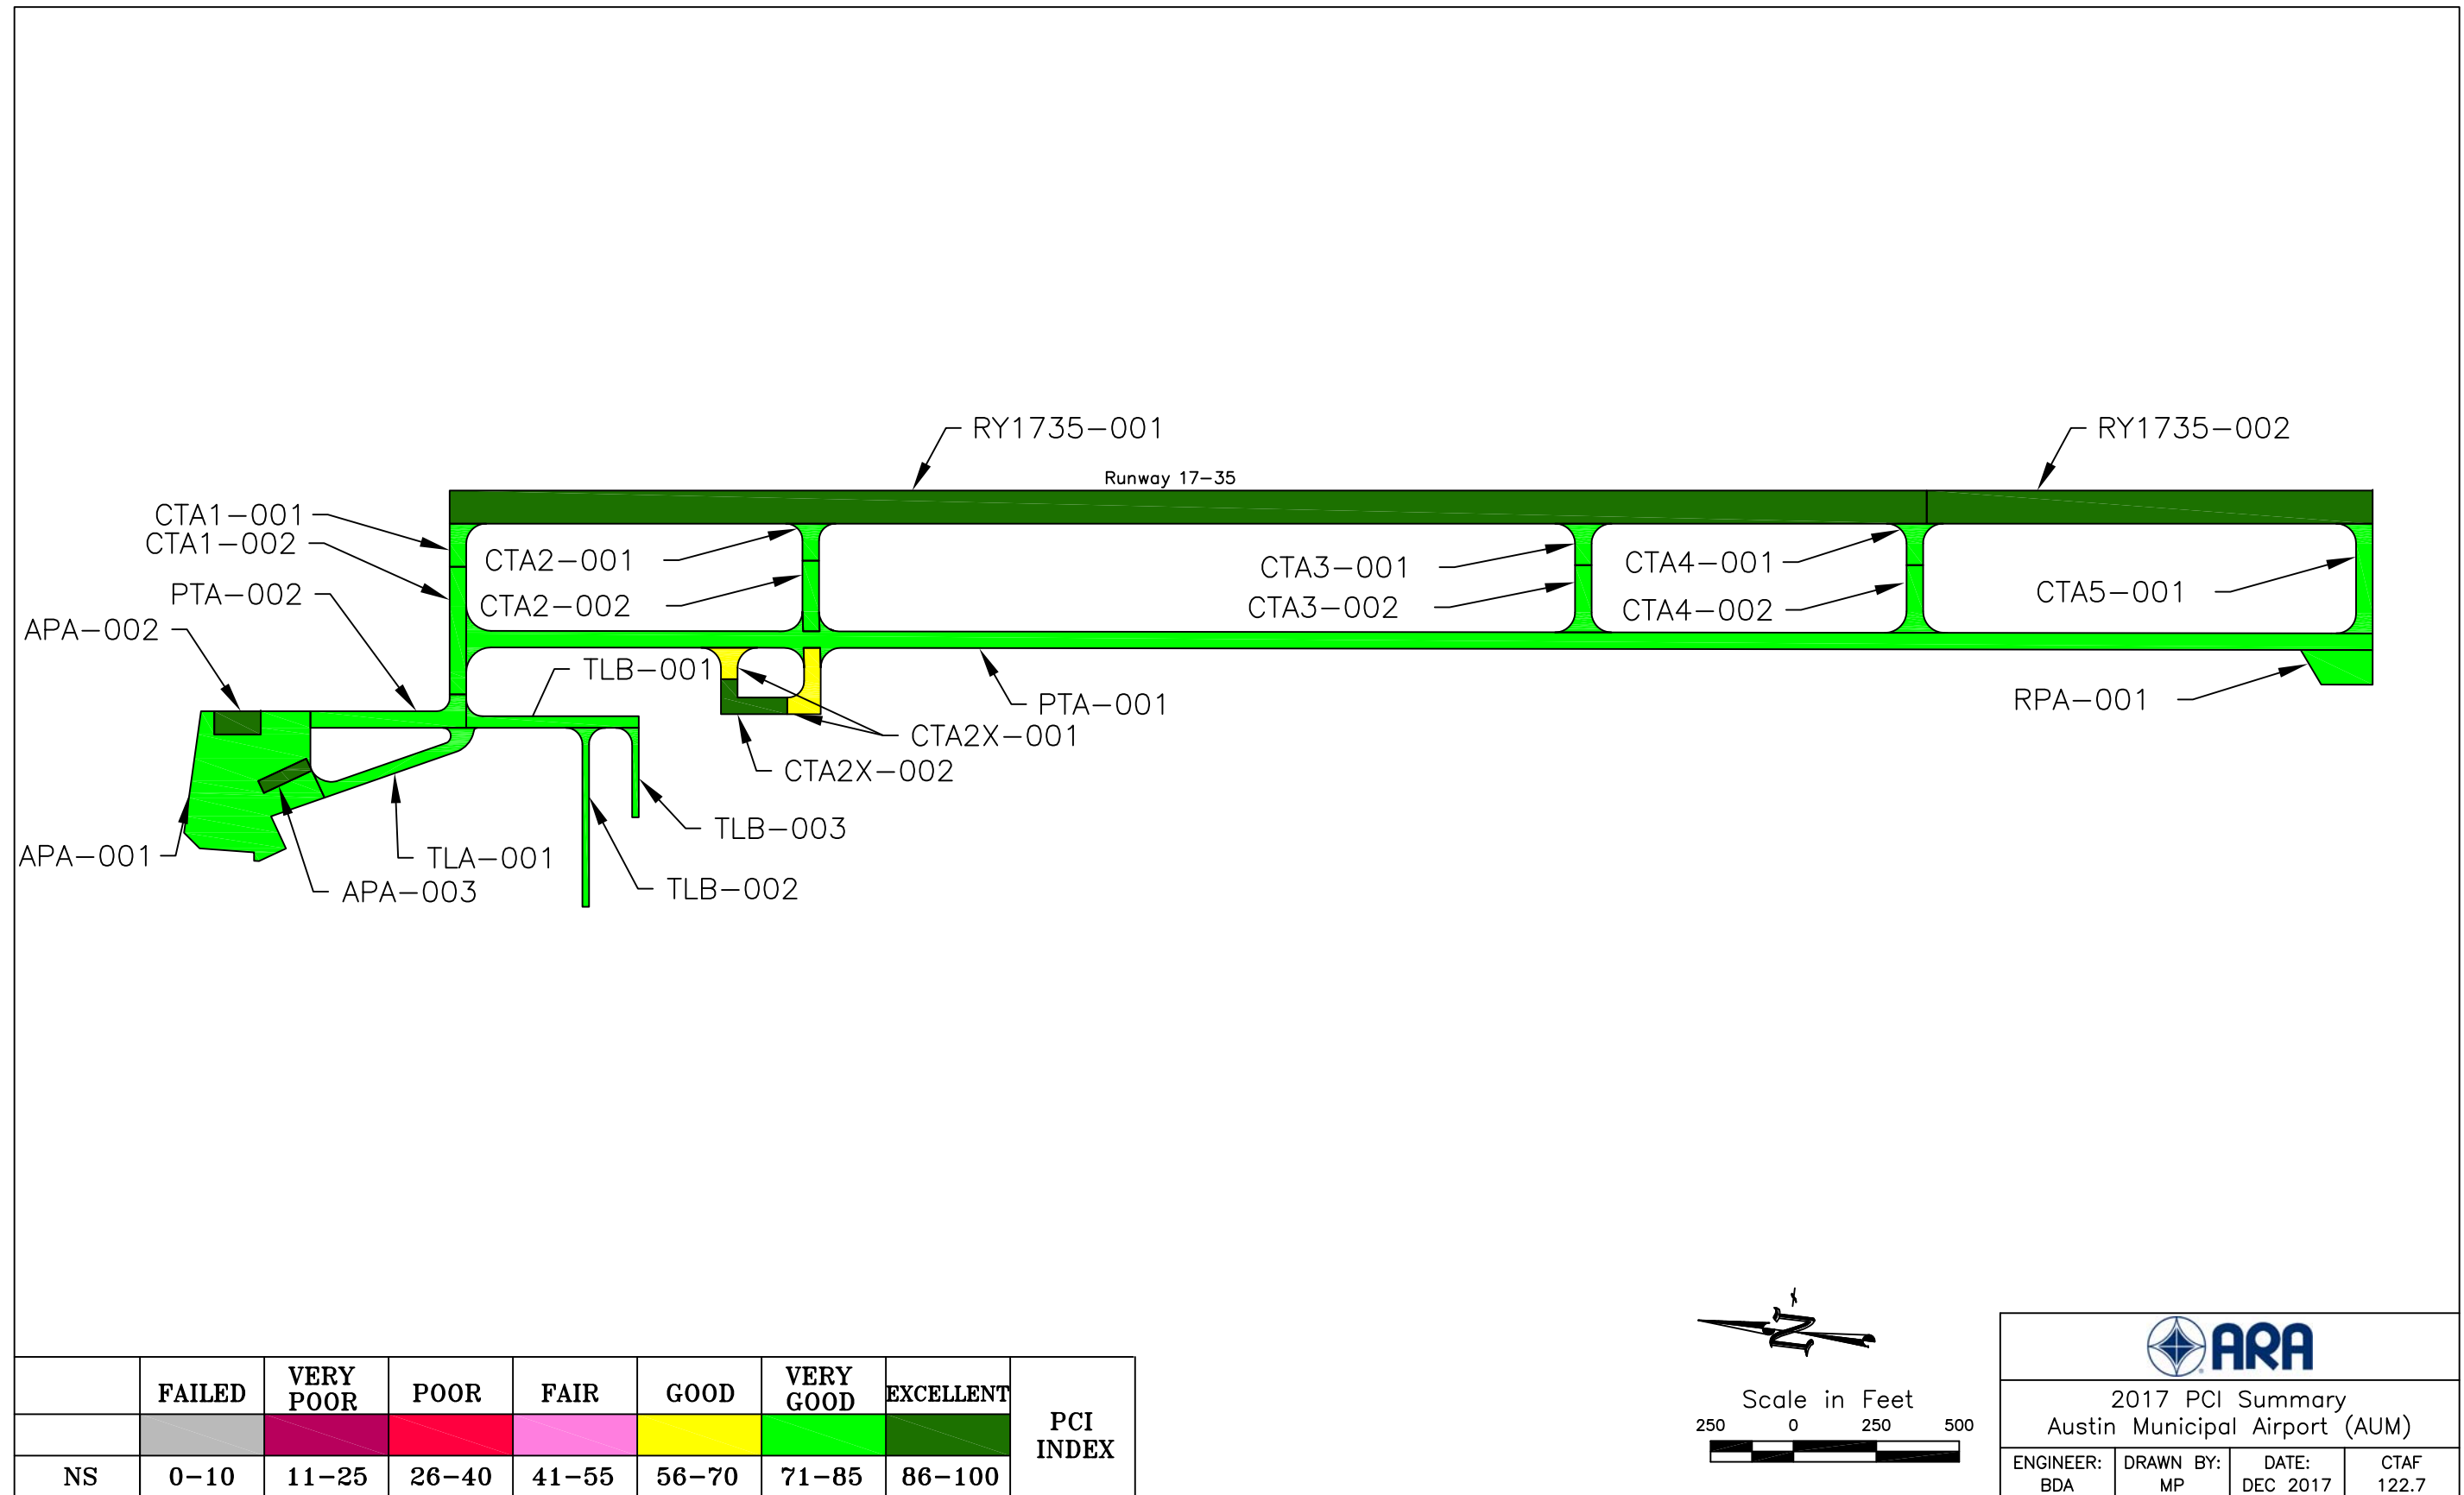
Figure 4. 2017 Pavement Condition Index Rating at Austin Municipal Airport (AUM).

The results of the 2017 PCI inspection are presented in figure 4. The overall area-weighted, inspected PCI for AUM is 84. When summarizing PCI values, an area-weighted calculation is used instead of a straight mathematical average because the area-weighted calculations eliminate the skewing of the PCI due to the disparity of the section sizes.
