Pavement Condition Report

Red Wing Regional Airport (RGK)

December 2017

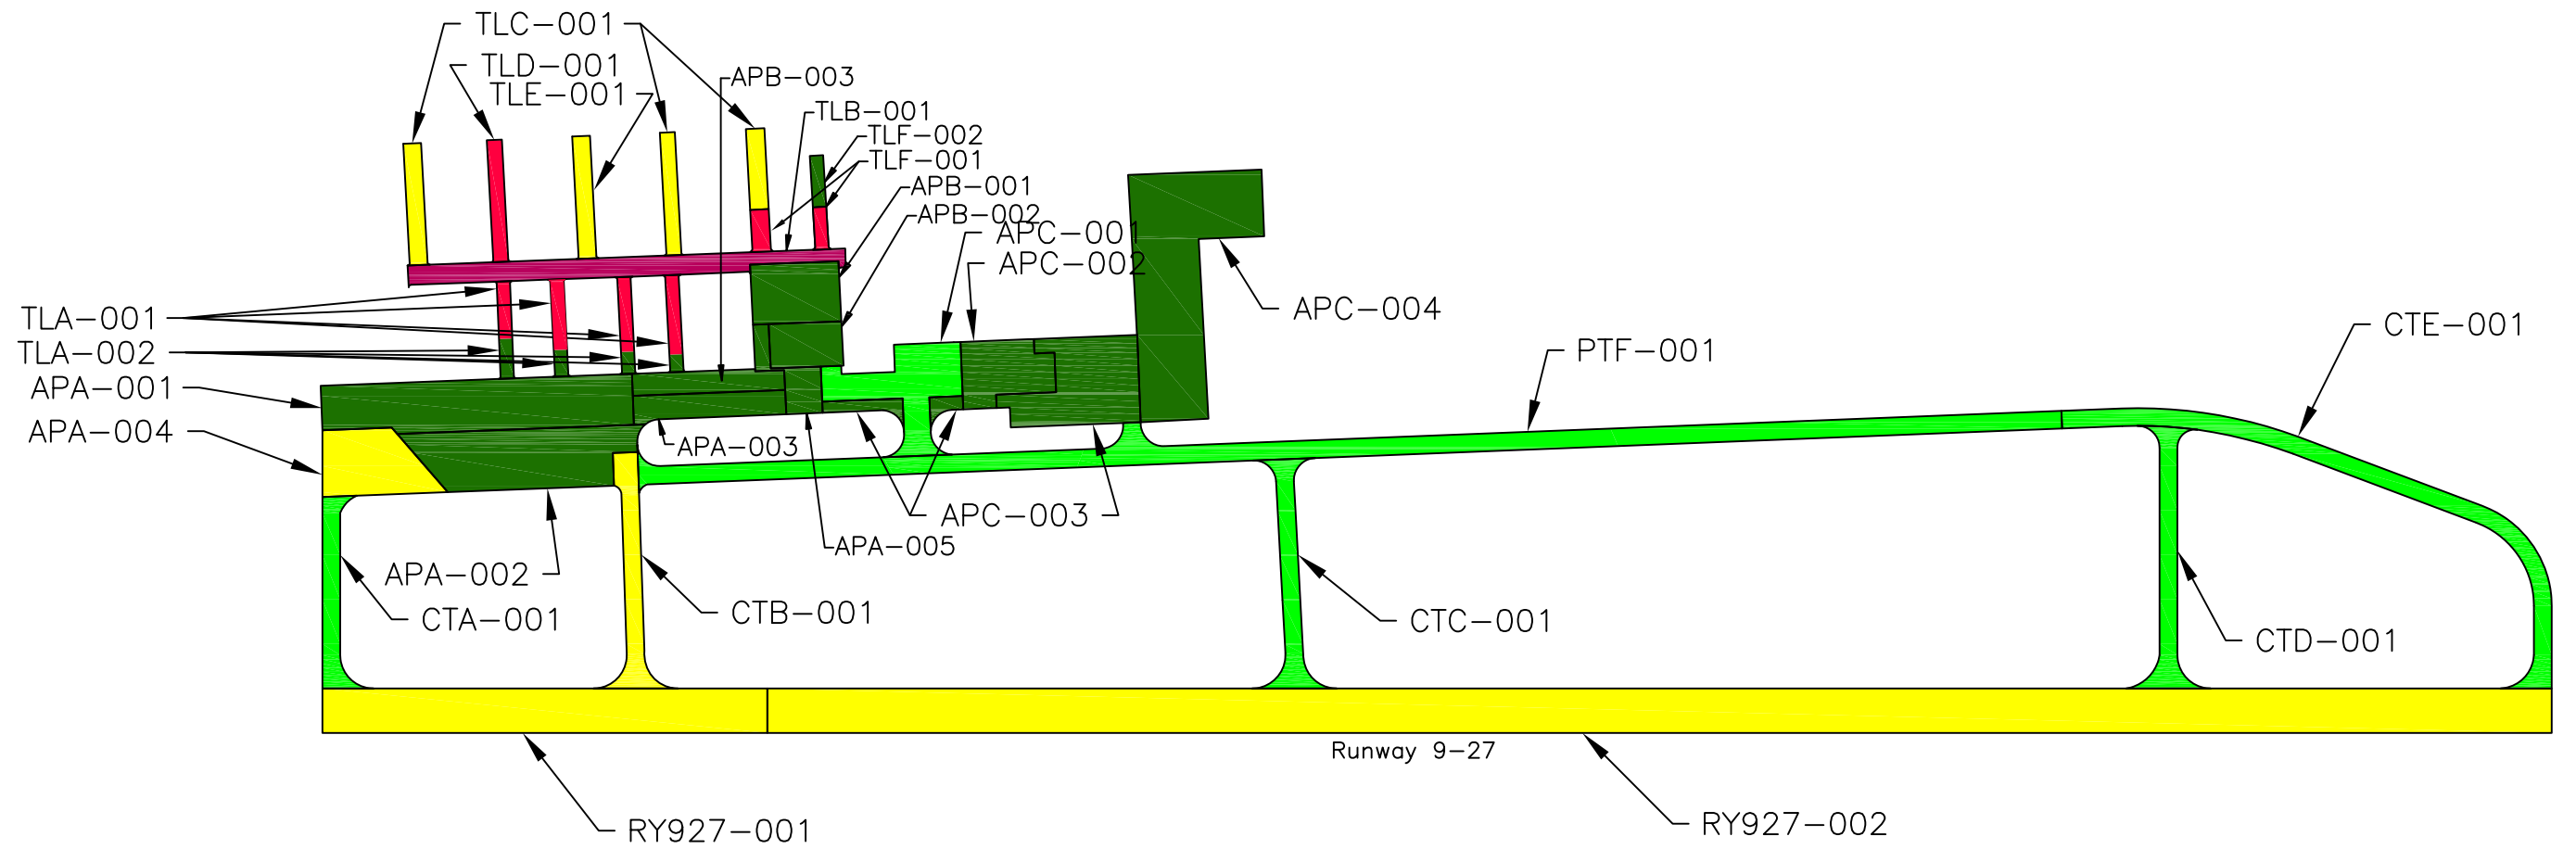
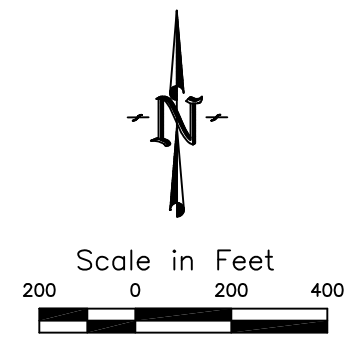
Figure 4. 2017 Pavement Condition Index Rating at Red Wing Regional Airport (RGK).

The results of the 2017 PCI inspection are presented in figure 4. The overall area-weighted, inspected PCI for RGK is 76. When summarizing PCI values, an area-weighted calculation is used instead of a straight mathematical average because the area-weighted calculations eliminate the skewing of the PCI due to the disparity of the section sizes.
