Pavement Condition Report

Brooten Municipal Airport (6D1)

December 2018

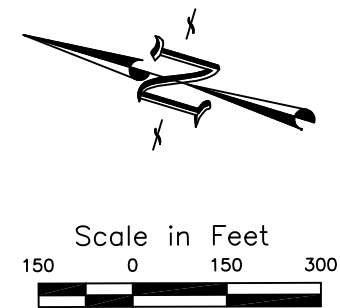
Figure 4. 2018 Pavement Condition Index Rating at Brooten Municipal Airport (6D1).

The results of the 2018 PCI inspection are presented in figure 4. The overall area-weighted, inspected PCI for 6D1 is 59. When summarizing PCI values, an area-weighted calculation is used instead of a straight mathematical average because the area-weighted calculations eliminate the skewing of the PCI due to the disparity of the section sizes.

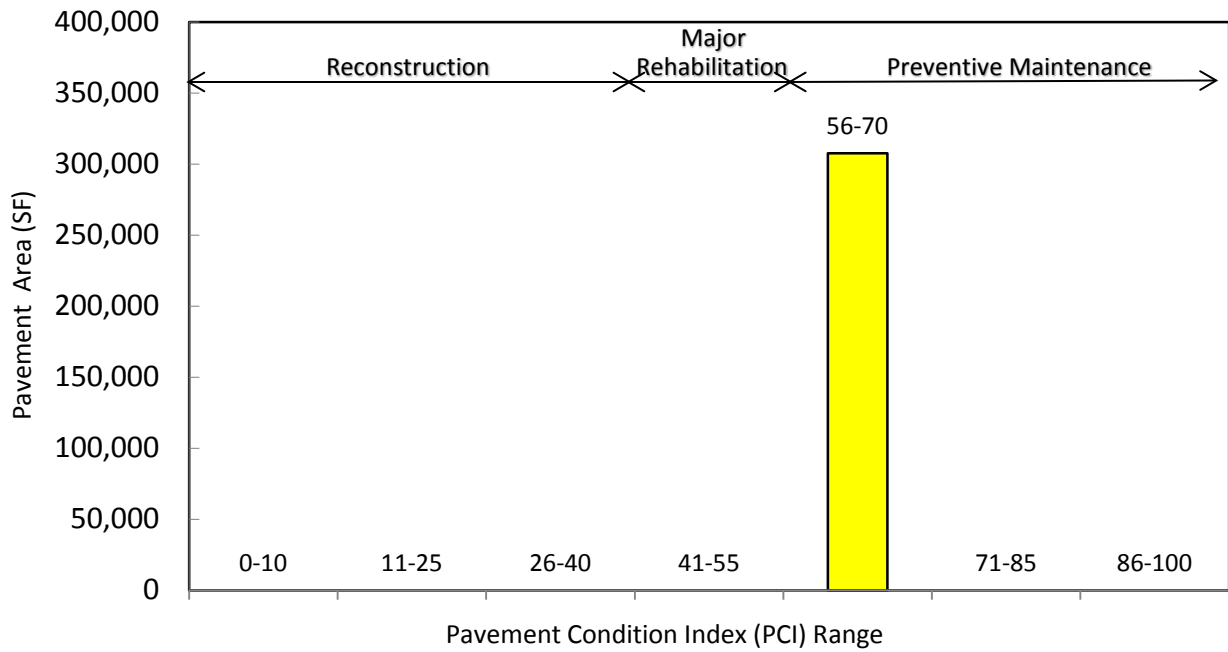
Figure 5. Condition distribution.

Figures 5 and 6 present the overall PCI for 6D1 by area distribution and pavement use, respectively. Table 3 presents the PCI summary for each section at 6D1, including the drop in PCI per year. Generally, pavement sections will deteriorate between 1 and 3 PCI points per year. Sections deteriorating at higher rates may need maintenance above the normal application rates and should be closely monitored in case major repairs become necessary earlier than expected.

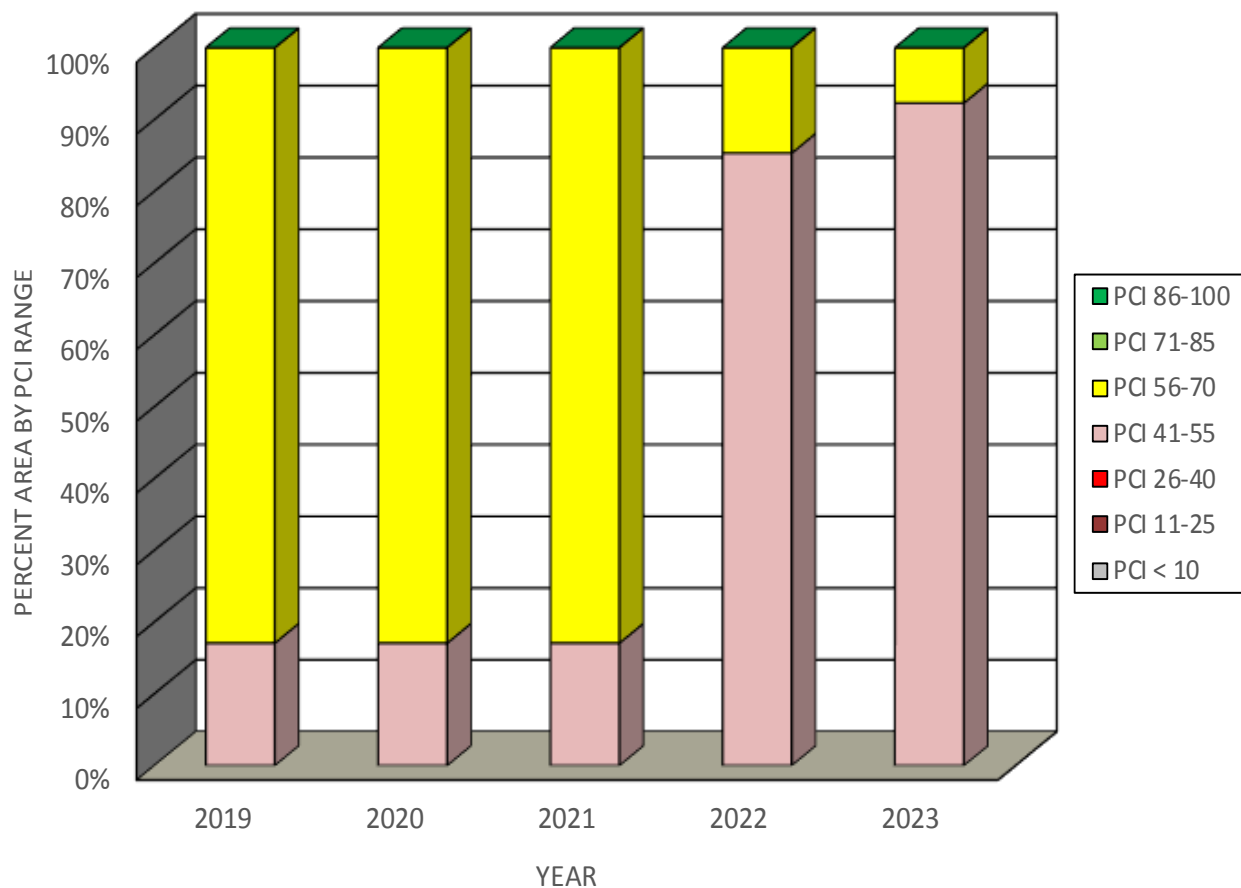
Figure 7. Projected PCI by percent area.

Figure 7 shows the projected PCI at 6D1 by percent area for the next 5 years assuming no major repairs (overlays, reconstruction, etc.) are performed during that period. It shows how quickly a pavement network can deteriorate when no capital improvements are made.
