# Pavement Condition Report

## Fertile Municipal Airport (D14)

Applied Research Associates, Inc.  
6314 Odana Rd  
Madison, WI 53719  
(608) 274-6409

**December 2018**

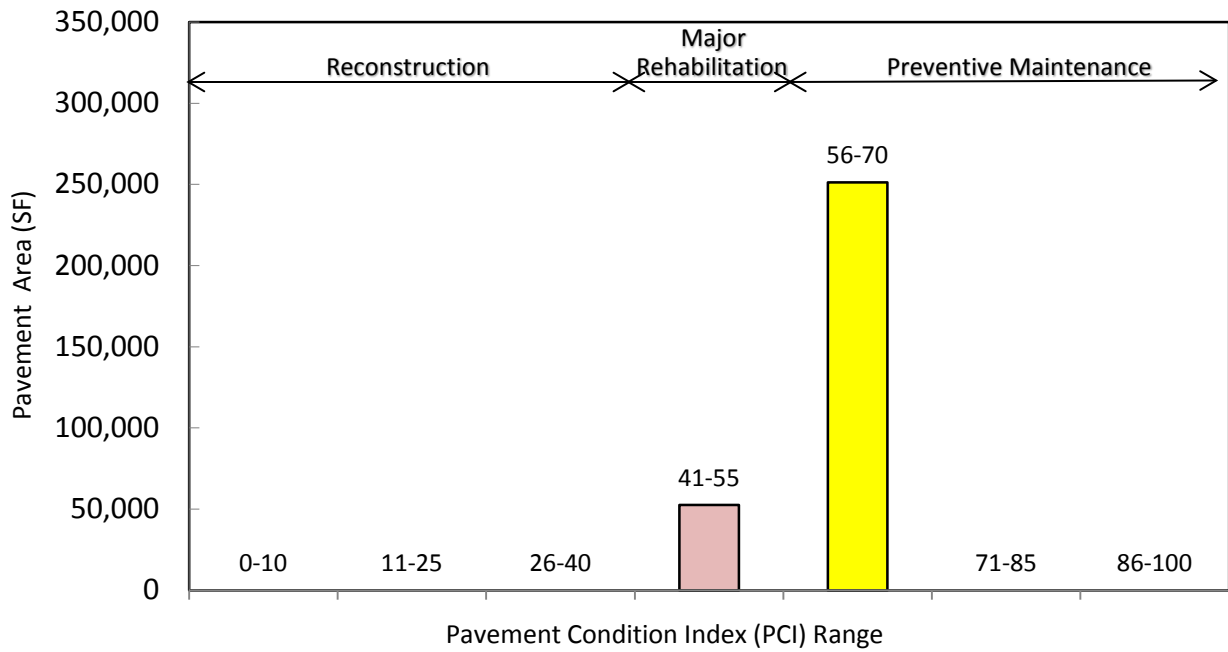
Figure 5. Condition distribution.

Figures 5 and 6 present the overall PCI for D14 by area distribution and pavement use, respectively. Table 3 presents the PCI summary for each section at D14, including the drop in PCI per year. Generally, pavement sections will deteriorate between 1 and 3 PCI points per year. Sections deteriorating at higher rates may need maintenance above the normal application rates and should be closely monitored in case major repairs become necessary earlier than expected.

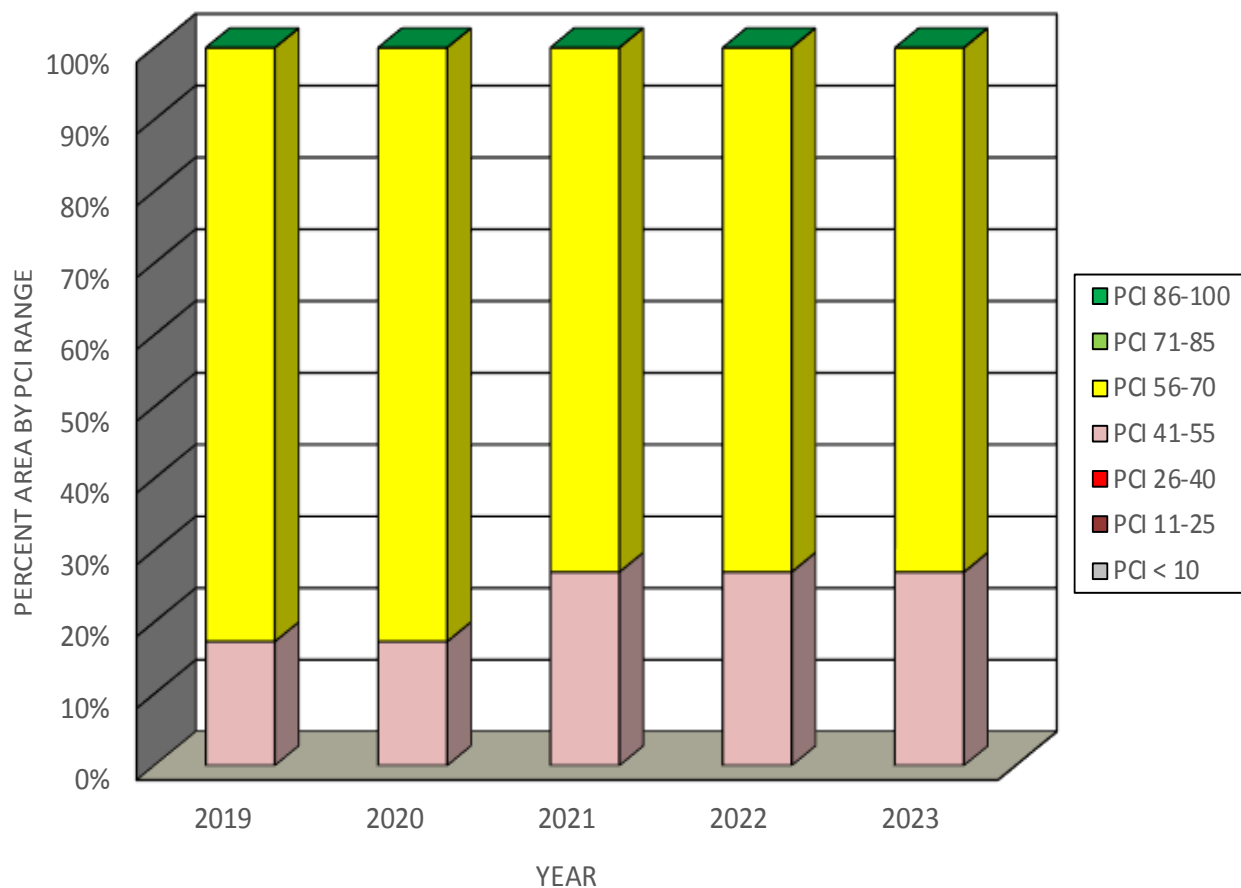
Figure 7. Projected PCI by percent area.

Figure 7 shows the projected PCI at D14 by percent area for the next 5 years assuming no major repairs (overlays, reconstruction, etc.) are performed during that period. It shows how quickly a pavement network can deteriorate when no capital improvements are made.
