Pavement Condition Report

Walker Municipal Airport (Y49)

December 2019

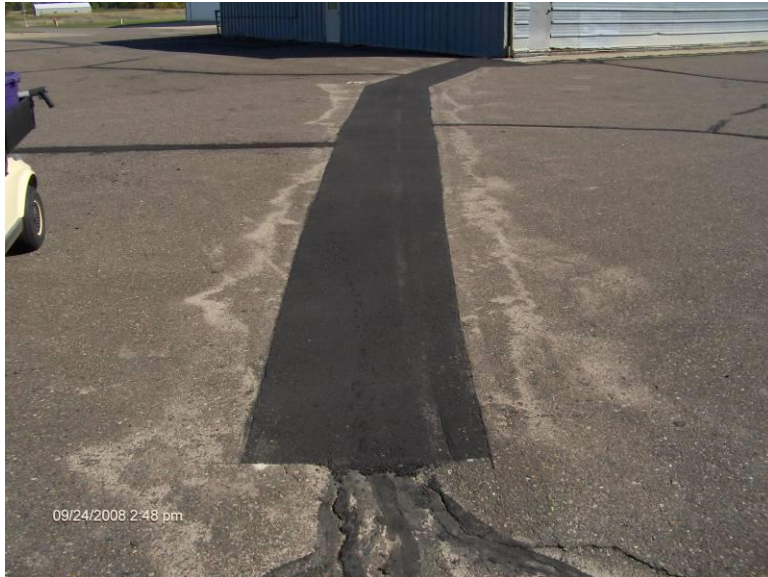
Example of Patching

Patched areas are defined when a portion of the original pavement is replaced with a material intended as a semi-permanent repair. A patch is documented as a defect because it is considered a break in the integrity of the pavement structure. Patches are constructed for a variety of reasons including utility repairs, correcting grade issues, and addressing a defect in the original pavement. The severity level of patches is determined by the amount of distress (i.e. cracking, depression, weathering/raveling, etc.) occurring within the limits of the patched area.

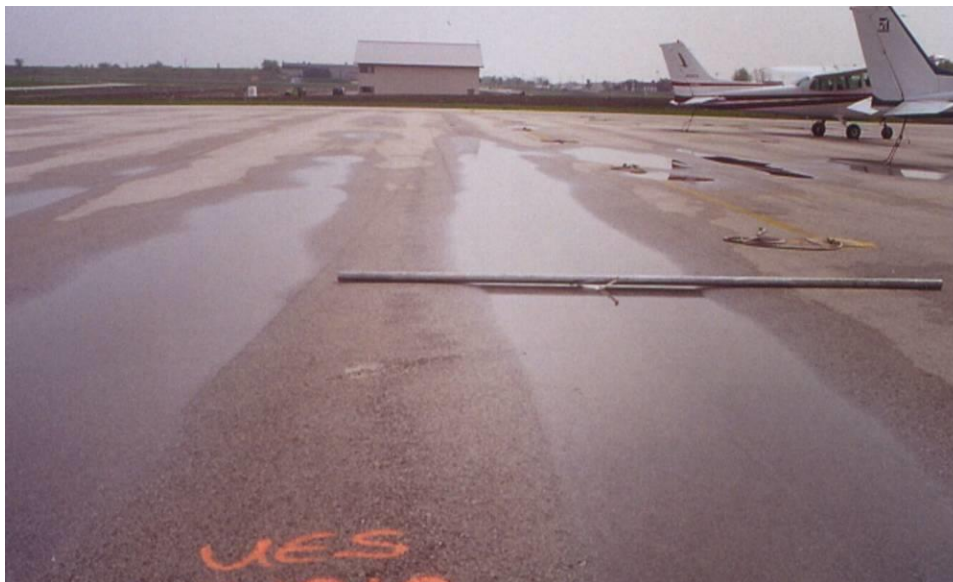
Example of Rutting

Ruts are localized, load related, areas of pavement having elevations lower than the surrounding sections. Rutting is due to base and subgrade consolidation, caused by excessive wheel loads or poor compaction. Ruts indicate structural failure, and can cause hydroplaning. At low severity, ruts have an

average depth of ¼ to ½ inches. At medium severity, ruts have an average depth of ½ to 1 inch. High severity, ruts have an average depth greater than 1 inch. Full-depth patching is the appropriate repair for ruts.

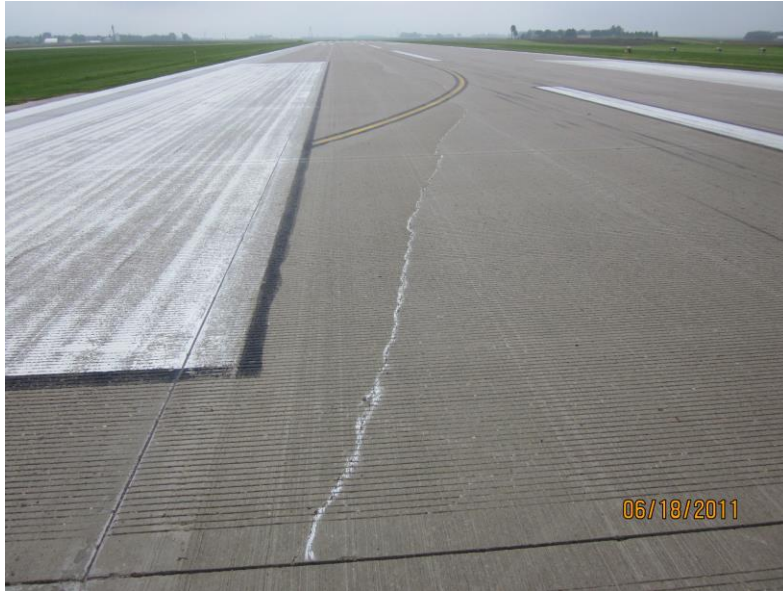
Example of Longitudinal, Transverse, and Diagonal Cracking

LTD cracking is most often a result of externally applied loads and/or constrained temperature deformations. External loads cause LTD cracking through flexure. Temperature changes on restrained slabs will result in stresses due to friction or curling. When any of these stresses exceed the strength of the slab, cracking will occur. LTD cracking is recorded at low, medium, or high severity, depending on the width of crack opening and degree of deterioration. At low severity, the crack is less than 1/8th inch wide with little spalling and no corrective action is indicated. At medium severity, LTD cracks can be up to 1 inch wide with moderate spalling, and should be repaired and sealed using procedures similar to joint sealing. At high severity, cracks exceed 1 inch in width and may be severely spalled. High-severity LTD cracking is evidence of serious load failure of the slab, and correction may require patching or slab replacement. If the distress occurs in several adjacent slabs at medium or high severity, major rehabilitation of that pavement area is indicated.

When a slab is divided by LTD cracks into four or more pieces, the slab is said to be "divided" or "shattered." Shattered slab is a separate distress category and is indicative of significant structural failure as the slab loses its ability to distribute loads to subgrade and further slab deterioration can be expected. Shattered slabs are rated in three severities, with slab replacement recommended for medium and high severities.

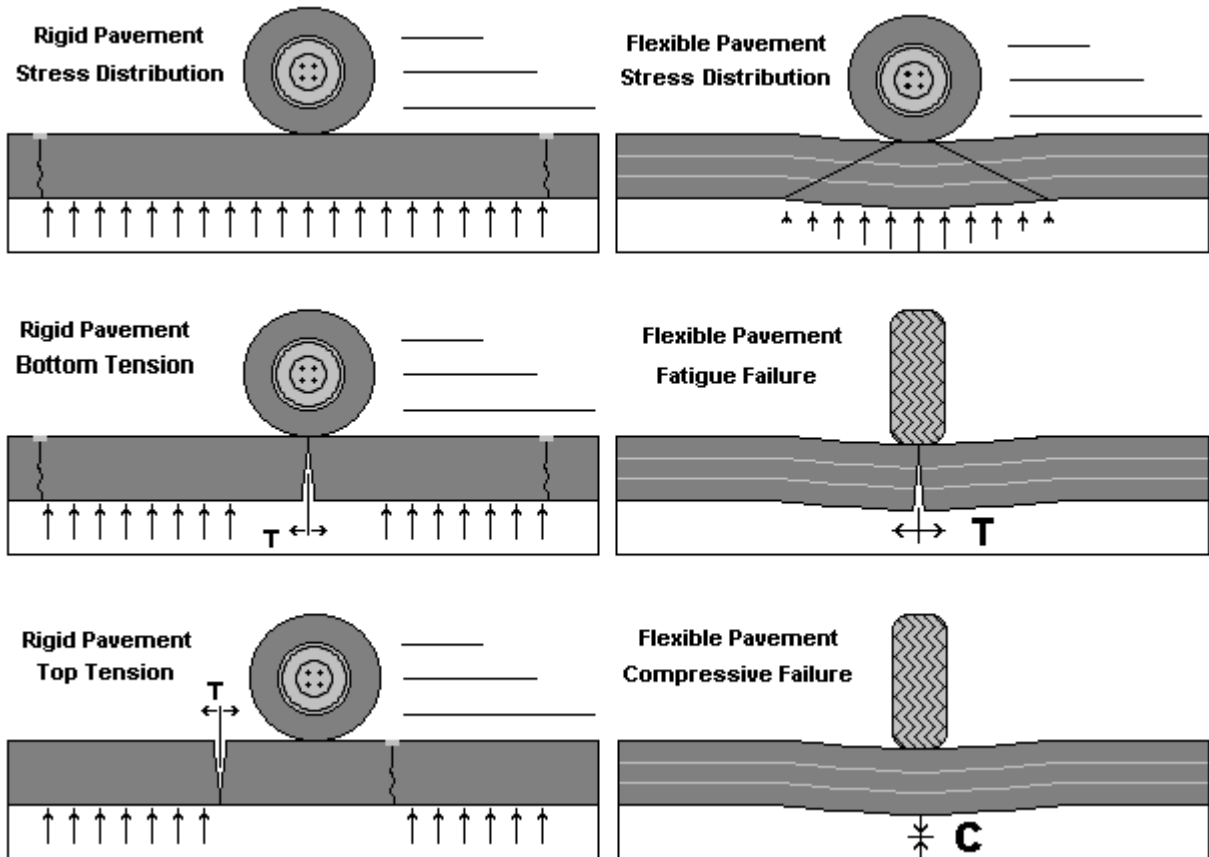
Figure G.1. Pavement failure.

Load-related cracks can start at the top or bottom of a pavement section. In asphalt sections, load-related (fatigue) cracks start at the bottom. If a load-related crack reaches the surface, it usually indicates significant structural deficiency. In PCC pavement, corner breaks are caused by top tension, and the crack propagates downward. Mid-slab LTD cracks are examples of bottom tension.

Spalls can be caused by either wheel loads or environmental factors, anytime there is movement between adjacent slabs. If a small rock is allowed into a joint, a differential movement between adjacent slabs can cause a spall. Spalling can be minimized by keeping joint and crack sealant intact.
